I've thought for a long time that there was something wrong with my headlight alignment. On dipped beam, it looked all right but on main beam the left and right "hotspots" almost touched each other when shone on my garage door. When I had a look at the headlights, the LH one seemed to line up OK with the wing and bumper but the RH one was way out of whack.

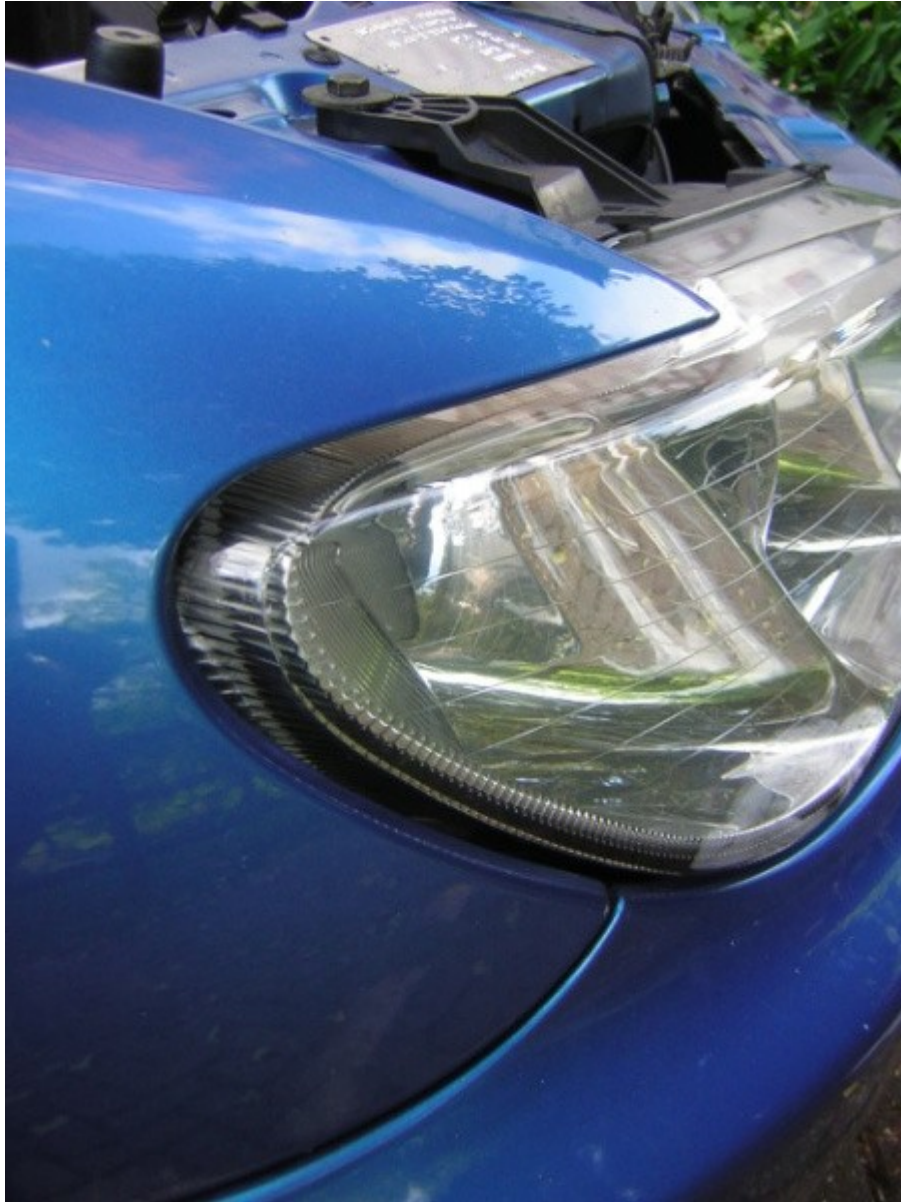
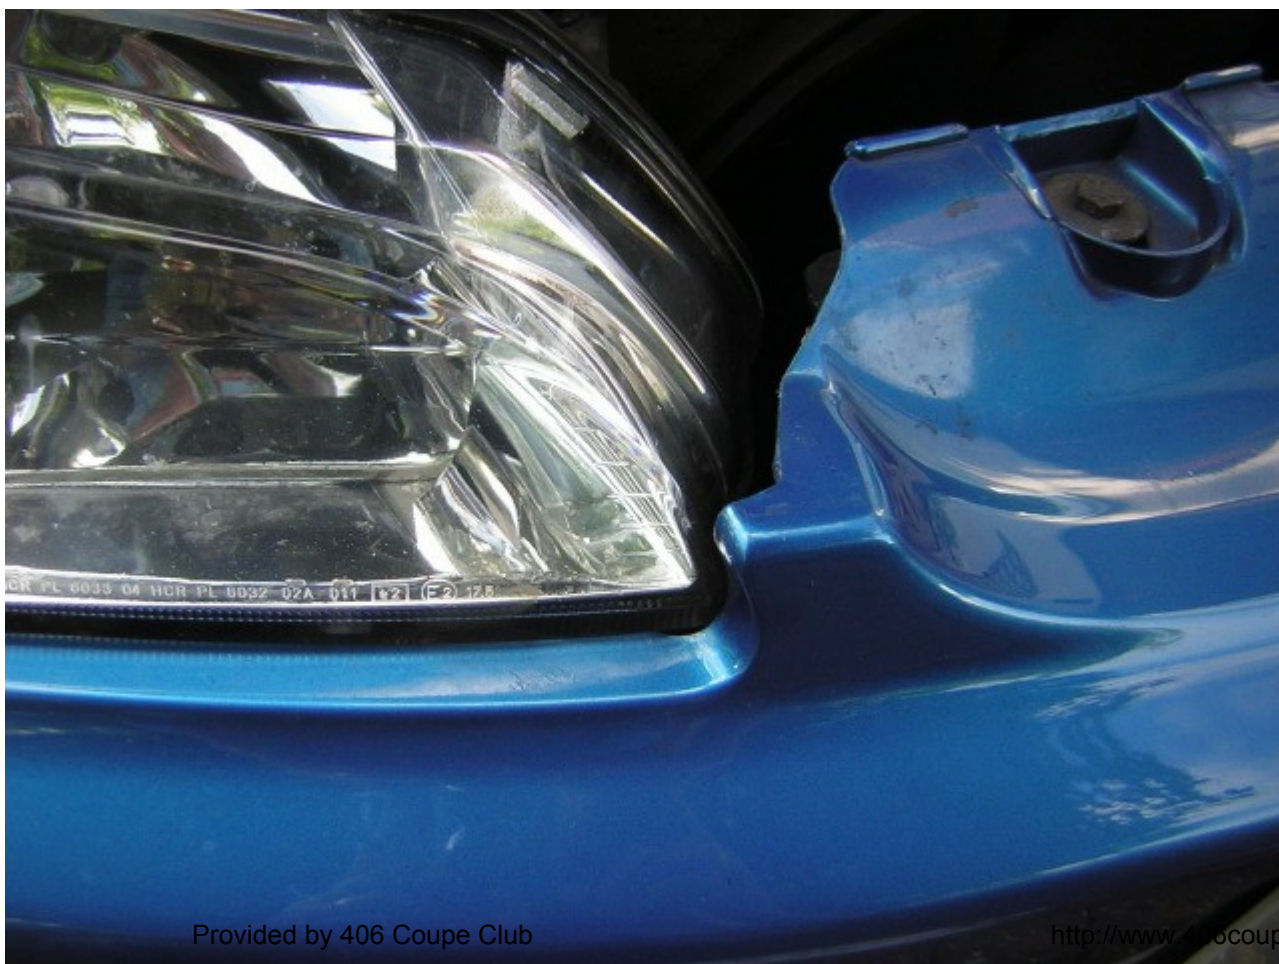
It was sticking out at the wing end and was too far in at the other.

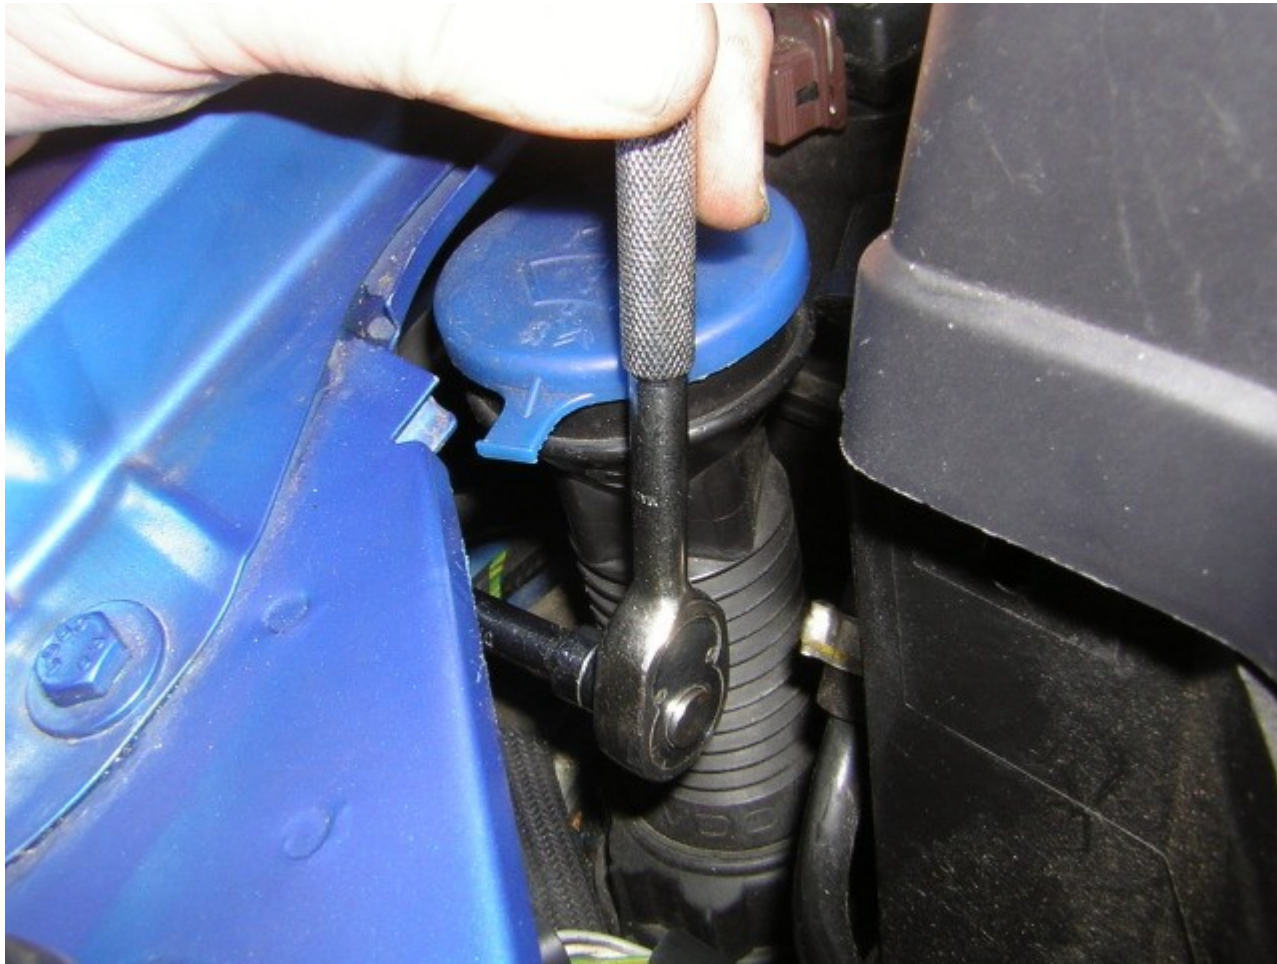
I removed the top mounting bolt then had a go at the outer one. This is a 10mm nut that screws on to a stud on the inner fliitch panel. I found that a 1/4" drive ratchet and extension would fit between the wing and the ECU box.

You can get a bit more room to work by unscrewing the washer bottle filler pipe but be sure to stuff a rag into the hole in case you drop the nut or worse still the ratchet. (I only just thought of that, I didn't do it at the time!!!)

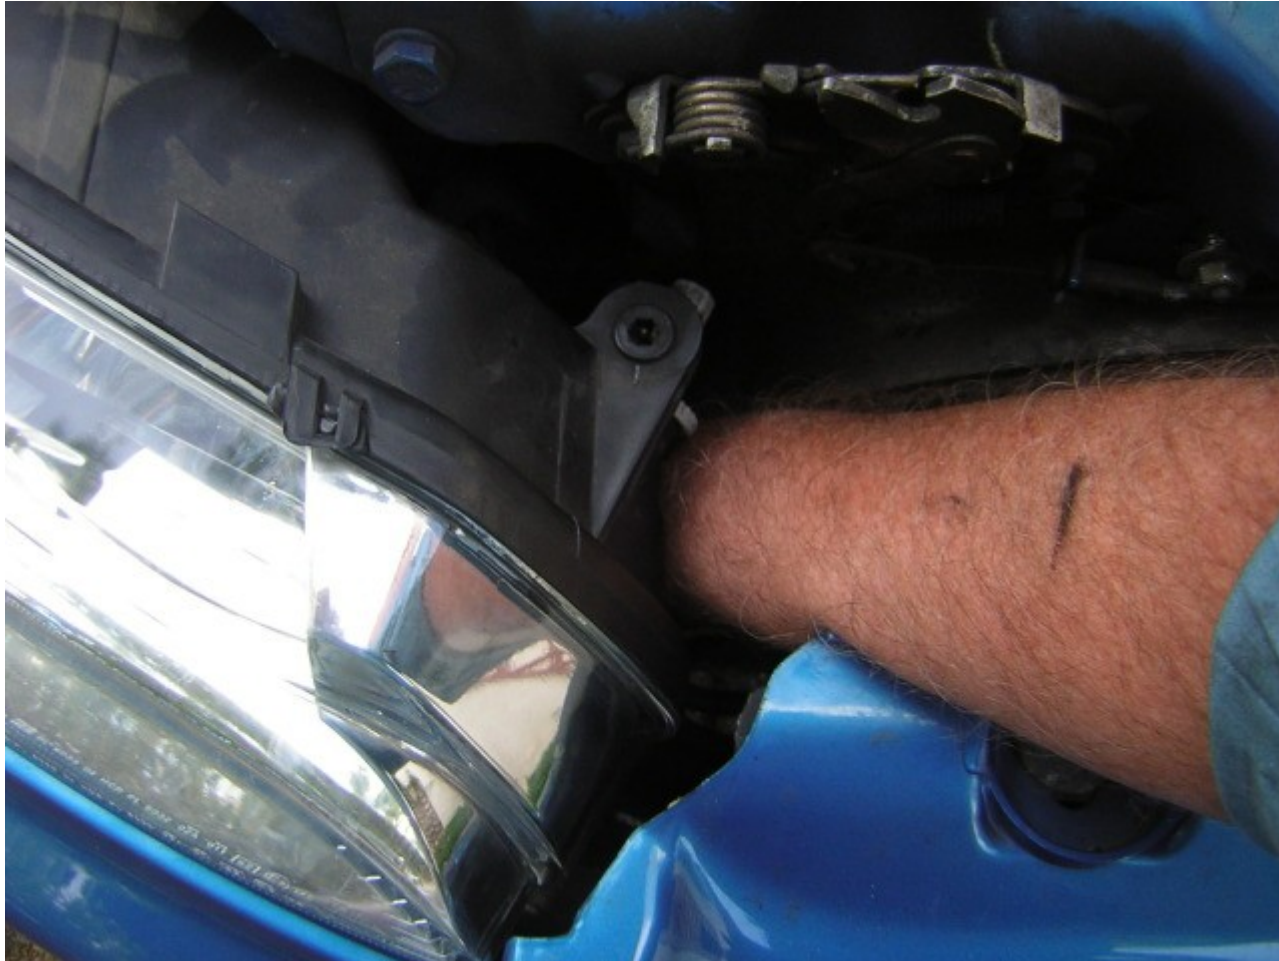
Now for the dreaded third nut. I had read up on other threads which talked about bending the bumper down and sticking a ratchet through the gap but this sounded horrible. I found I could stick my arm down between the bumper and the fan and could feel the nut well enough to get a spanner on it. However it was a tight squeeze and is the part of the job where skin was lost.

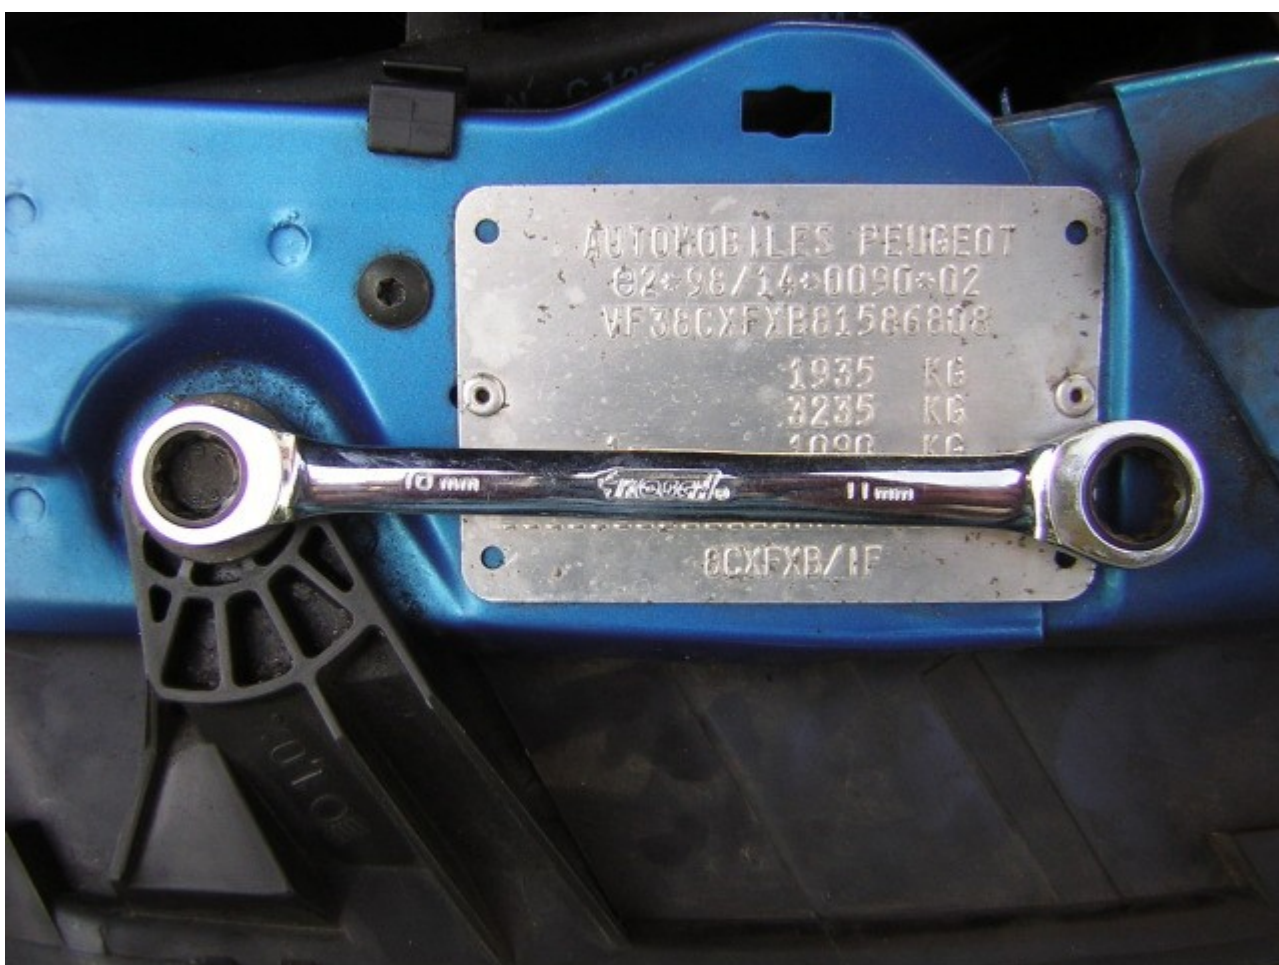
For those of you unfamiliar with this, it's called a Gearwrench and is a ring spanner with a ratchet mechanism built in. I've had a set of these for some time but this is the first time I've used one. Magic!! <http://www.406coupeclub.org>

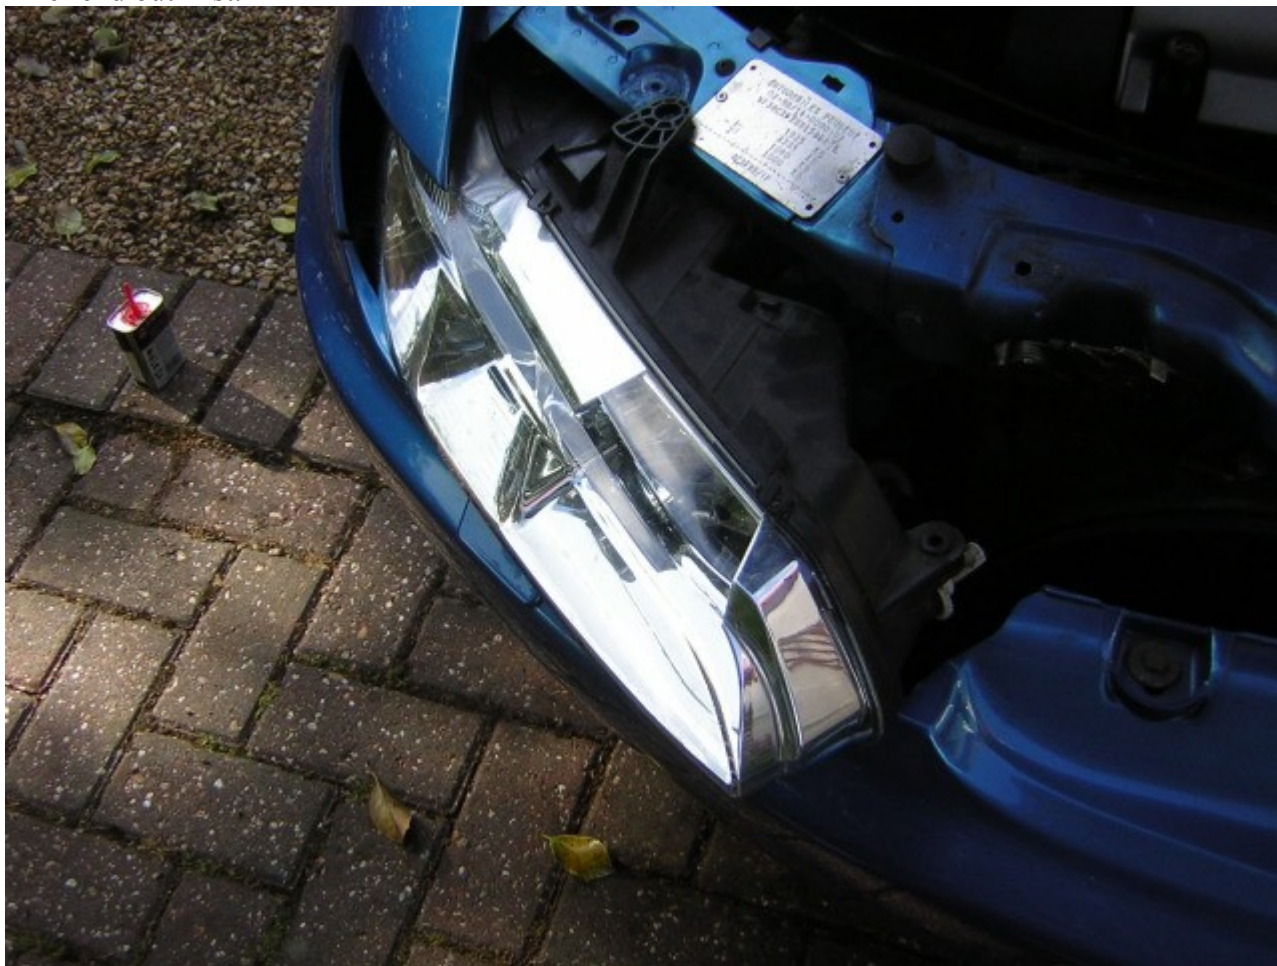
Eventually the third mount was free. I disconnected the plugs and wiggled the unit out. It came out best by swinging the inner end out first.

Also it helped to twist the levelling motor about 1/4 of a turn (I didn't need to take it right off). After some fiddling about the light came off in my hand!! It was then possible to get a good look at the two hidden mounting studs and the appropriate lugs on the headlight.

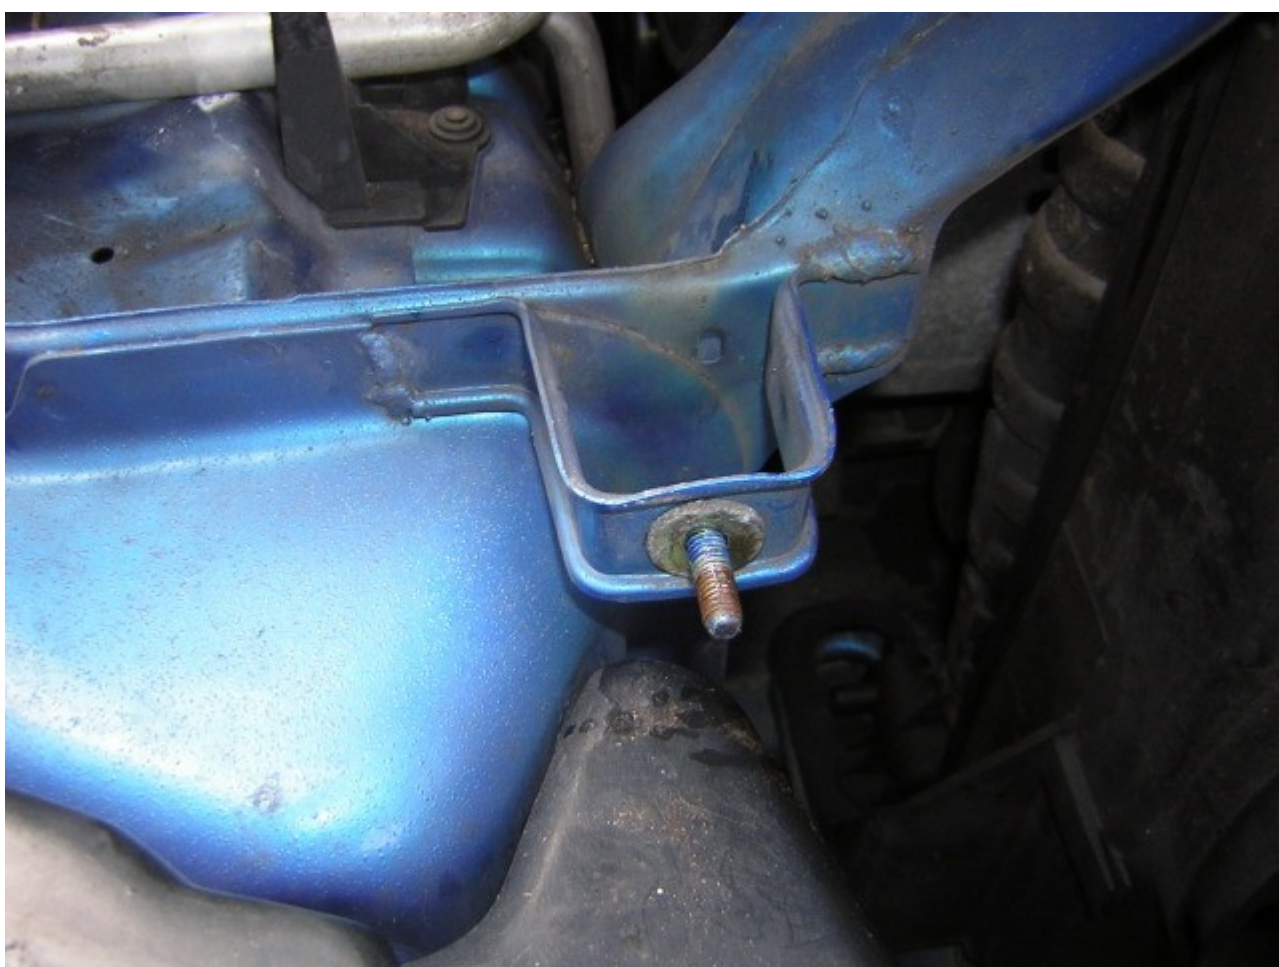
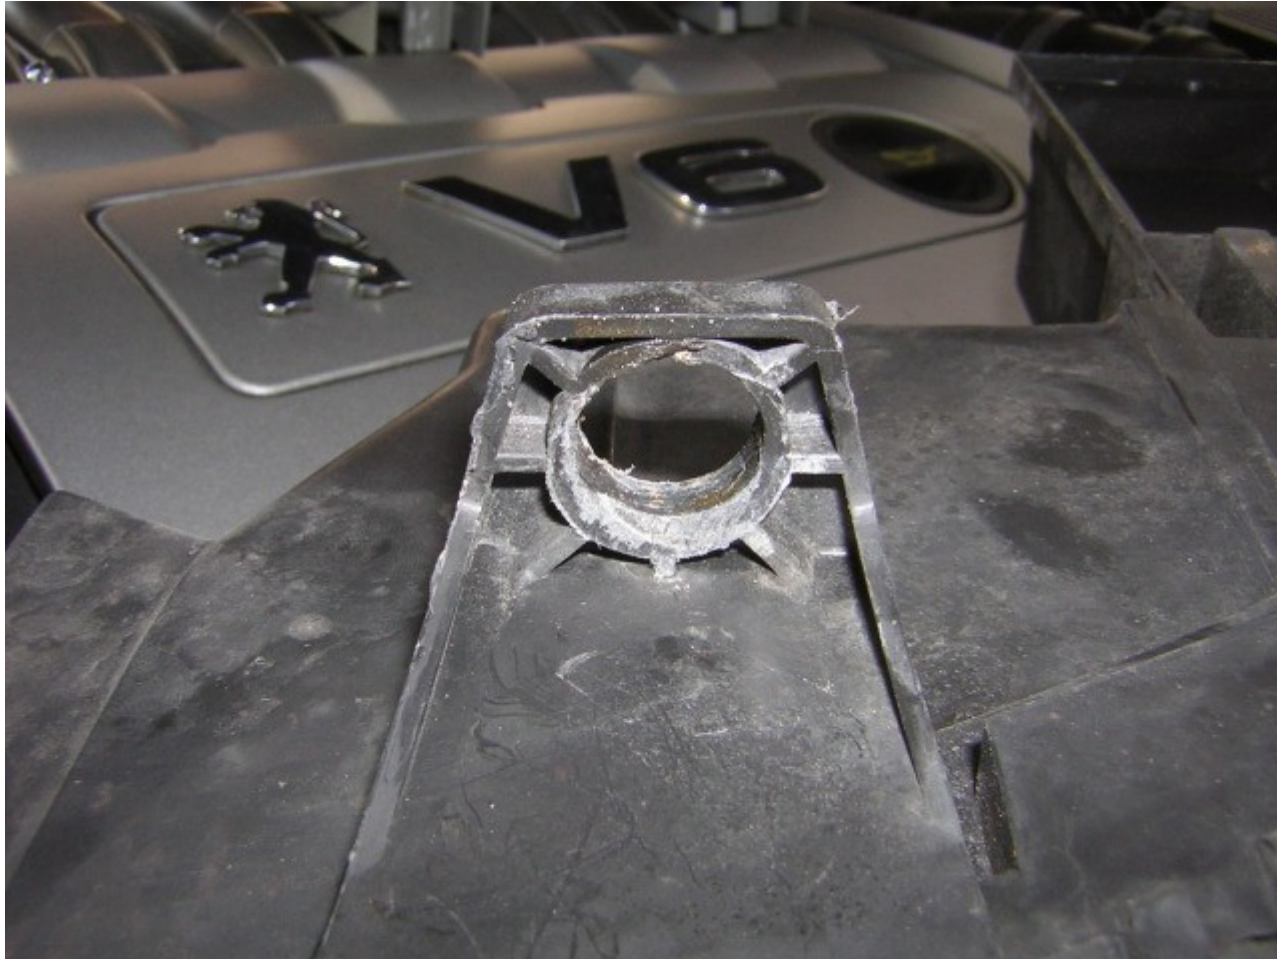
Now the lower mount.

The lower one looked a bit bent to me so I put the nut back on and tapped it straight. However it also seemed to me that, with the nut done up tight, the light would go back to its old crooked position, so I cut down an old rubber grommet to act as a packing piece. After a couple of goes, I got the right thickness and decided to put the light back. A tip here is to put some oil or grease on the studs and run the nuts up and down a couple of times so you will be able to hand tighten the nuts as much as possible before needing a spanner.

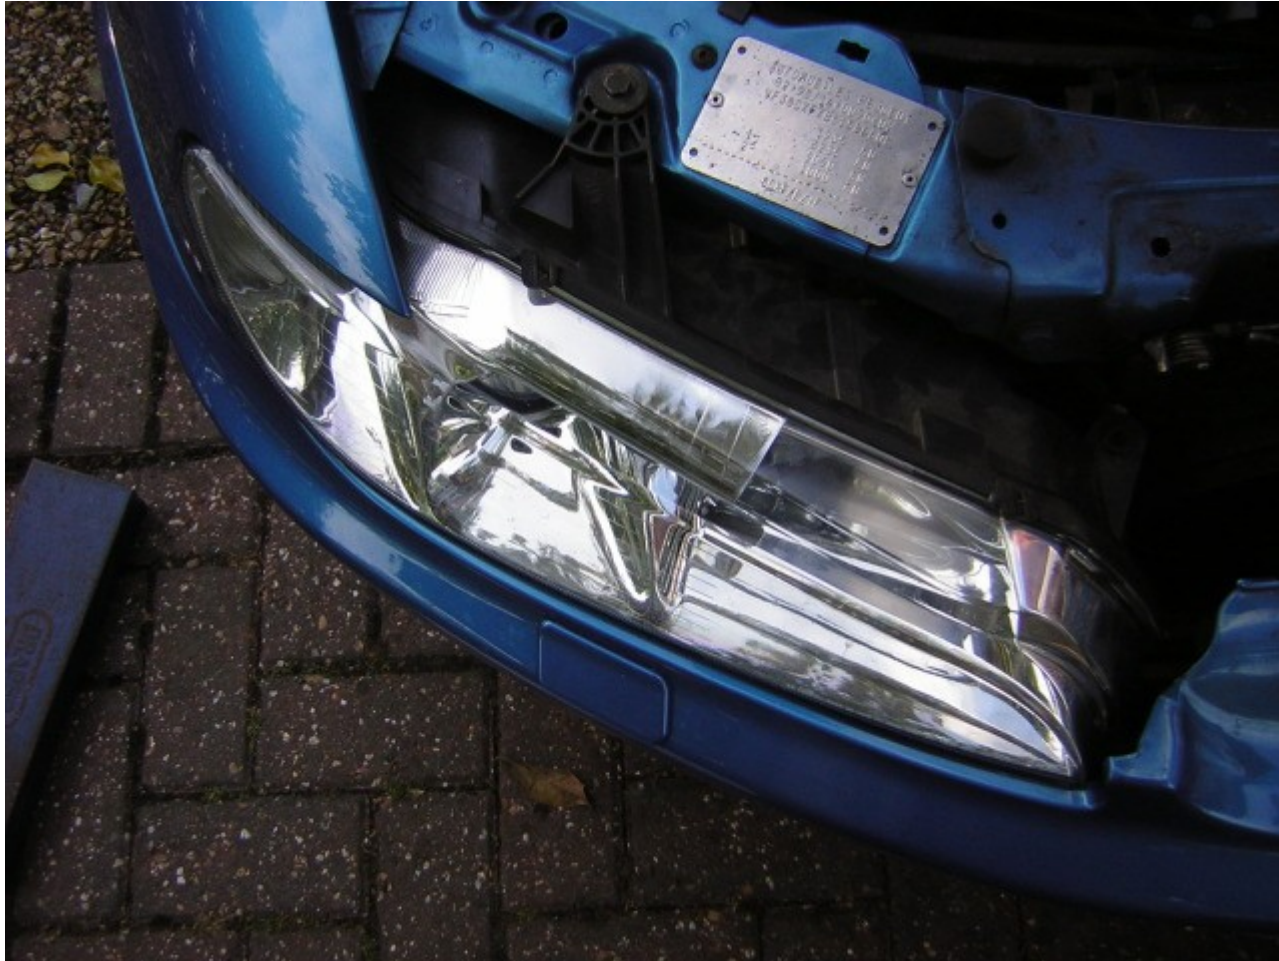
Once the unit was back in the alignment with the body was much better. It is still not perfect, it needs a bit more packing on the lower mount but I have a feeling it may have to come out again anyway so this will do for now.

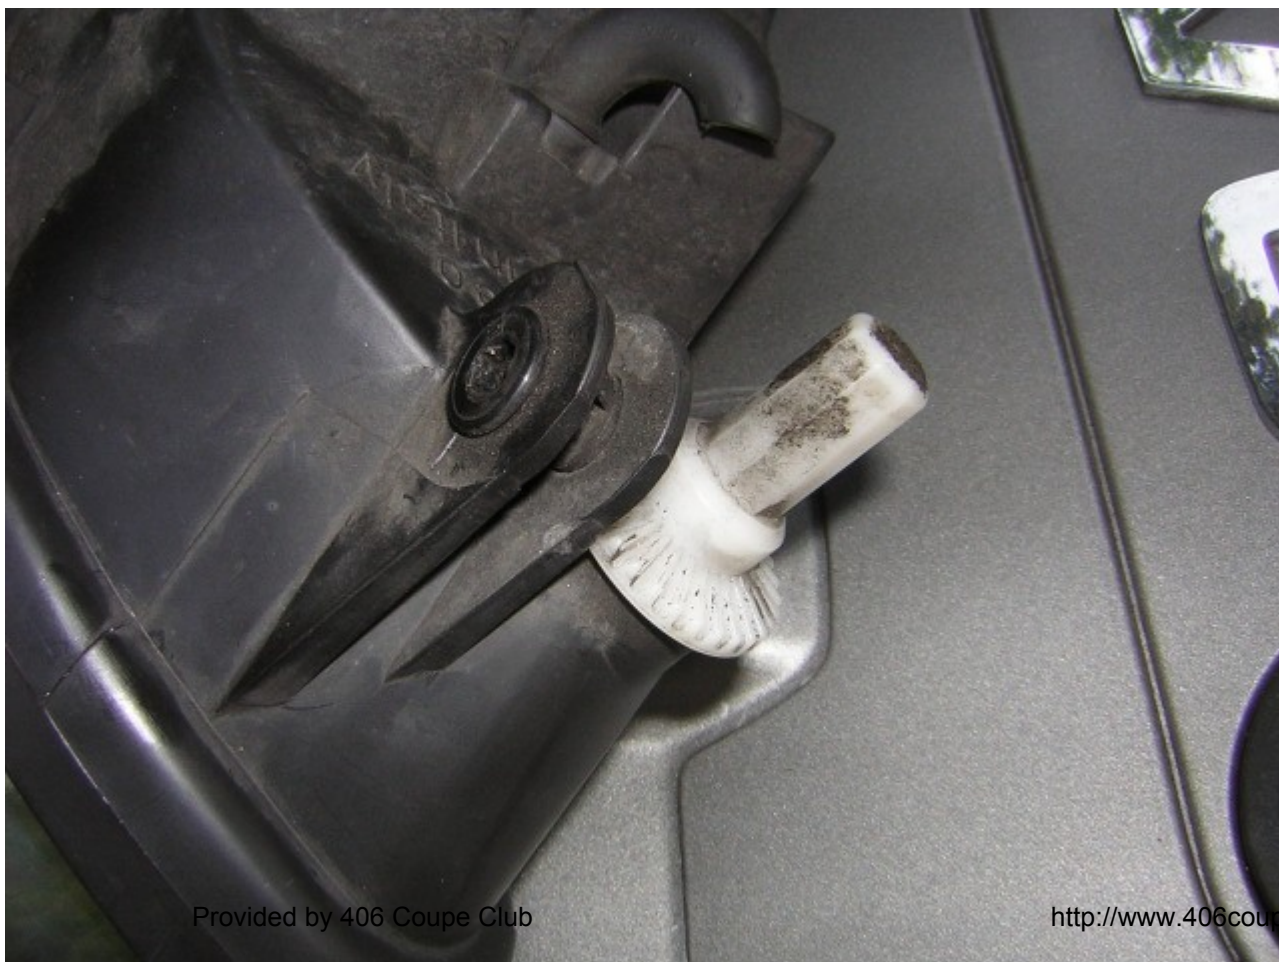
At each inner end of the two headlights there is another adjuster that also needs an allen key and drives a bevel gear. I understand this may be a horizontal adjuster. It doesn't move the light but seems to act on the reflector inside the unit.

I need to play with it some more to see what it does. Note that you can only get at this, or even see it, by removing the black trim panel.
