I've had random system immobiliser defective messages & decided to buy a new pick up ring as it was cheap to do & easy to replace. Occasionally when I turn the ignition on to position 2, I'm greeted with a beep, the orange key icon on the instrument panel & the message on the MFD. If I turn it off & back on, it seems fine.

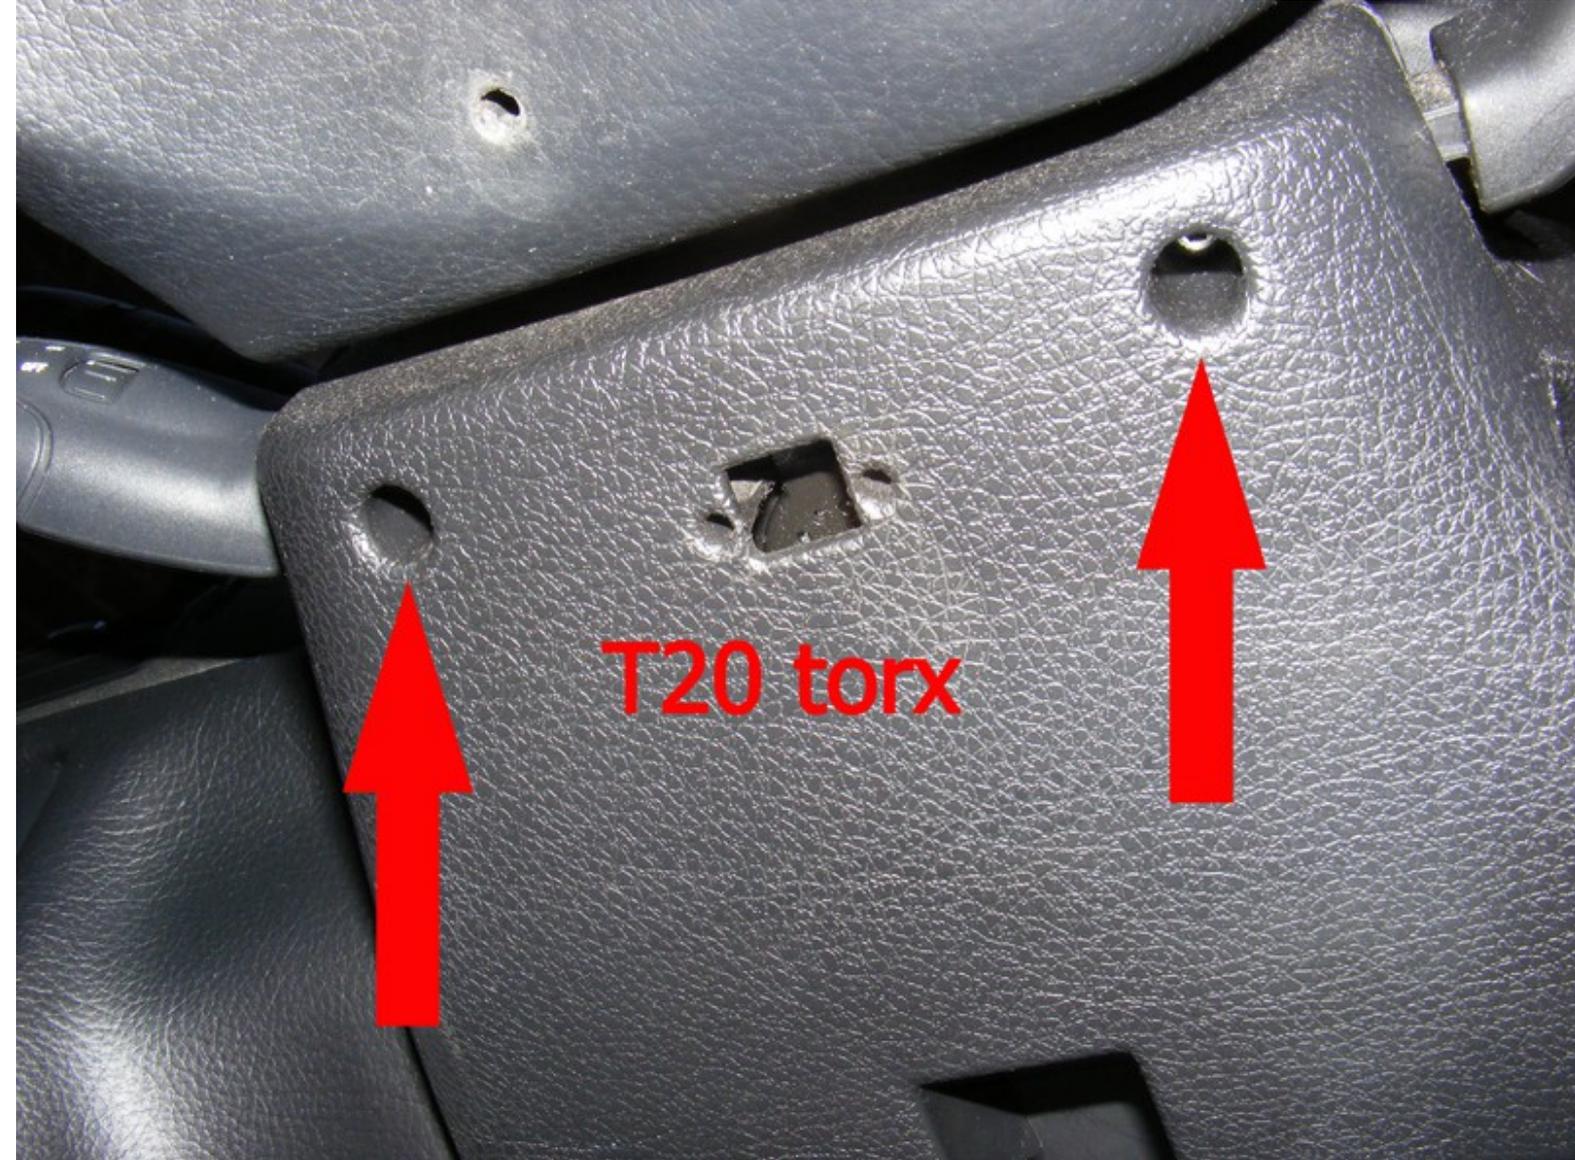
Use the T20 torx key & remove these 2 screws, they'll come all the way out so make sure you catch them:

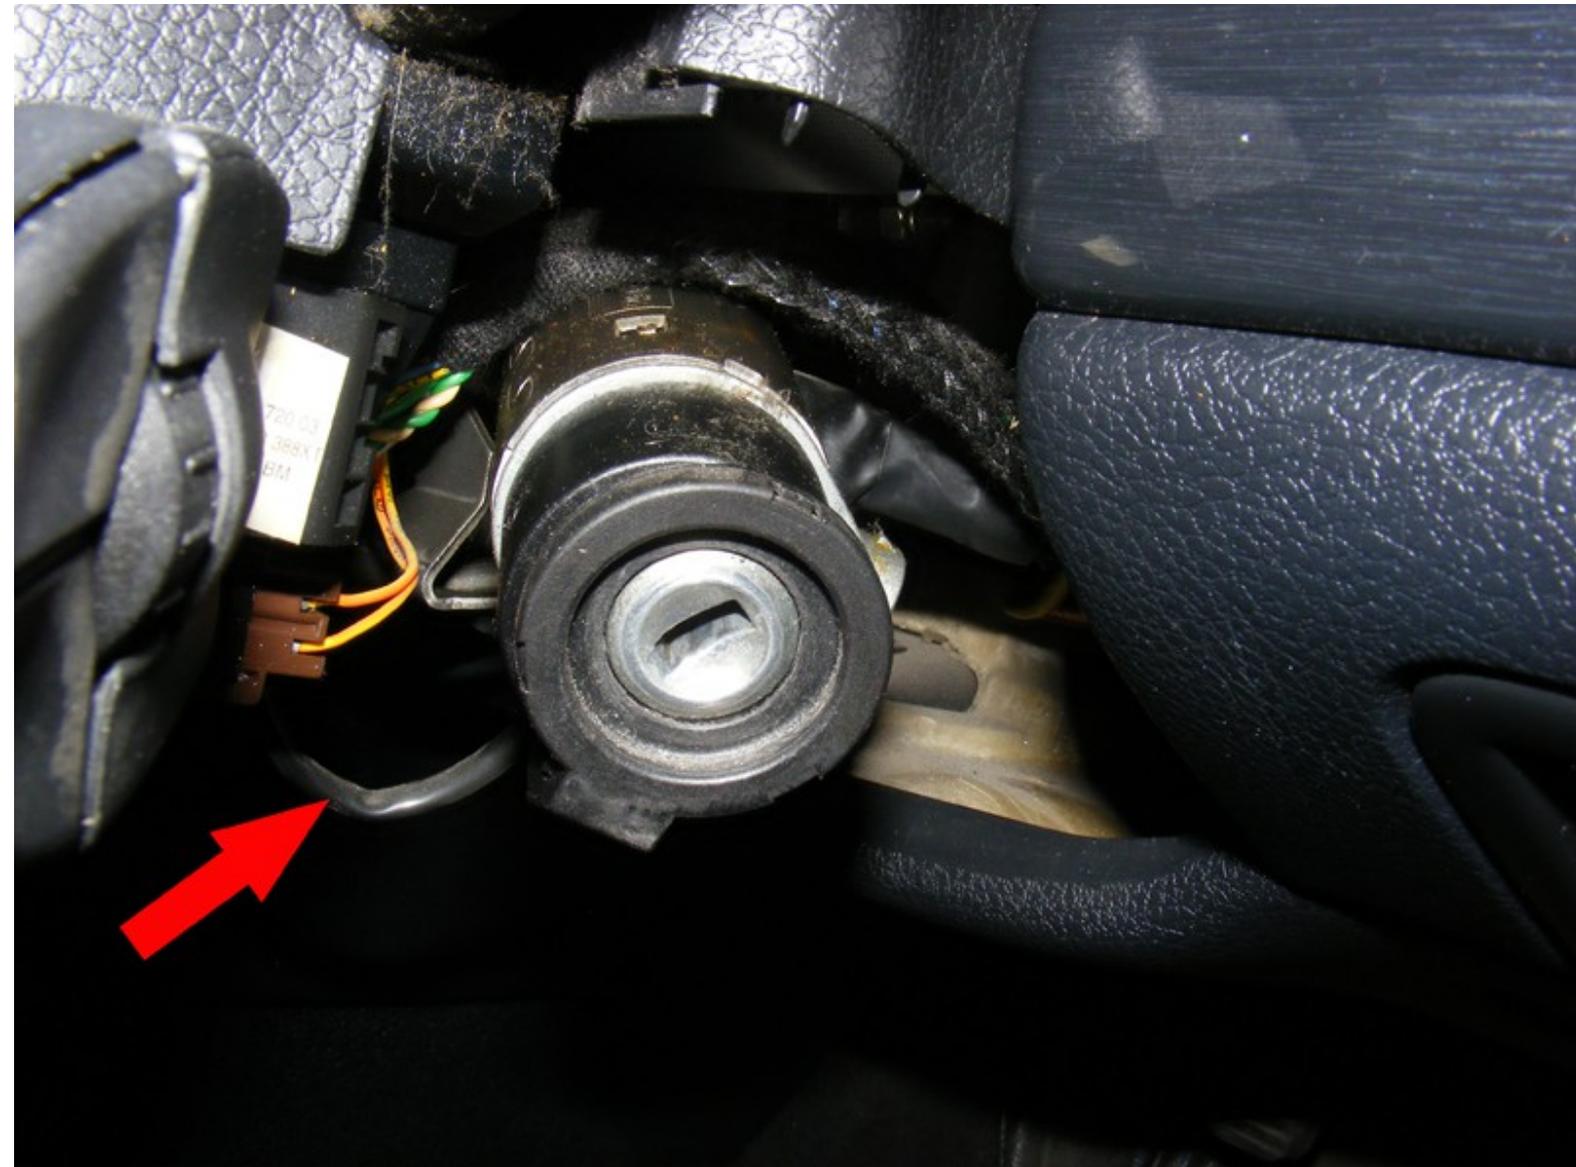
Once you've removed the 2 screws & pulled the lower half of the cover off, you'll see this. The arrow shows the wire from the pick up ring you're about to change:

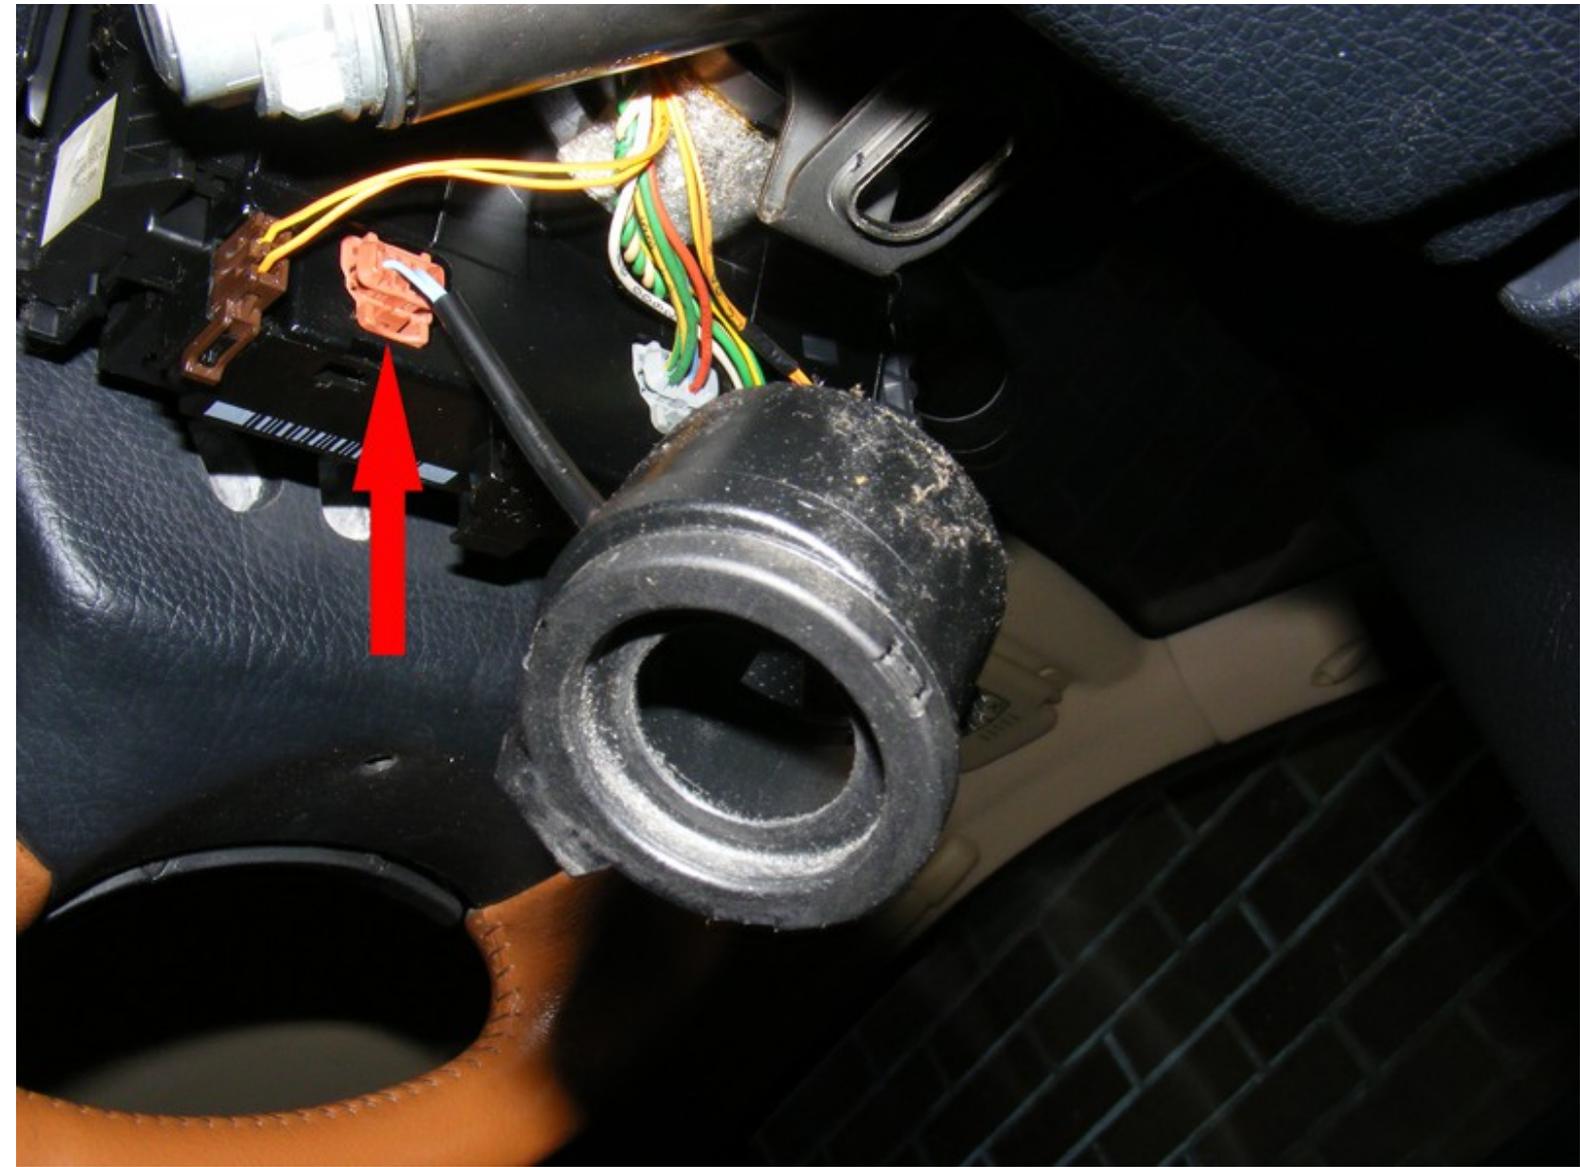
The wire is only about 4" long, so you can't miss it. Here you can see where it plugs into. At the bottom of this brown plug is a very small tab, you need to pull this tab downwards whilst pulling the connector out:

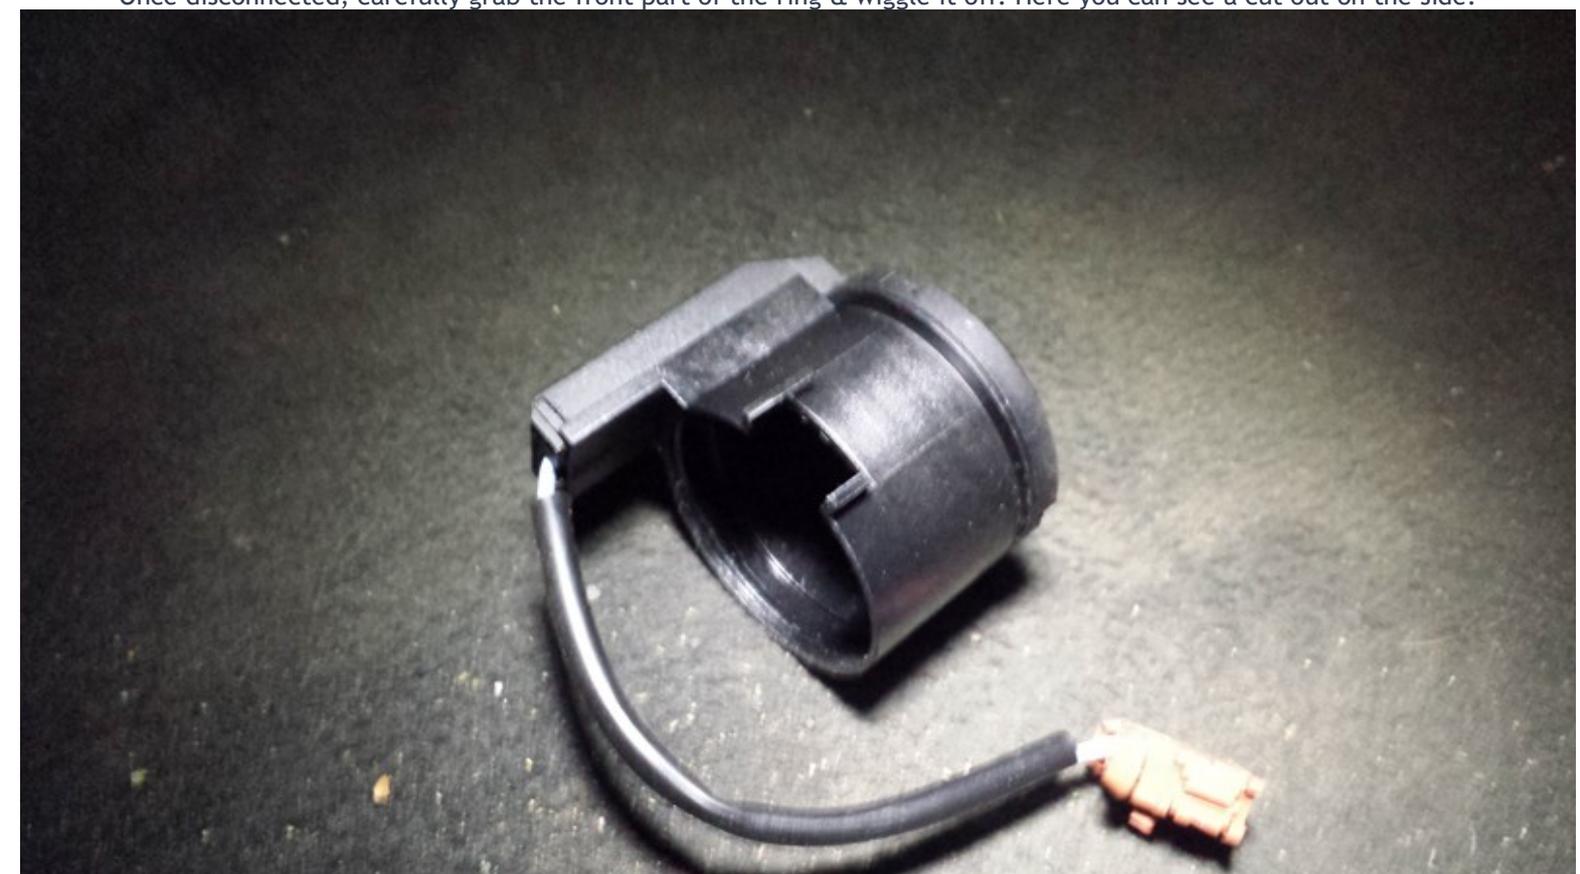
Once disconnected, carefully grab the front part of the ring & wiggle it off. Here you can see a cut out on the side:

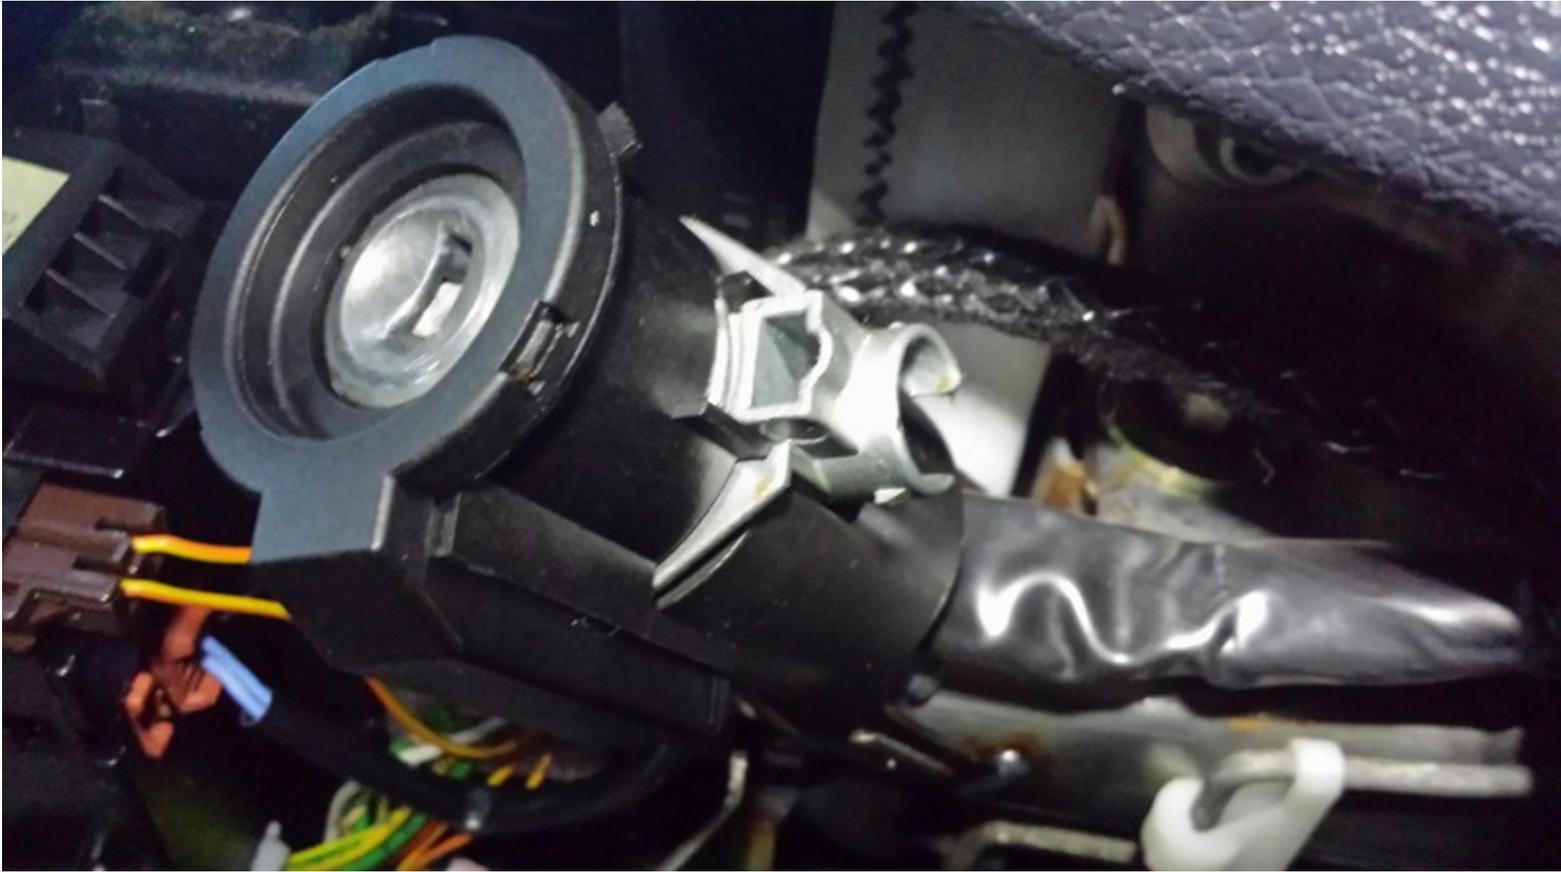
Fitting is easy too. With the cut out above towards the dash, it slips over the metal part of the barrel, the black chunky part of the new aerial points almost downwards:

Check your work by starting the car a few times, all should be well. Reassemble the lower panel & you're done.
