*Searchwords: oil cap leaking, oil in spark plugs wells, oil in spark plugs*

I've done this on my D8 V6 today during a 20 minute oil change, so the principle is the same regardless of engine.

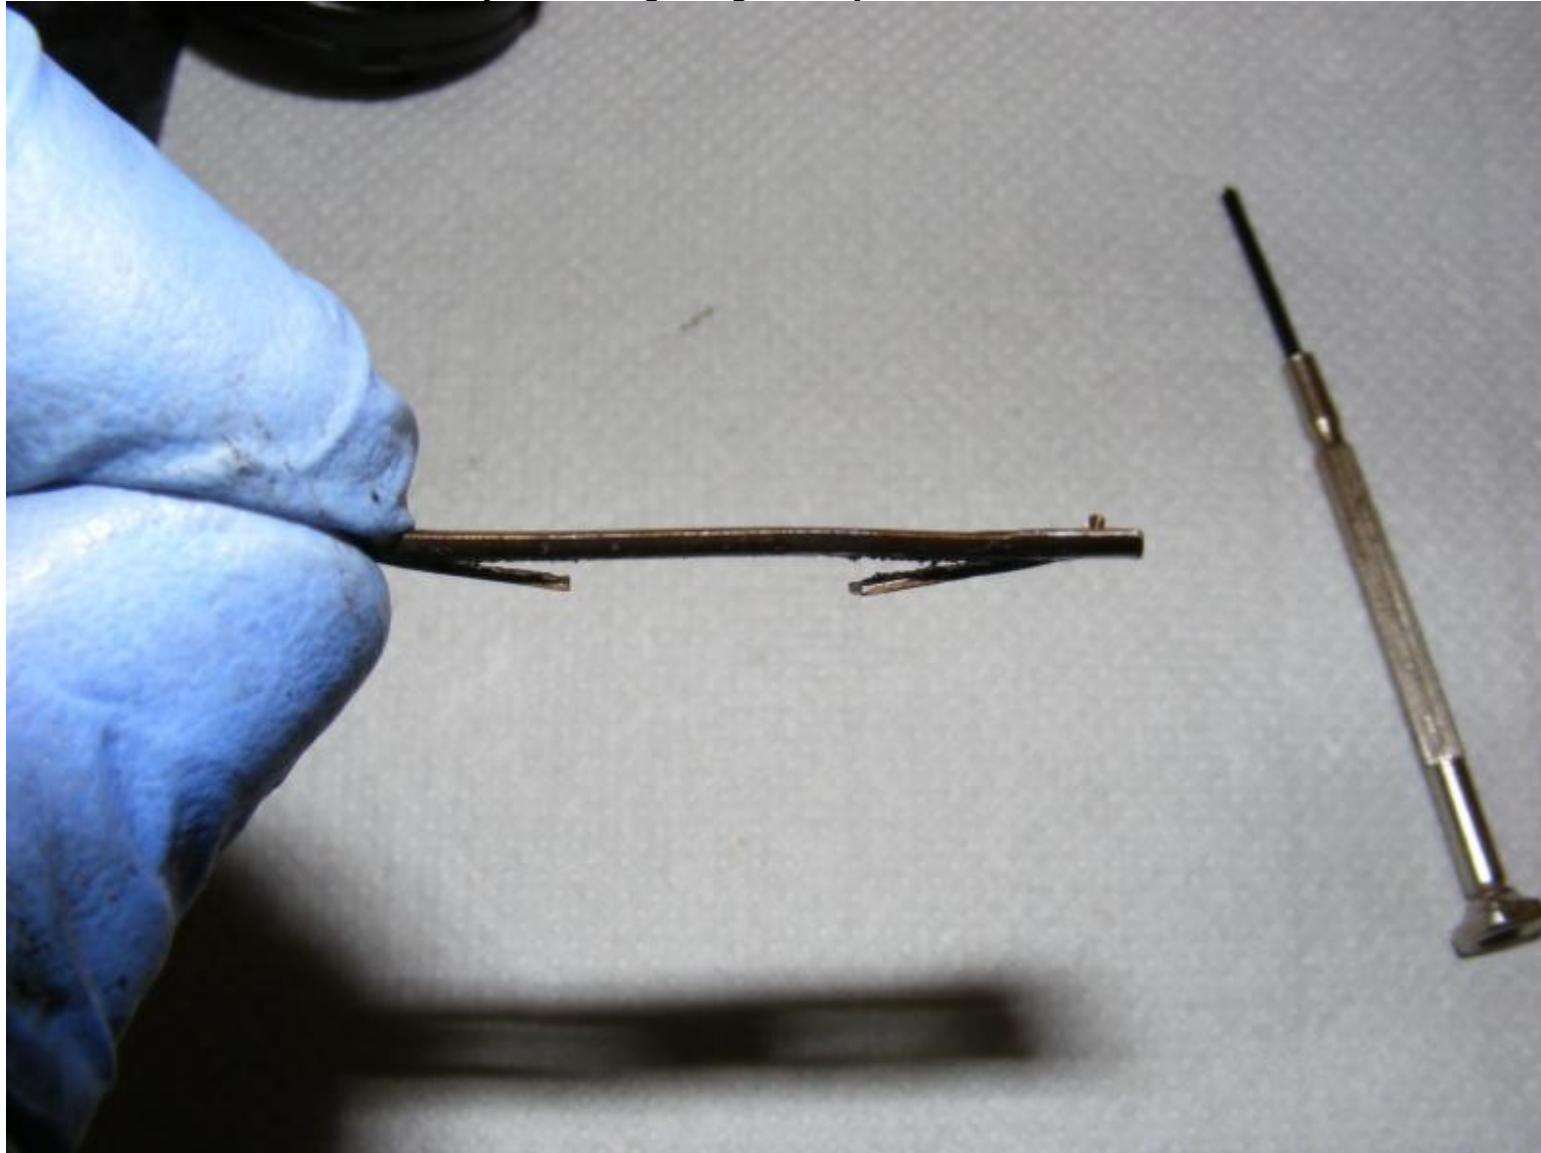
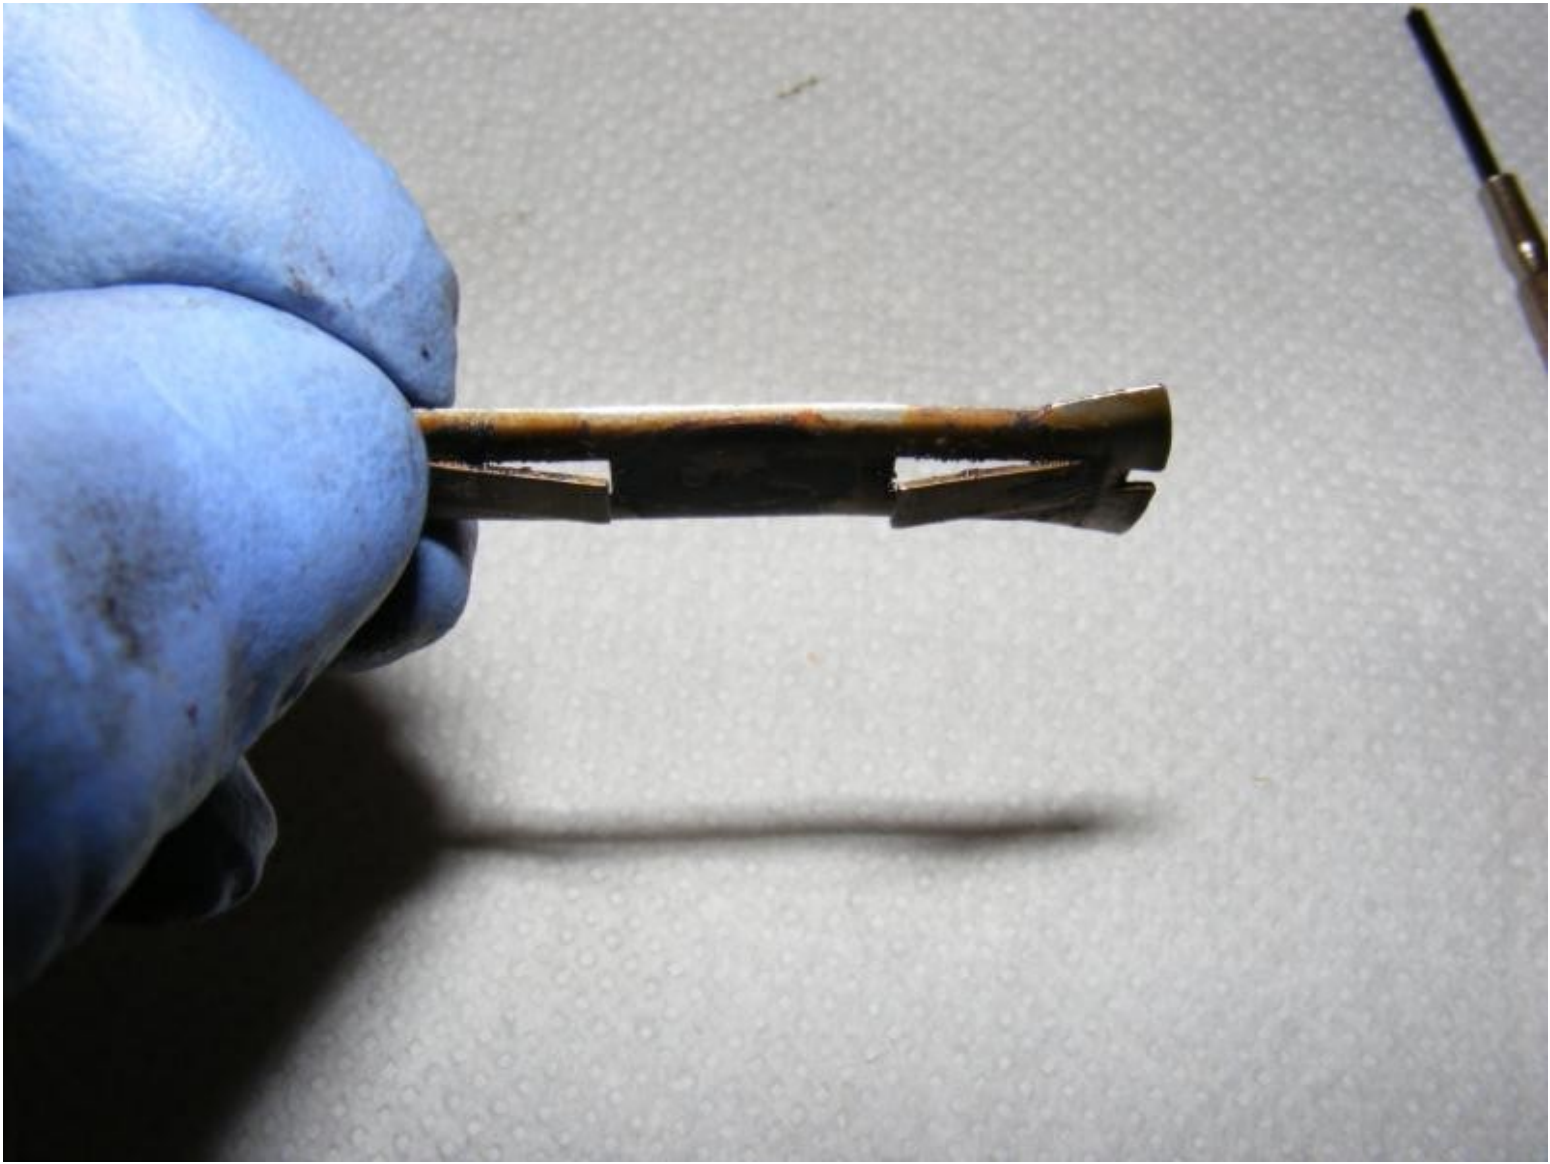
Once you've managed to get it out you'll be left with this:

First of all remove the oil filler cap. There's a metal bar going through it. Towards the centre of the bar is a piece of metal that is pushed downwards to stop the metal bar coming loose & dropping into the engine. What I did was used a small thin screwdriver to gently ease up the tabs that stop it moving so I could get it out. It's a fiddly job so just take your time. One side is wider than the other, so remove it by pushing towards the wider side.

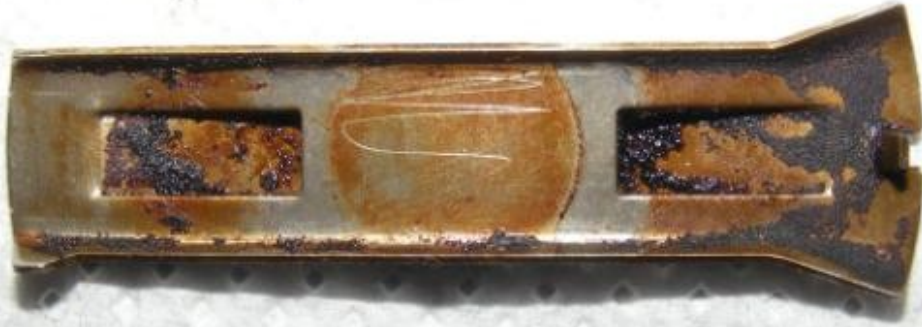
Top view of the metal piece. Notice the wider right side, it obviously comes out -----> way:

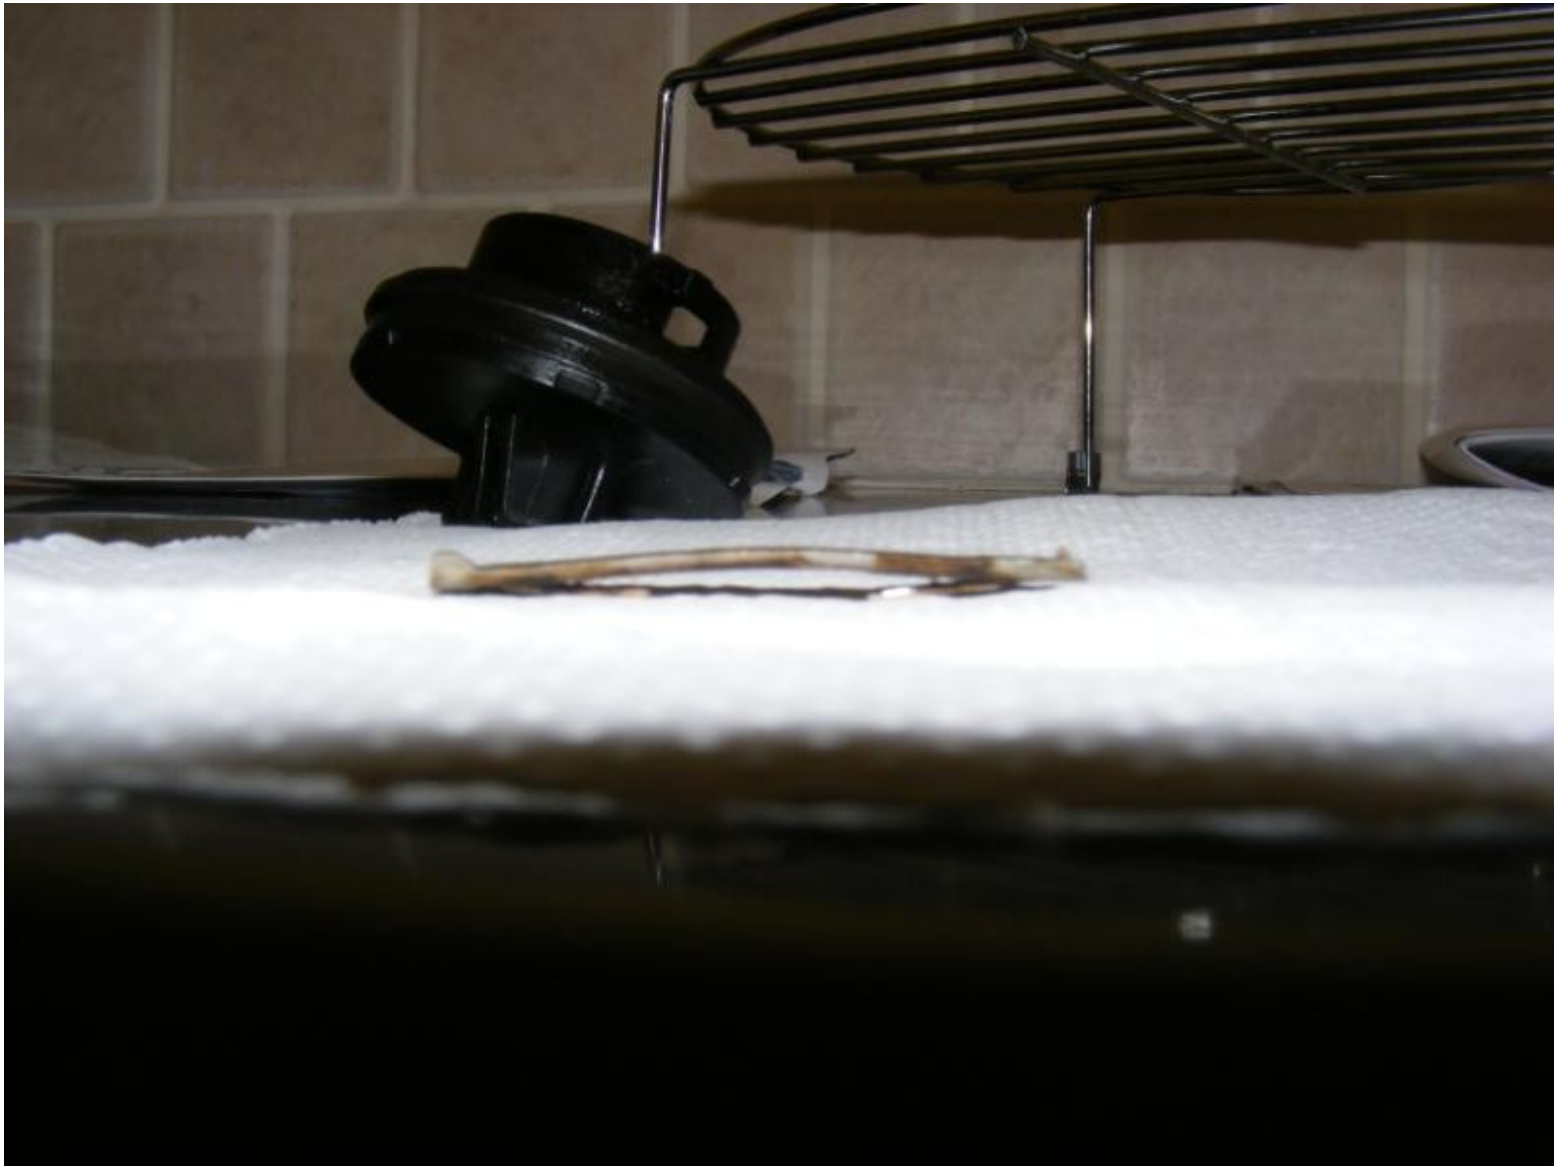
What you need to do is put a gentle bend right in the middle of it, so the sides are pointing downwards. It only has to be a light bend, nothing major:

What it seems to do is the edges of the clip are bent so the gap between them & the rubber seal is narrowed, this makes the seal tighter.

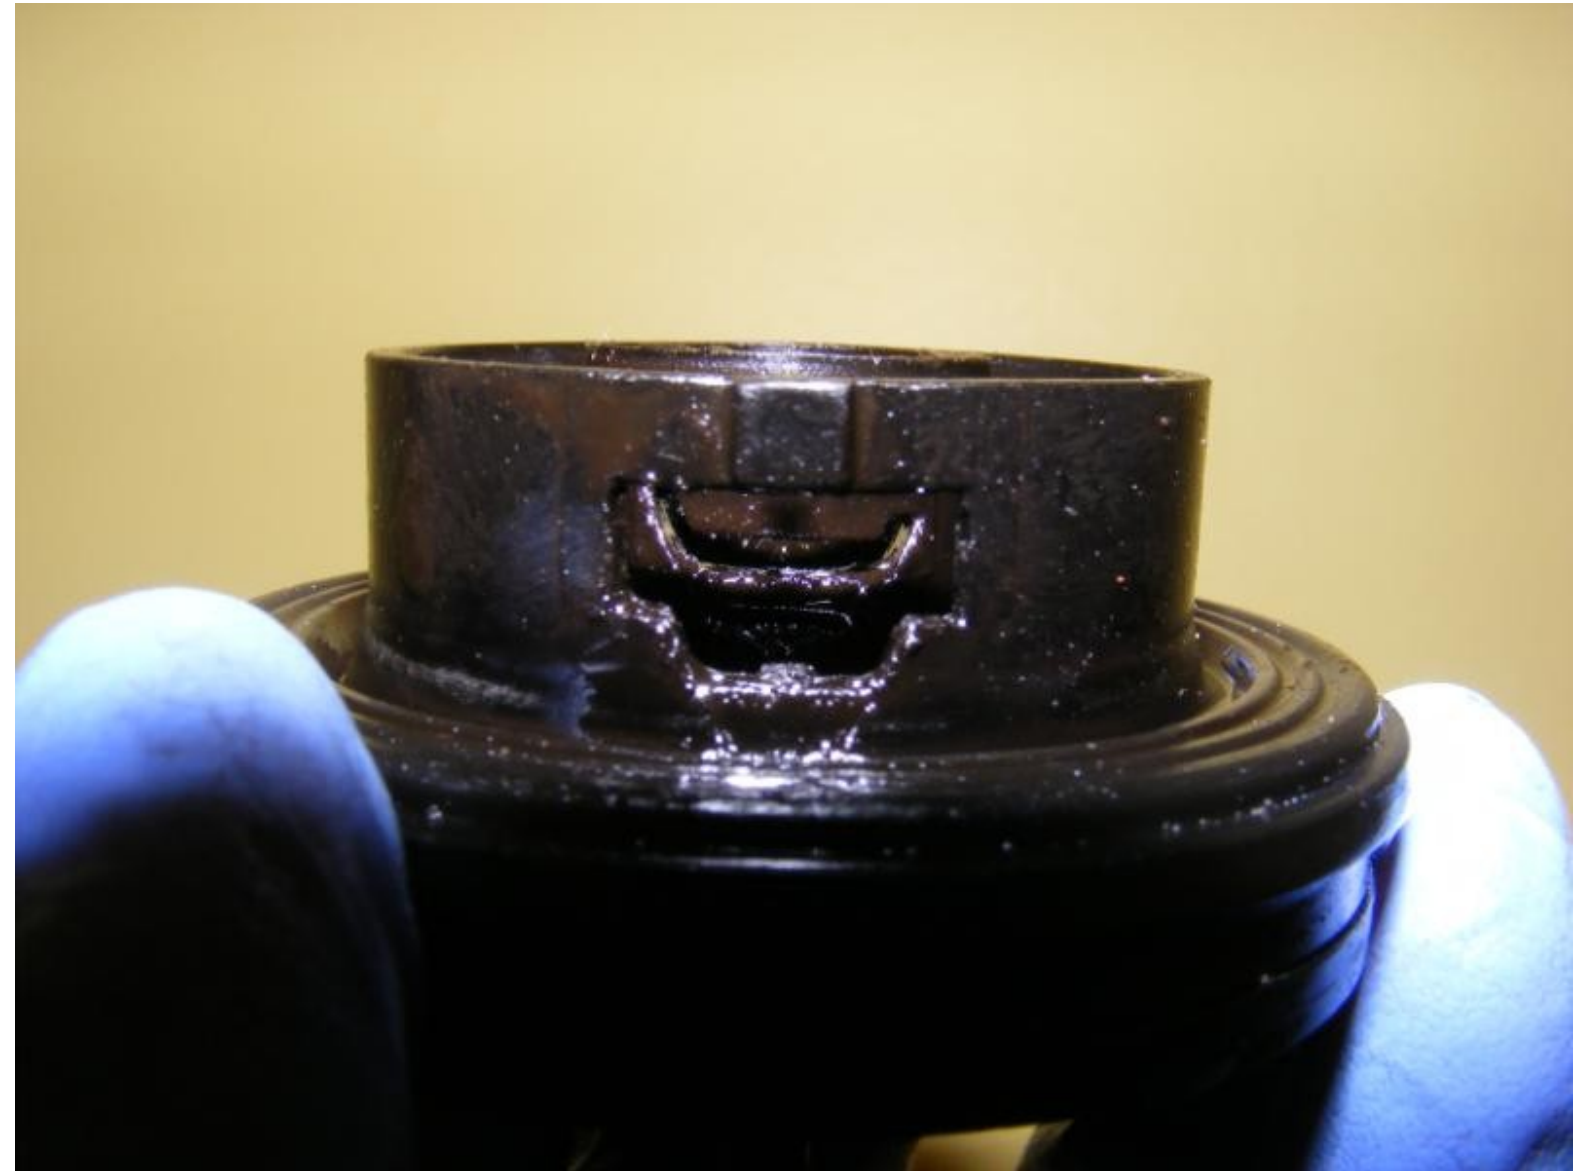
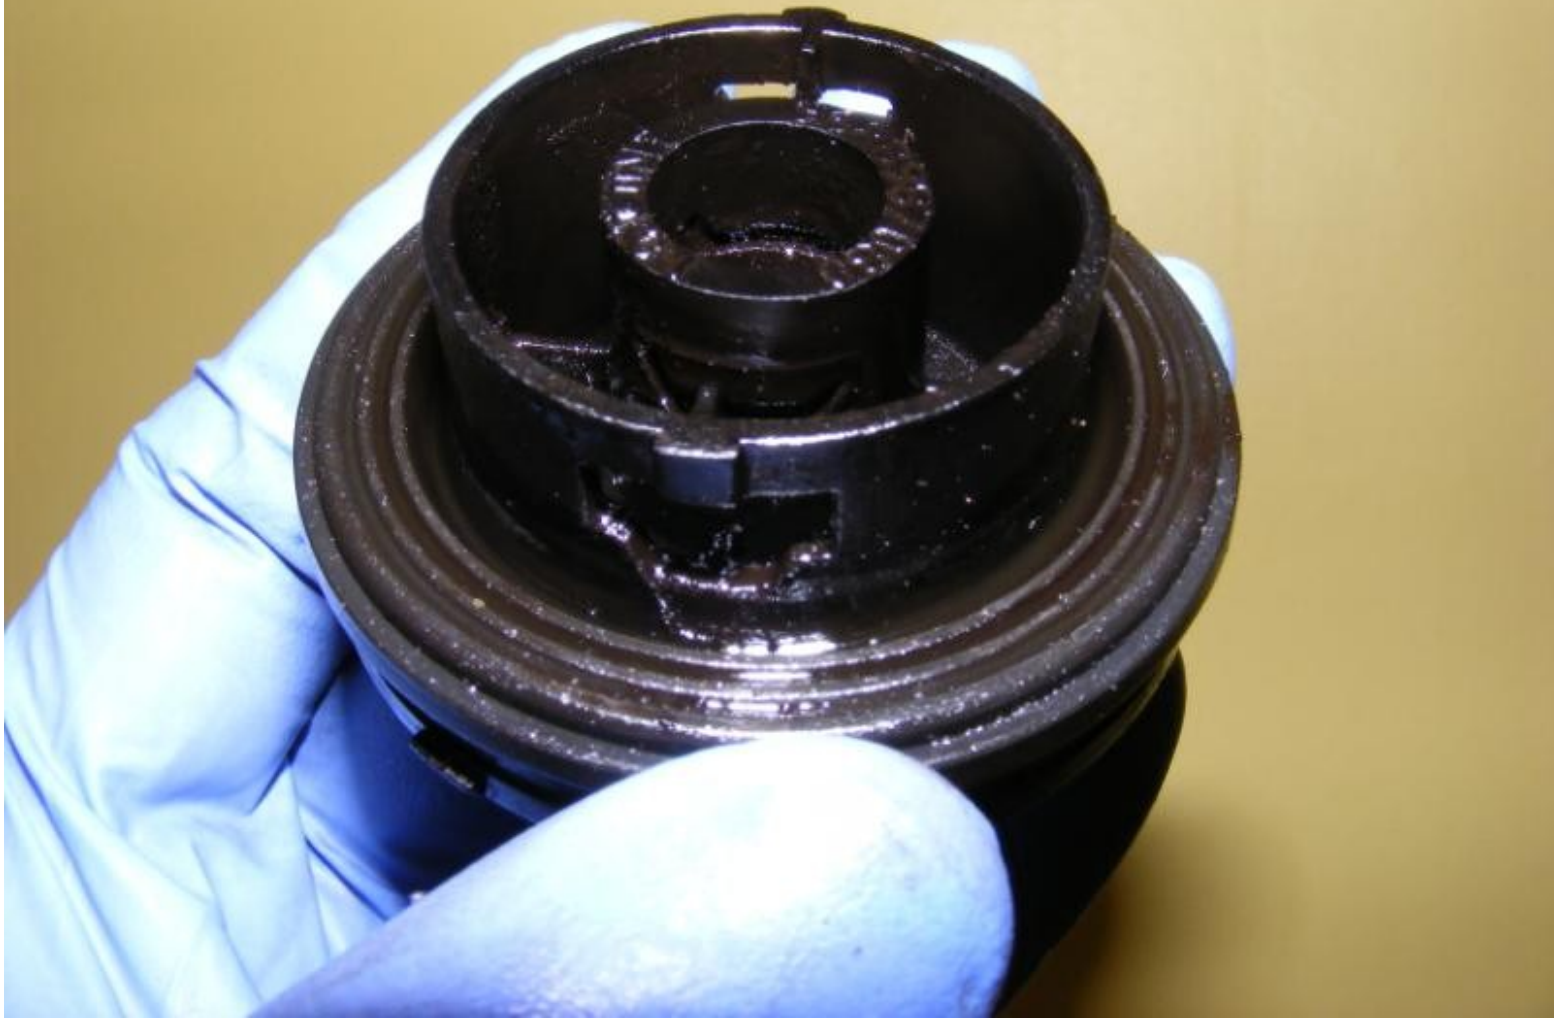
These 2 pics show where the metal has come from:

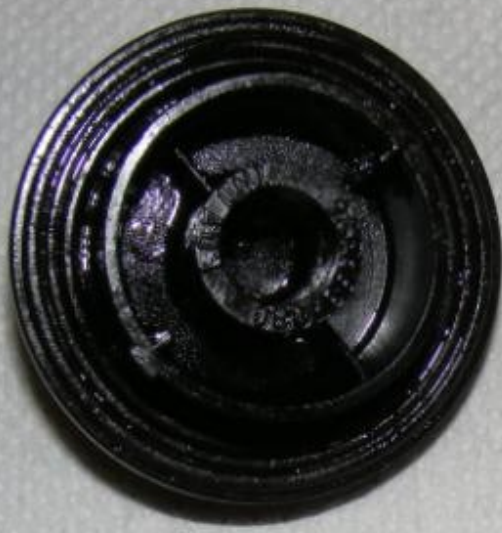
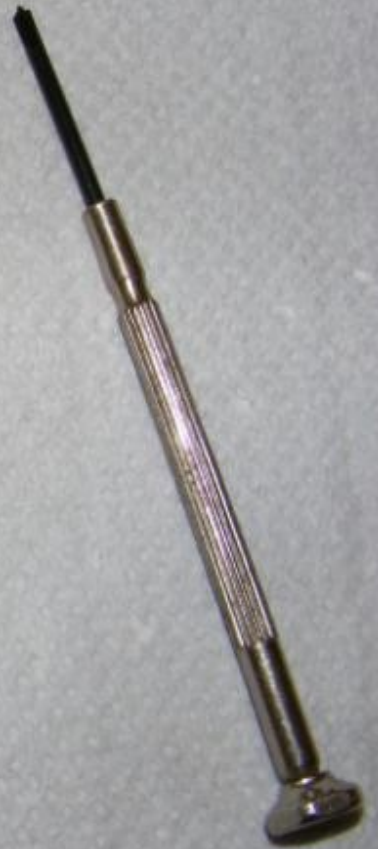
The metal piece out of the oil filler cap with the screwdriver used:

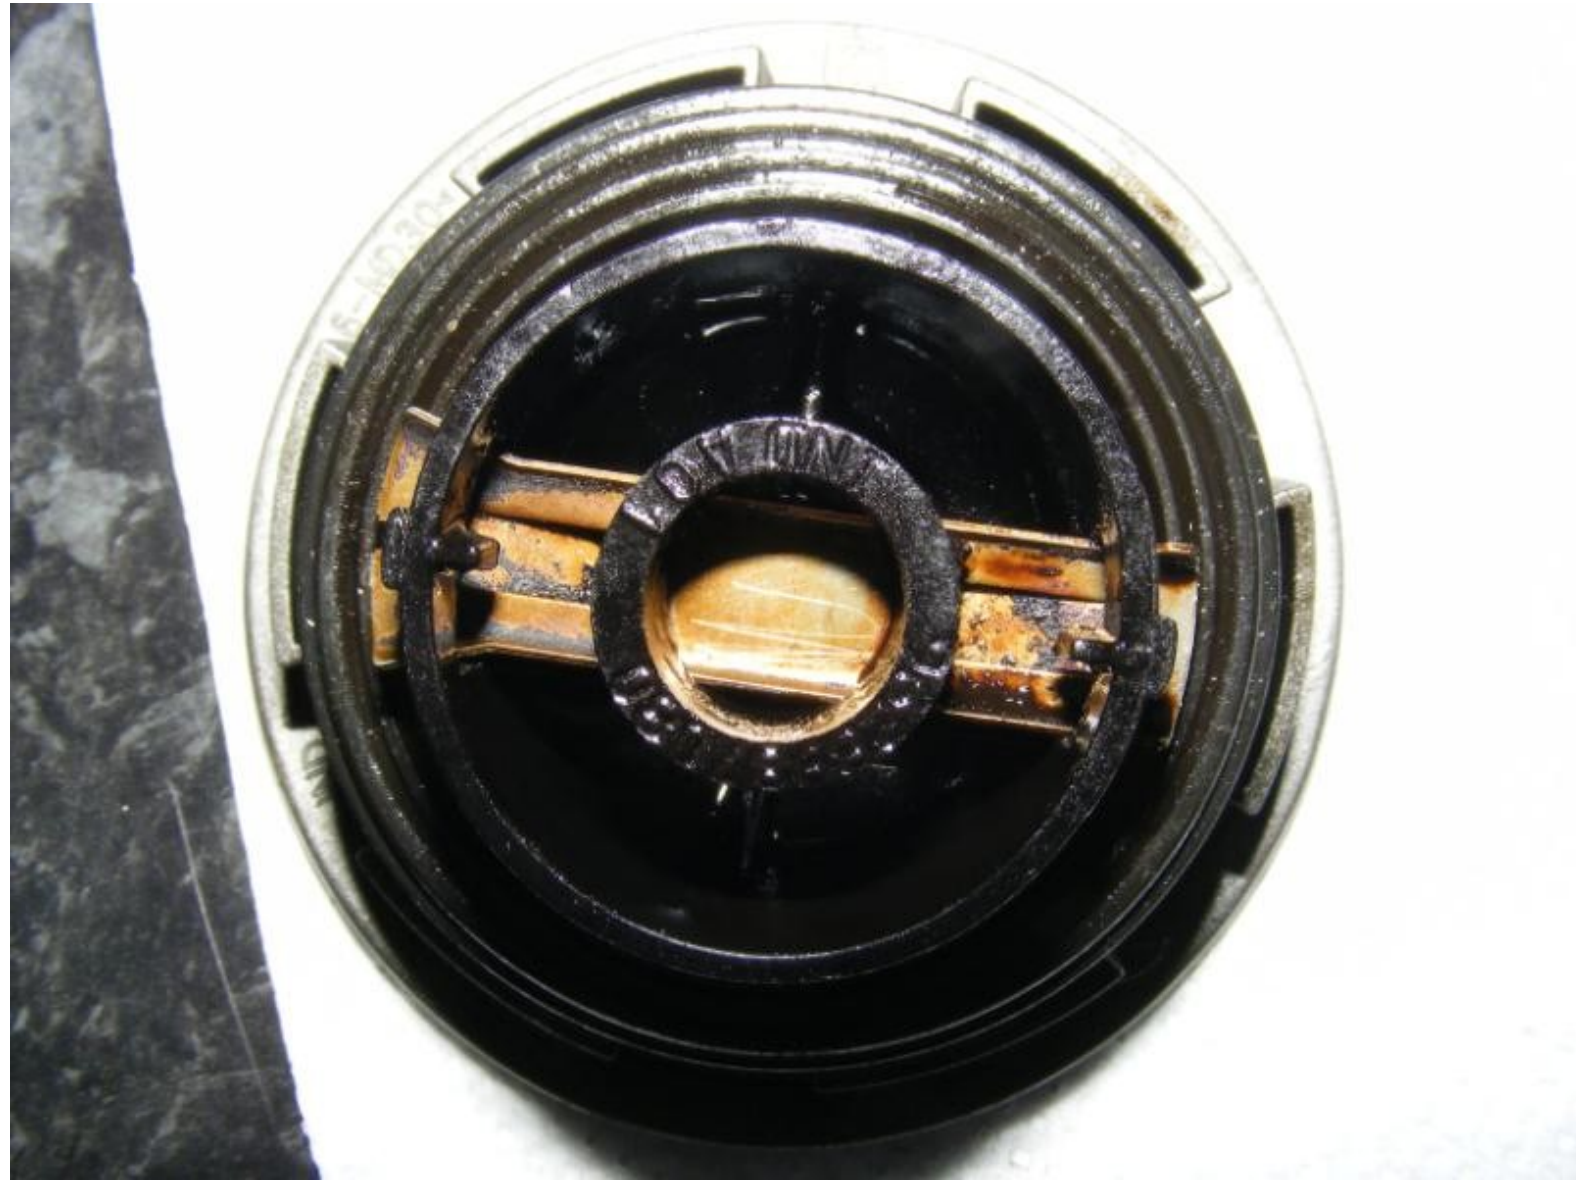
Once it's back you're left with this:

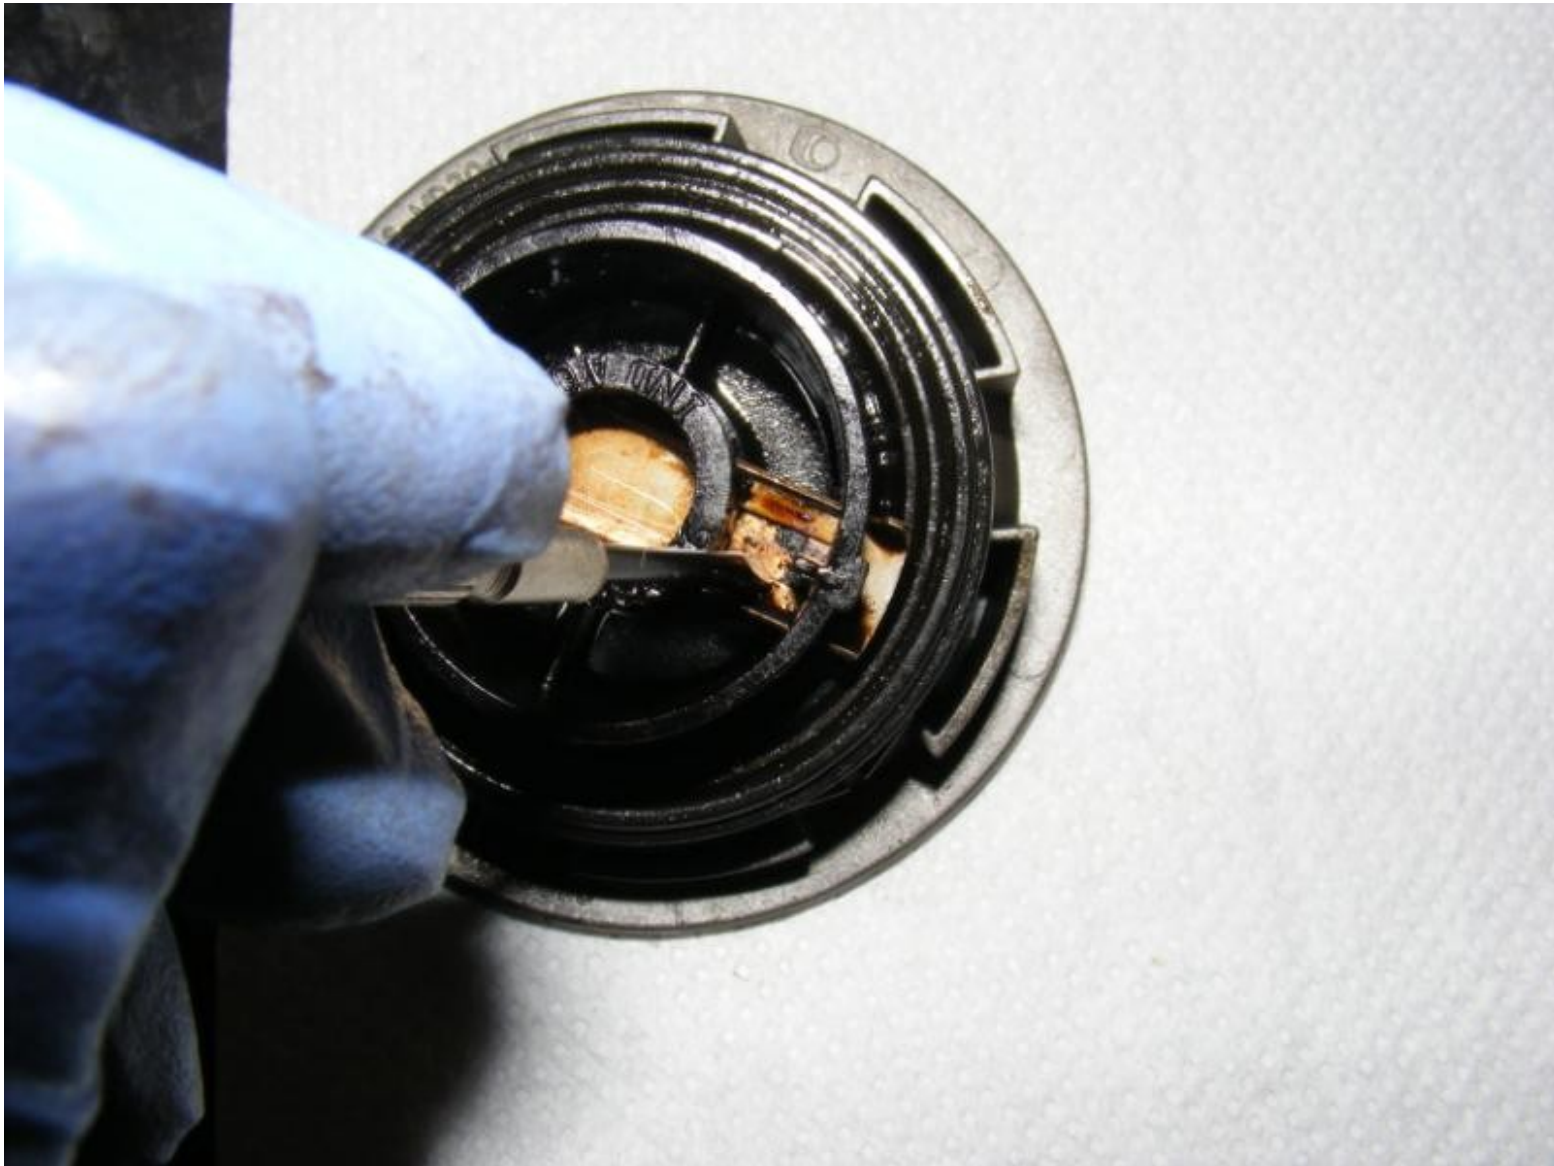
Now, remember the parts of the metal piece from above, where it has tabs to stop it moving out of place? These need to be gently, very gently pushed downwards to stop the piece moving out of the filler cap. So gently push down using a small screwdriver each of the tabs to the point where they're just below the gap where they came out of:

The mistake I made was pushing them too far, so they bent, I had to remove it, straighten the clip out & redo it.

The result was a noticeably tighter fit on the oil filler cap. After a run out to the local shop & back, I removed the oil filler cap & found that no oil had seeped past the seal. I'm not sure how long this fix lasts for, but initial tests show a good seal.
