Searchwords: heated rear screen, rear screen not fully clearing, heated screen element broken.

Following on from my recent thread in Electrical I thought I'd repair this today: [viewtopic.php?f=5&t=33920](http://www.406coupeclub.org/viewtopic.php?f=5&t=33920)

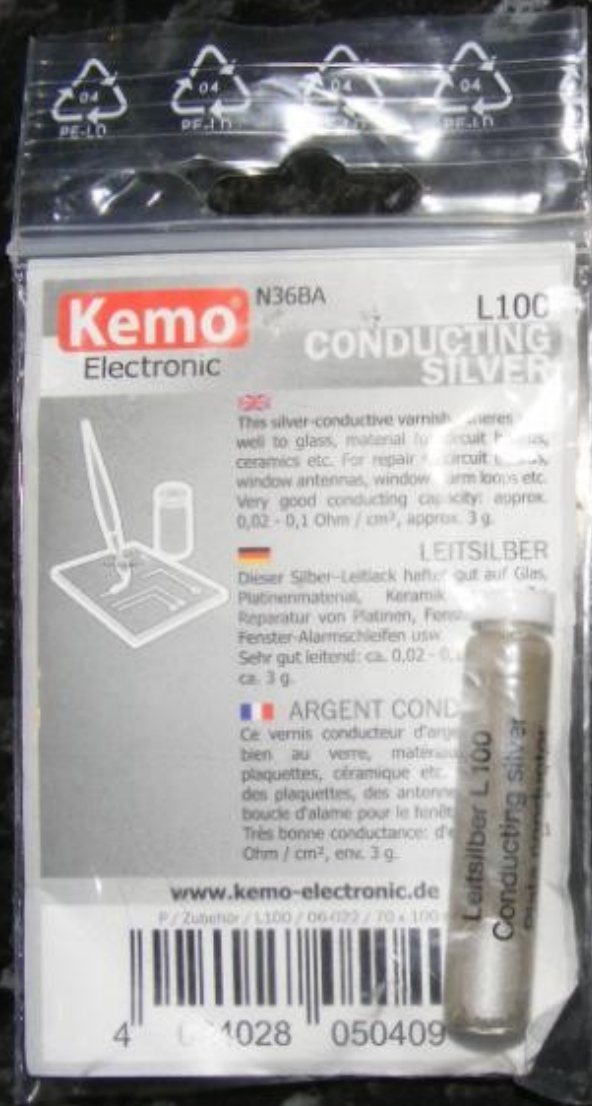
I ordered some conductive paint off ebay, it was around £7.50 with postage. It comes in a small 3g bottle. I applied with with a tiny paintbrush (coin to get an idea of brush size):

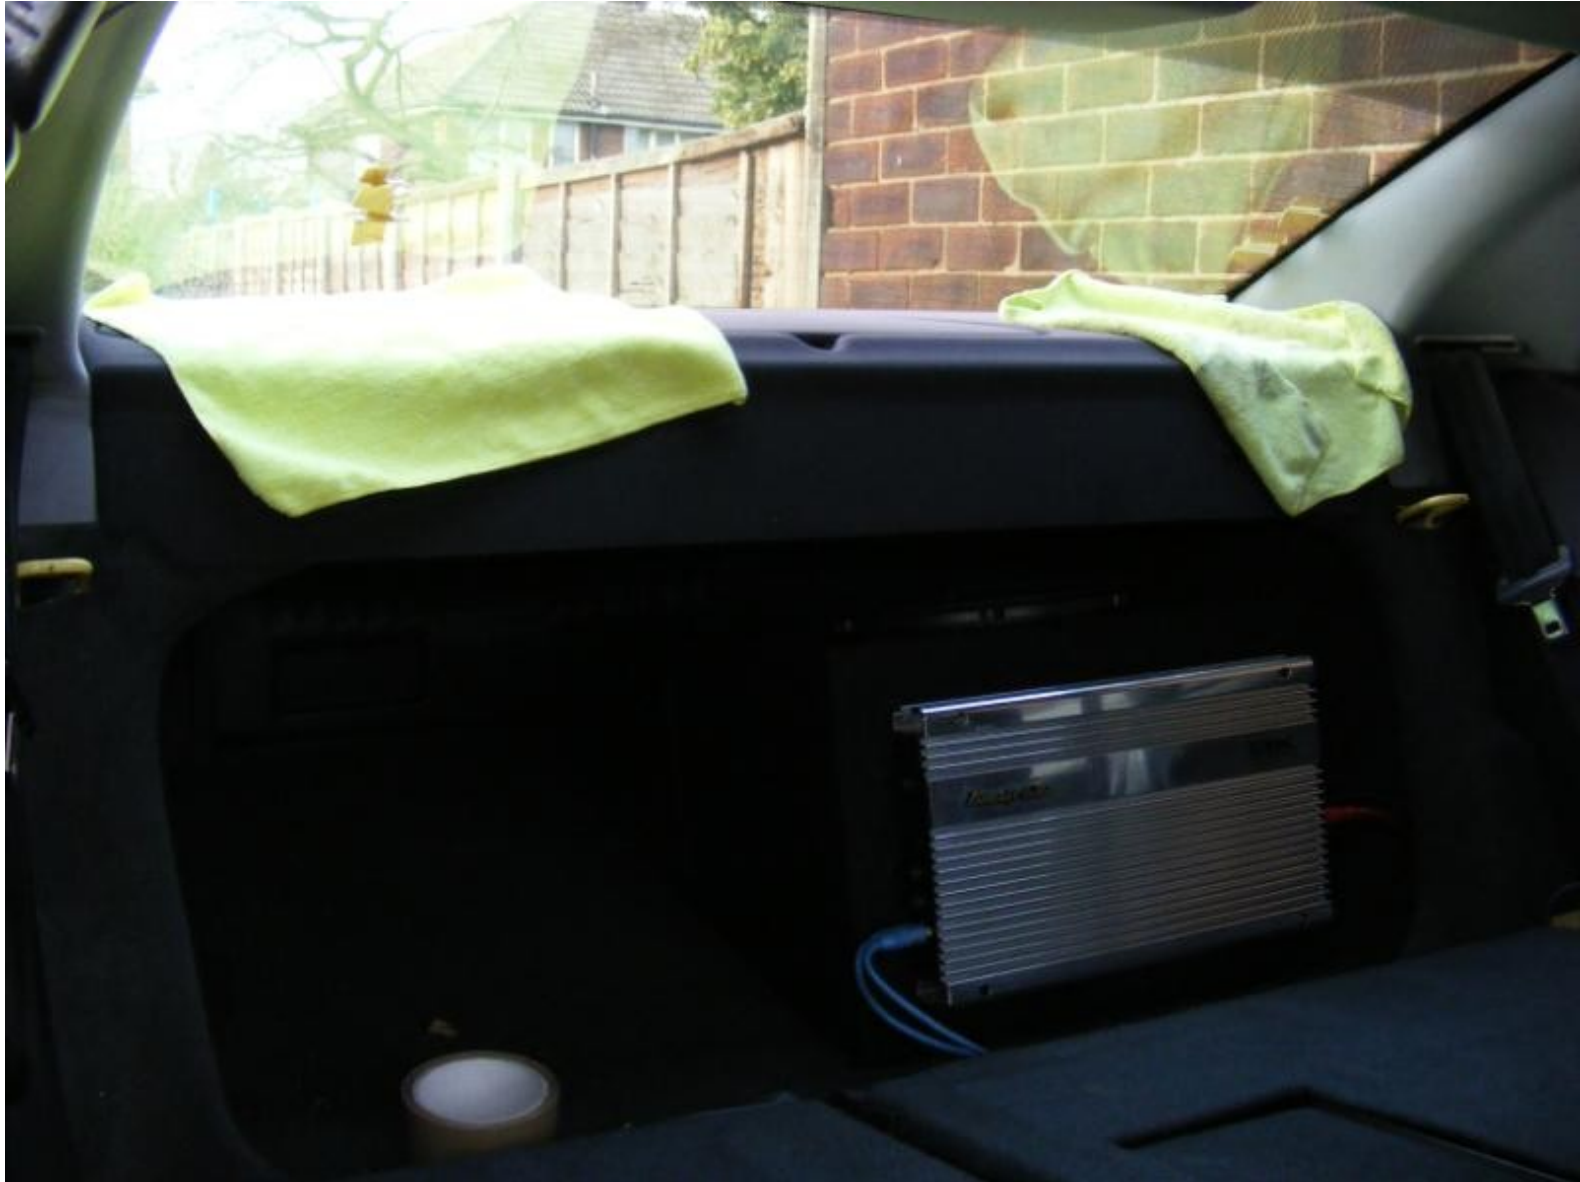
First off I flopped the rear seats down & cleaned the inside of the rear screen. Also lay the cloths on the parcel shelf below the area you're working on with the paint incase any of it drips on the shelf:

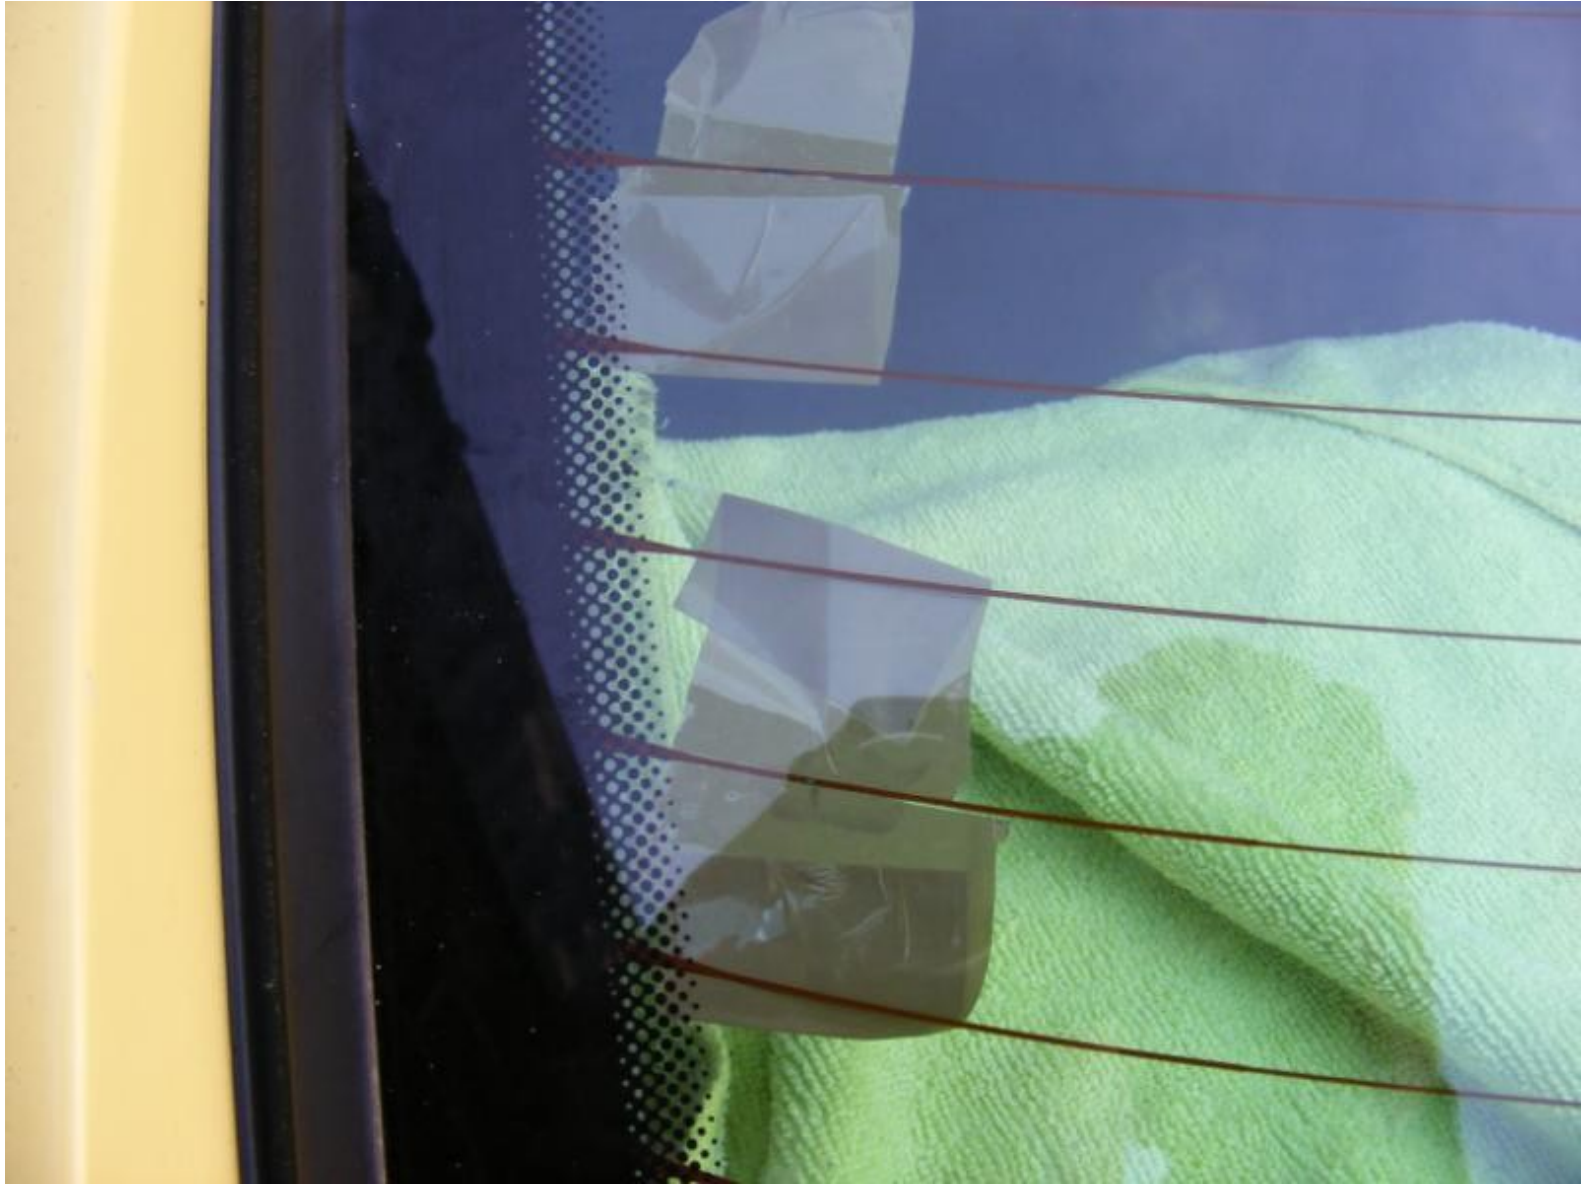
I found where mine were faulty, more than I originally thought. So I used brown tape & put a piece either side of the break in the element, as close to the original wire as possible:

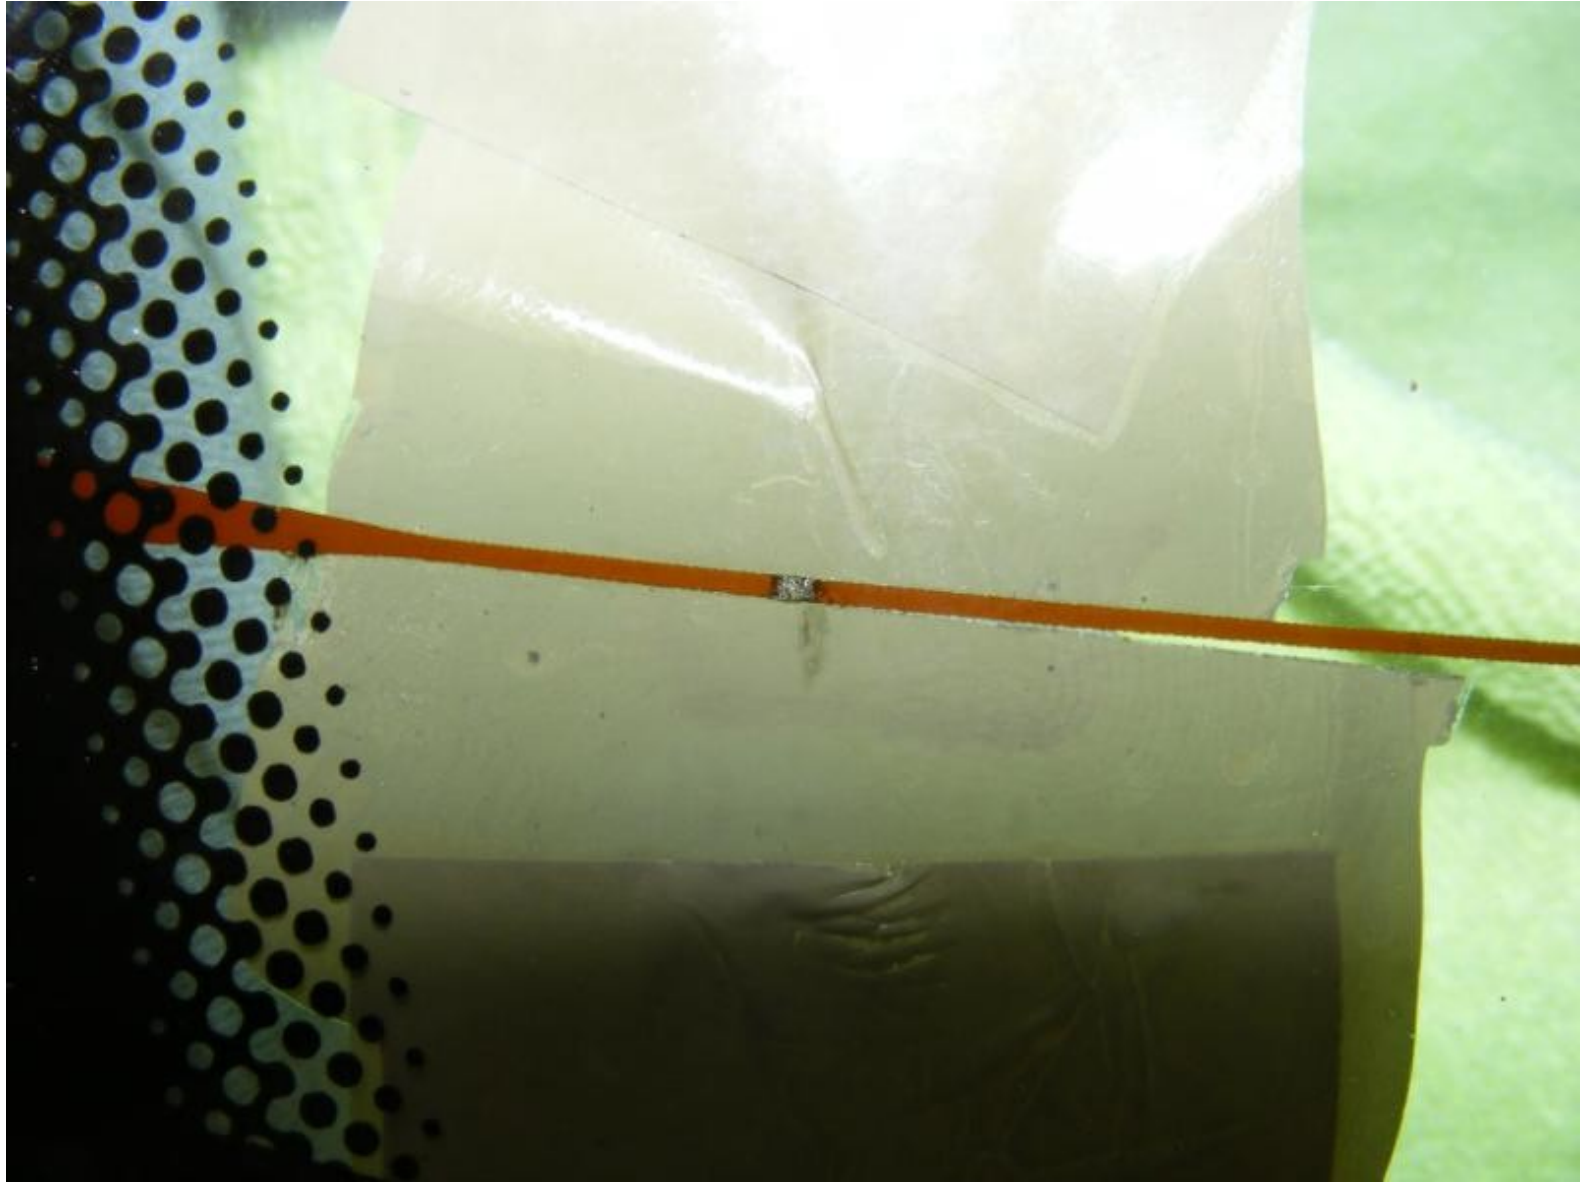
Close up of one of the many breaks:

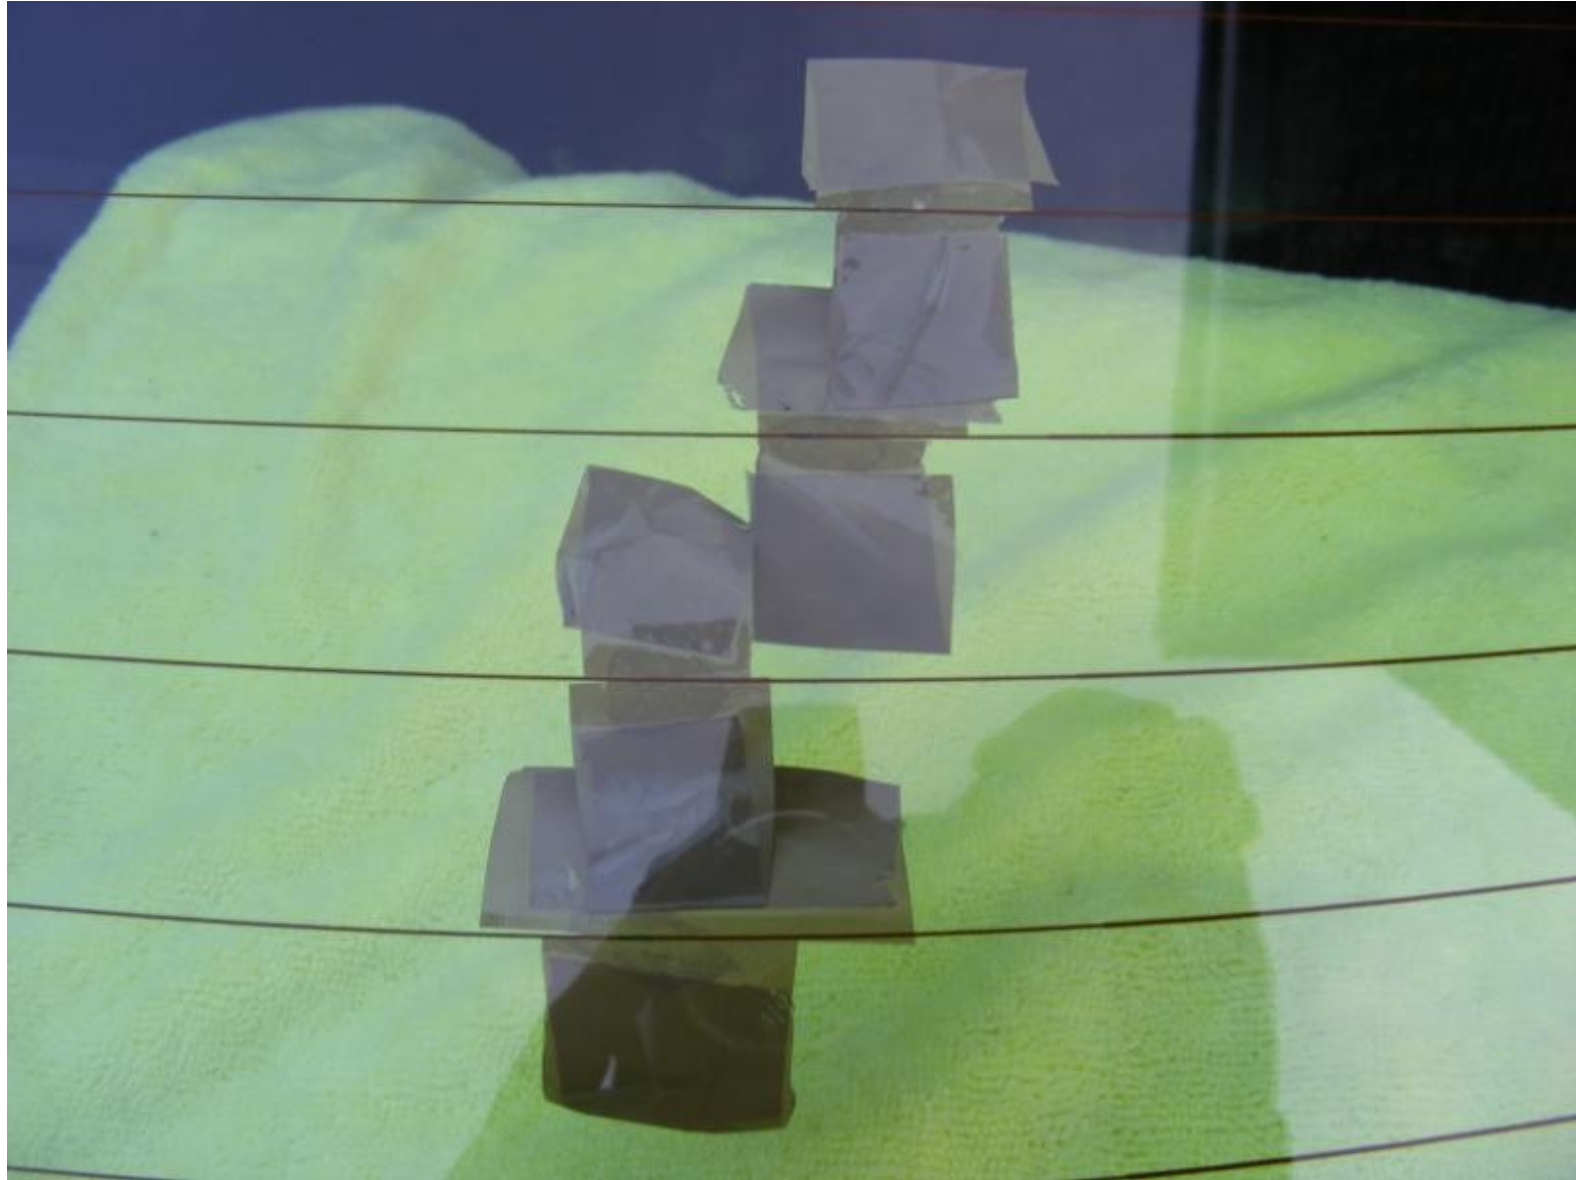
Taped up breaks from the other side of the screen:

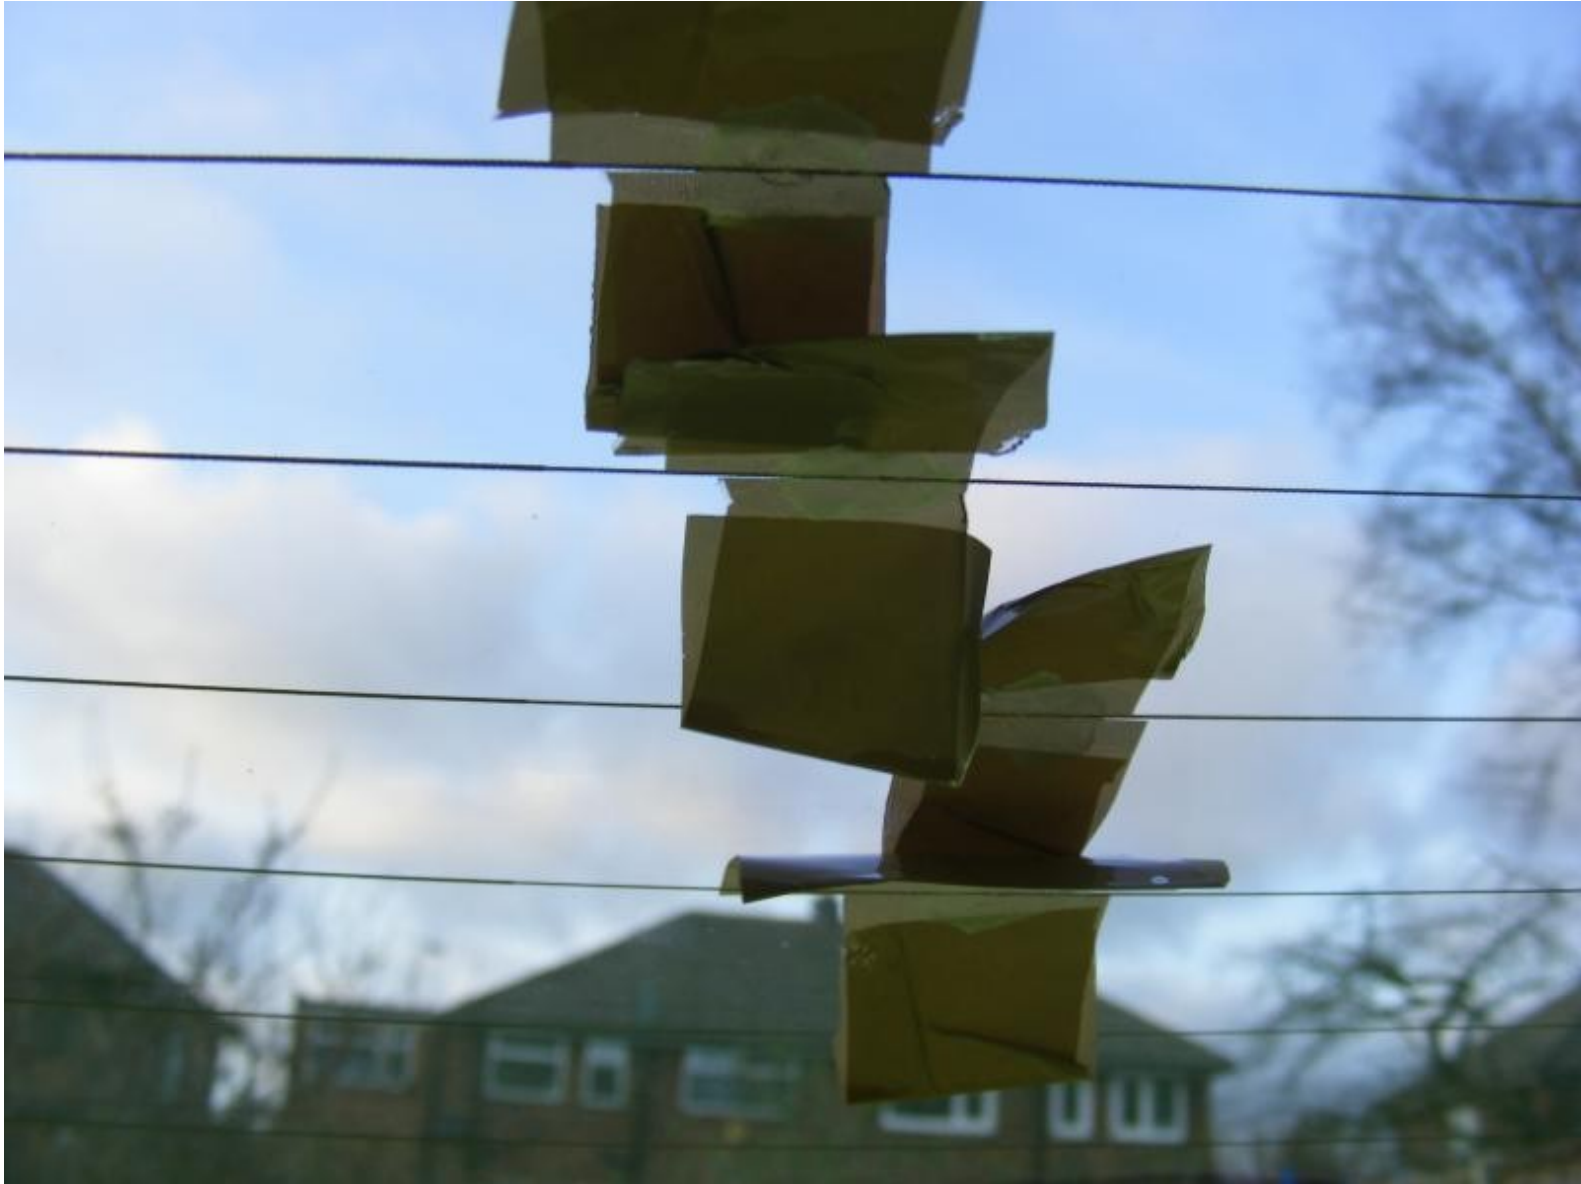
From the inside, these had already had the conductive paint applied:

That's basically it. It took just a minute to apply the paint, but probably 20 minutes getting the cellotape as close to the wire as possible to keep the lines tidy, not easy with the angle of the screen. I'll leave the tape on for an hour or so then remove it. I'll leave the cloths in place too, just incase any of the paint drips. I'm sure it won't as it was just a light coating 🤞 .

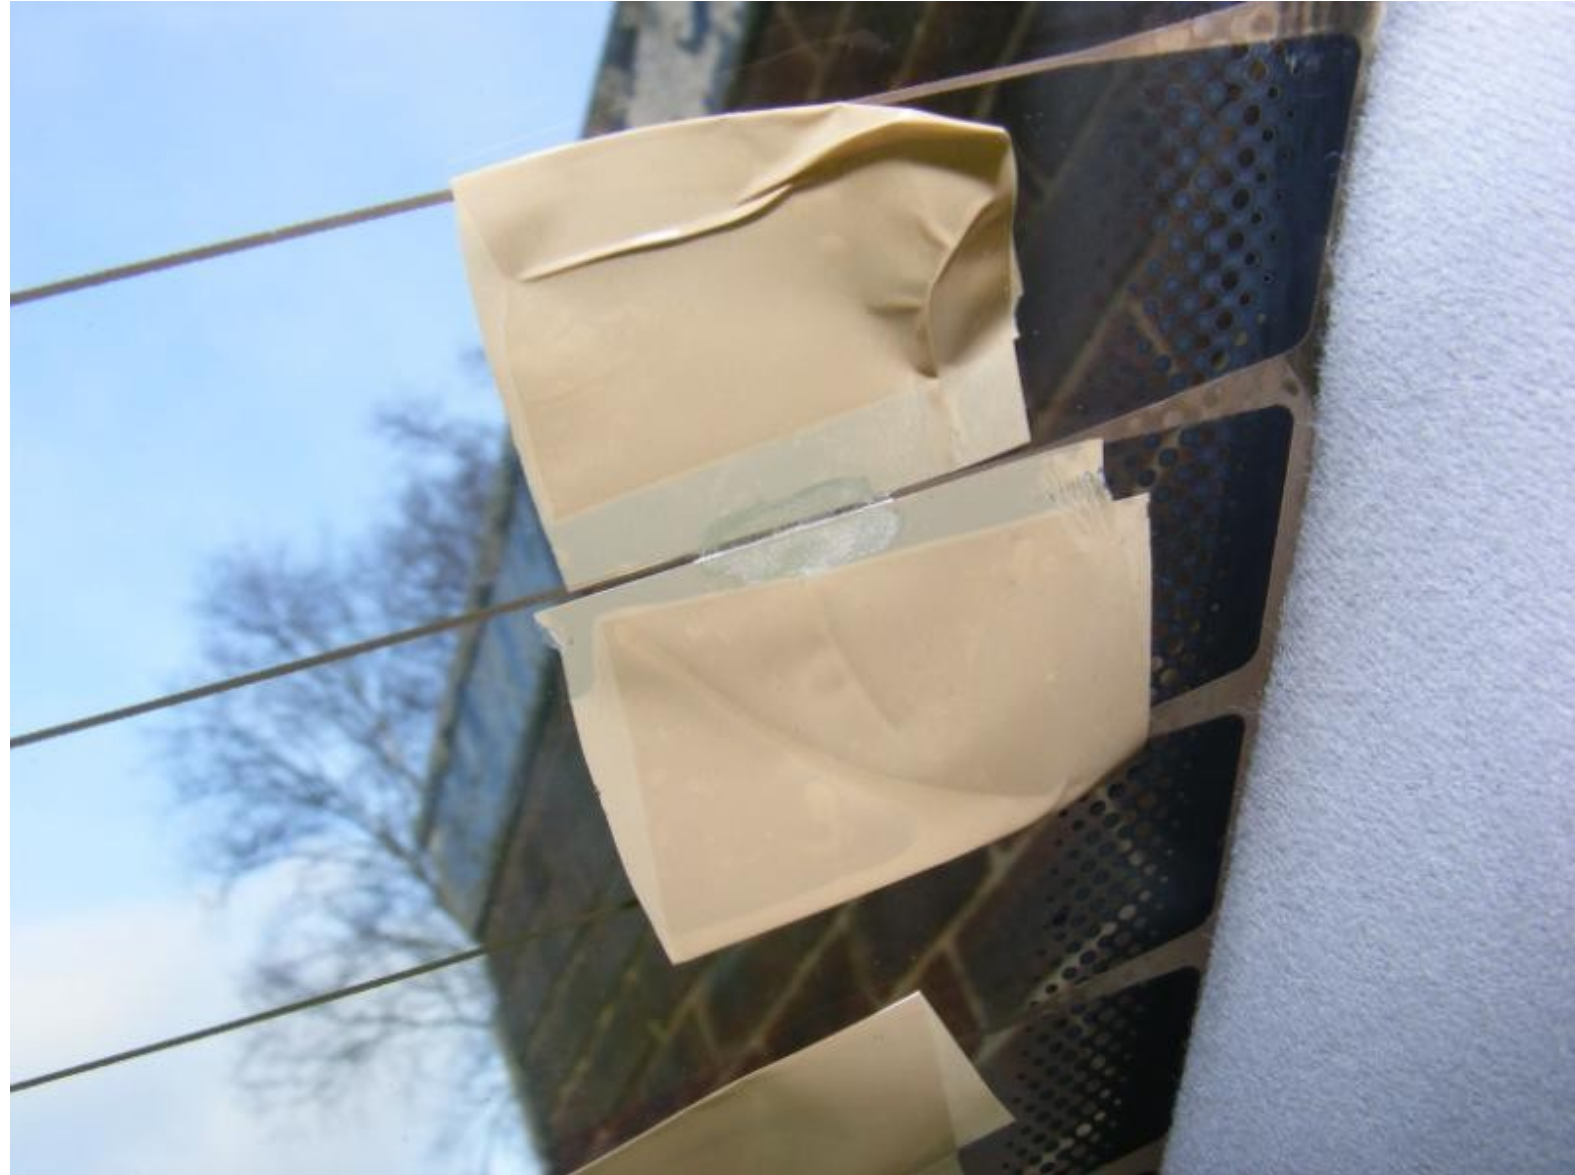
Close up of the paint on the passenger side:
