Please note that this is exclusive to a non-sunroof vehicle. Those with sunroofs will have additional fittings/fixings to deal with, of which I have no knowledge of.

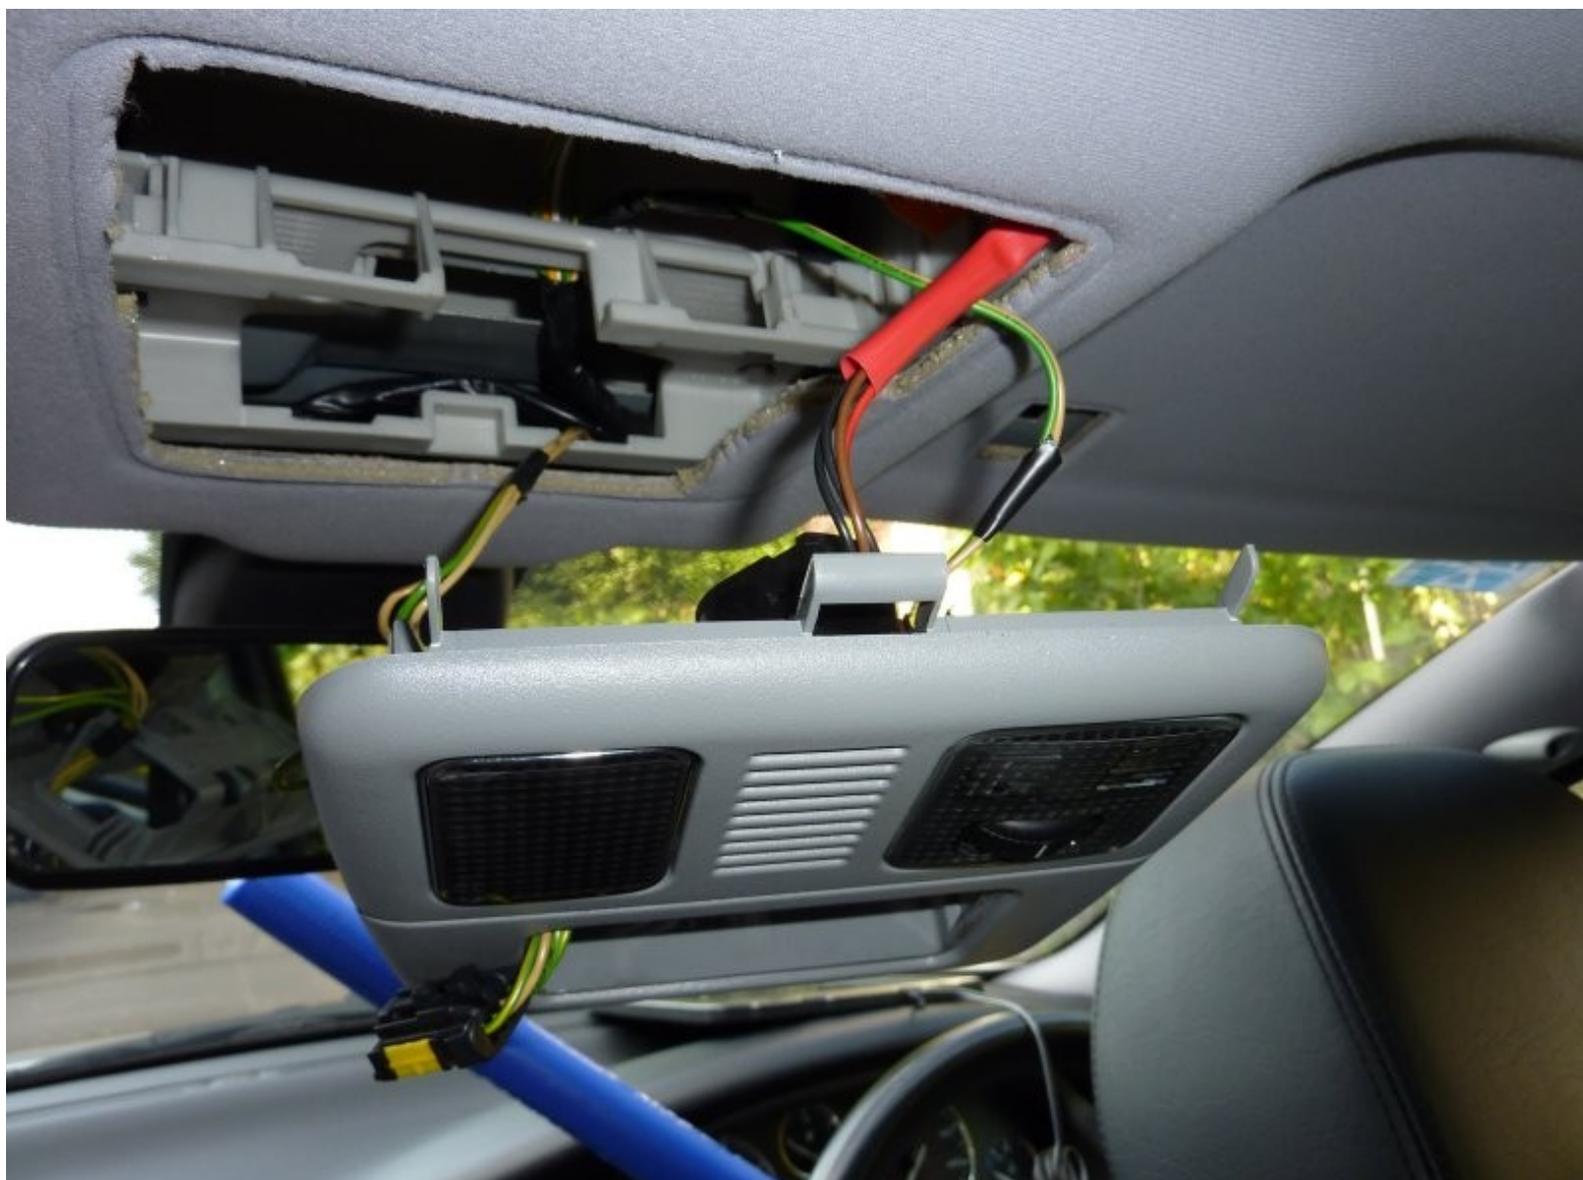
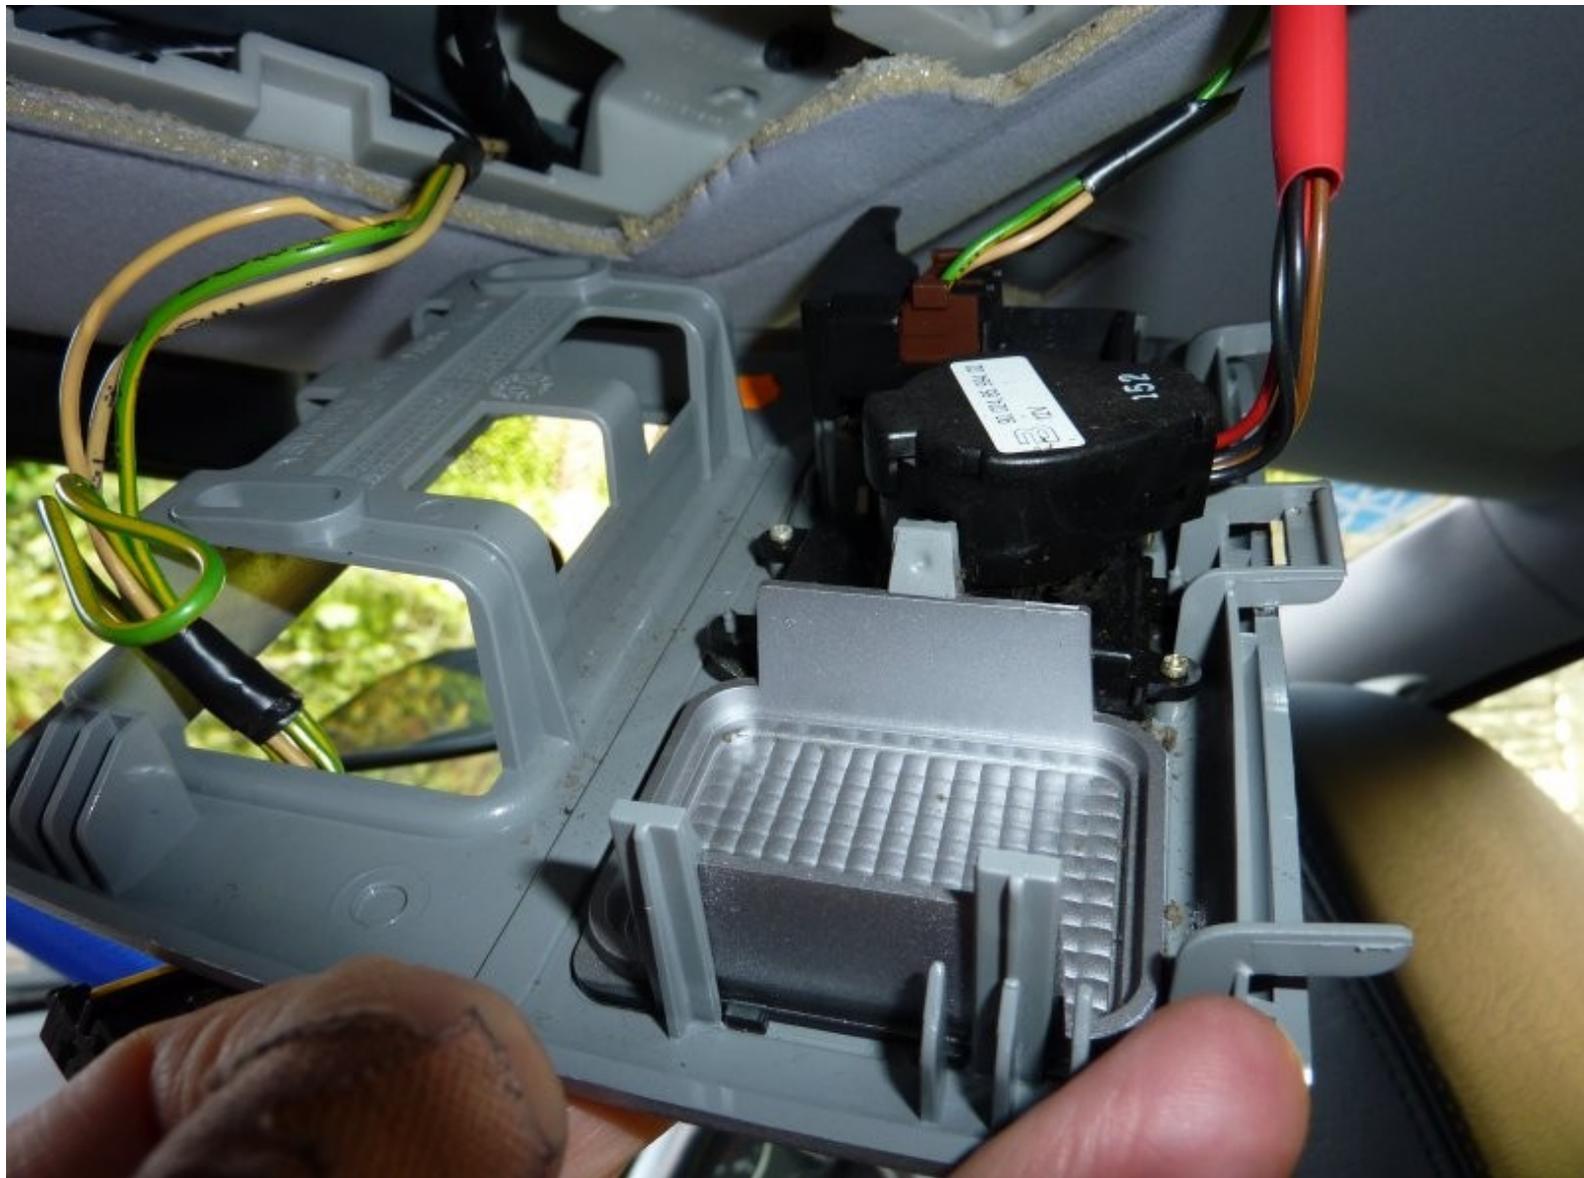
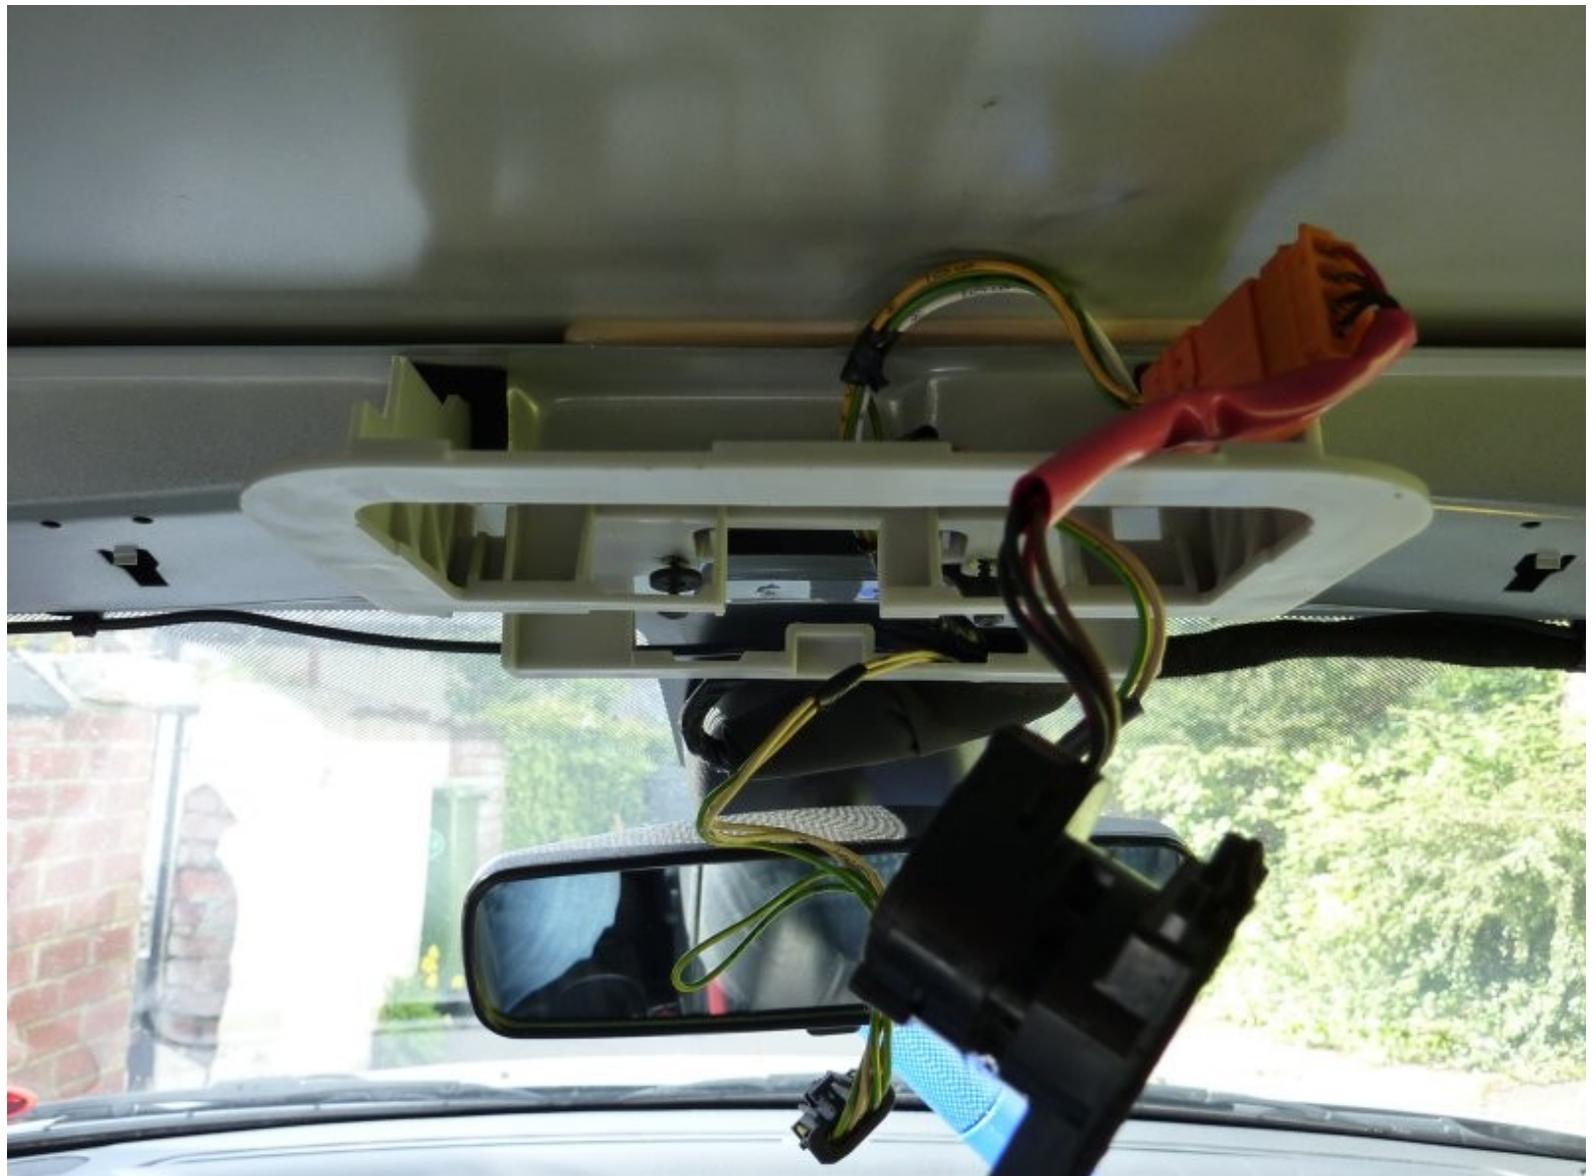
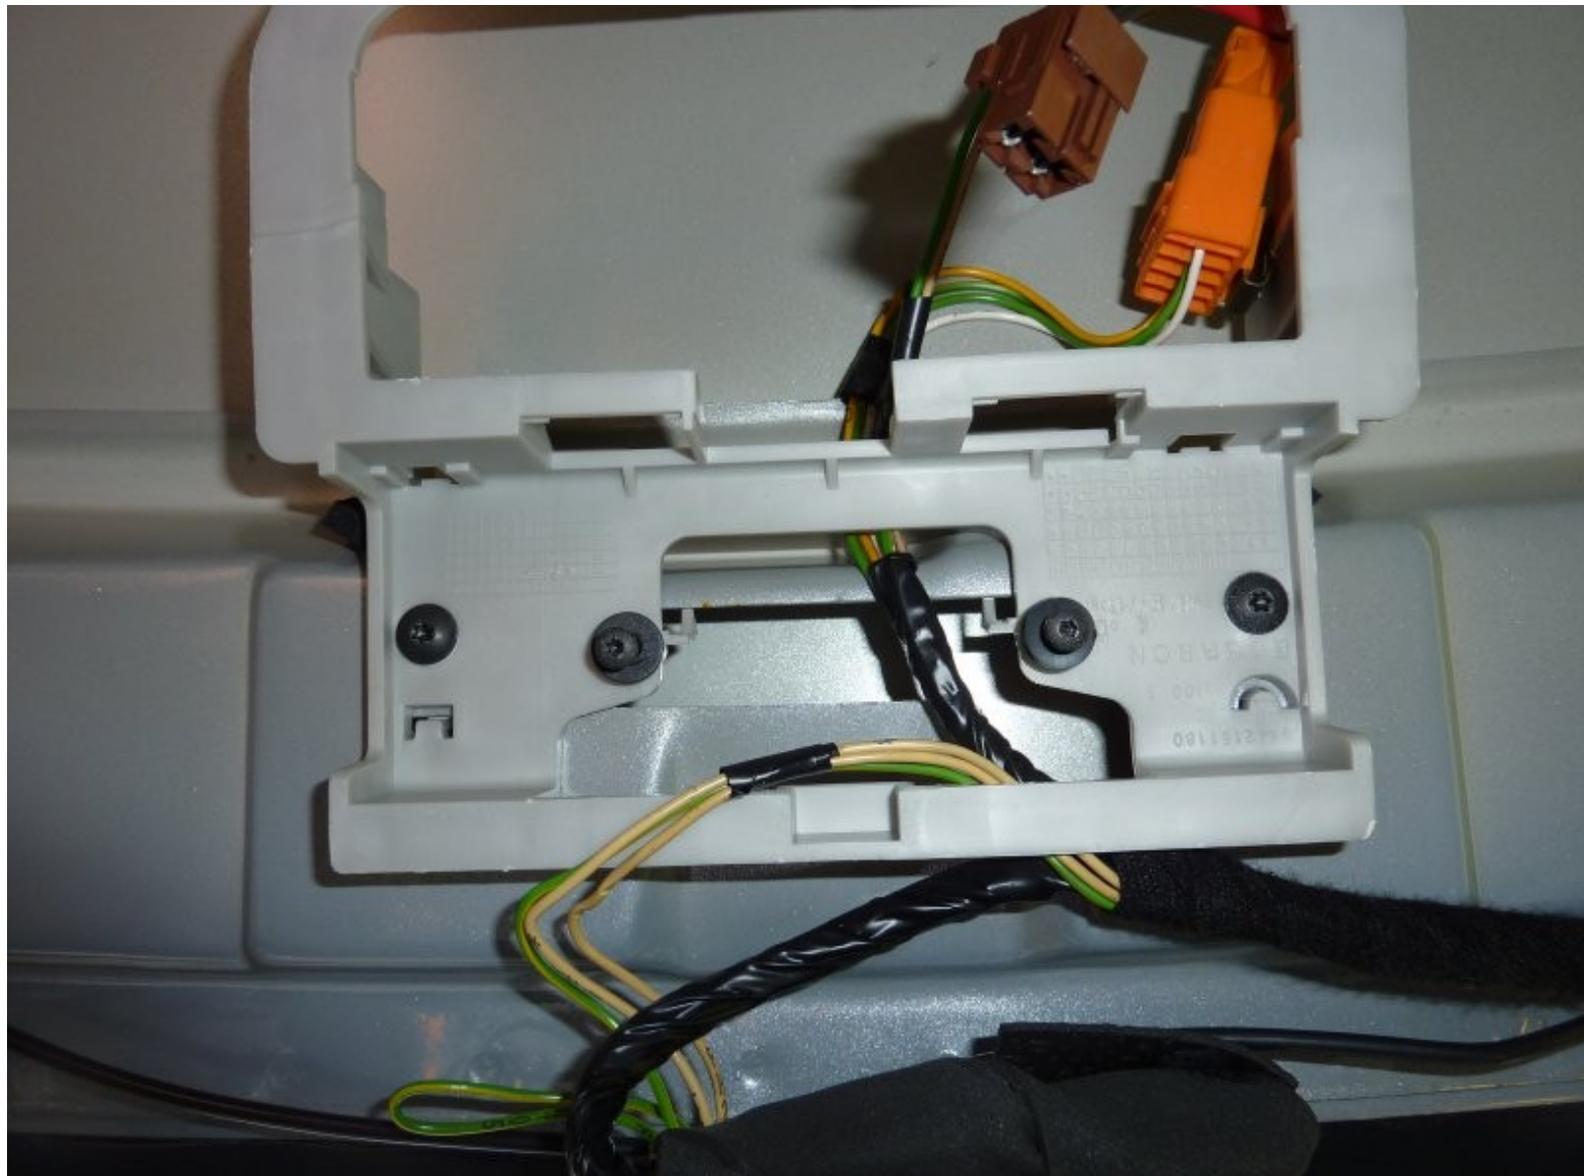
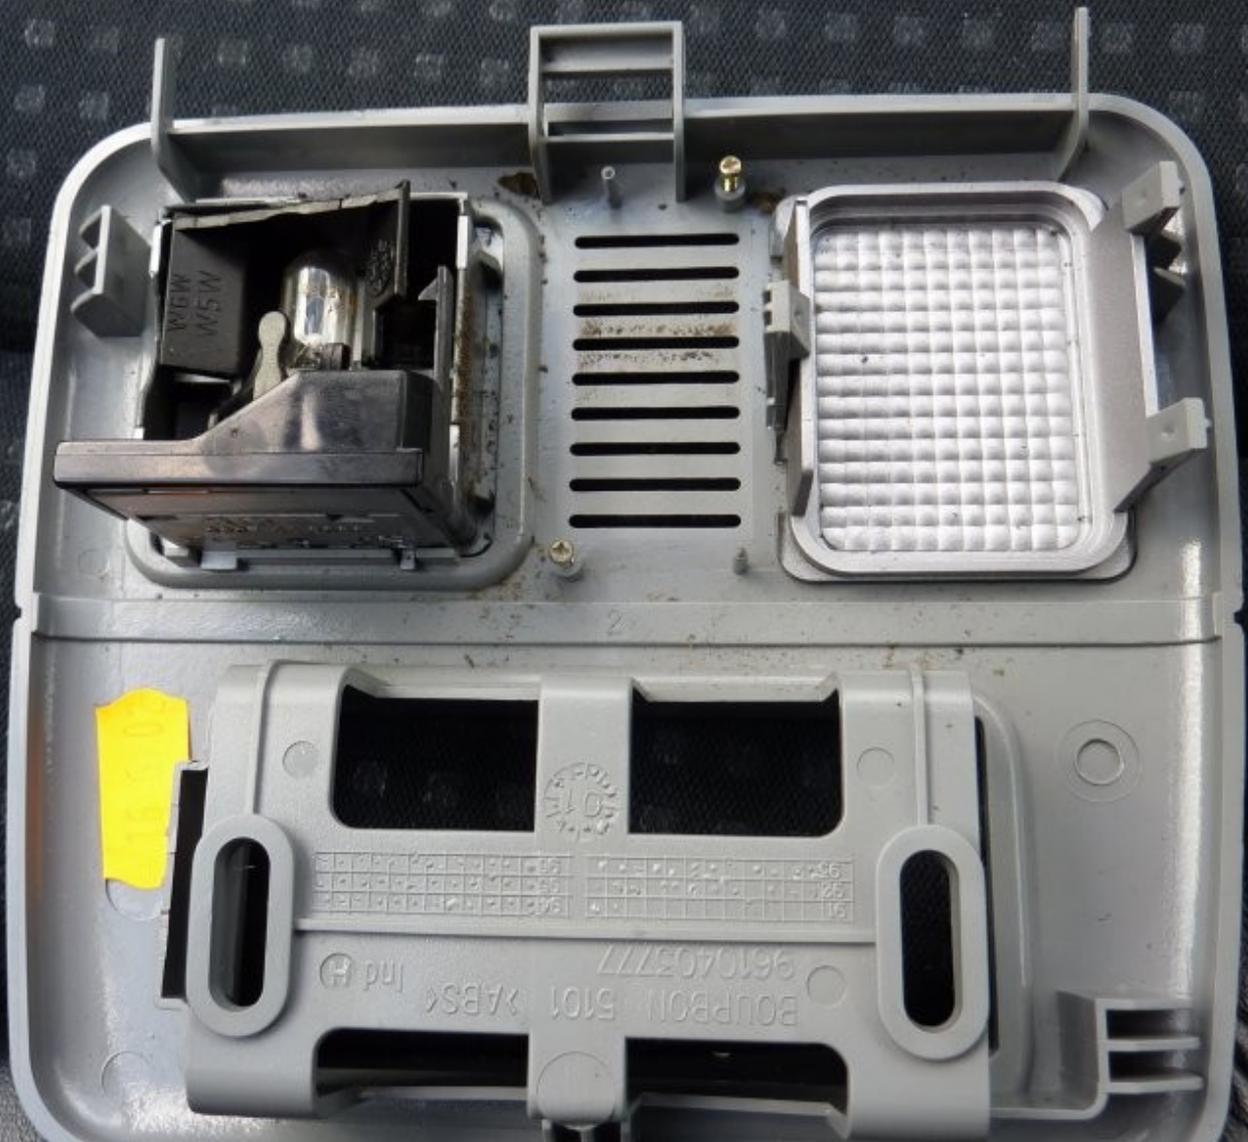
Firstly you will need to remove the fixings from the headlining area. Both Sun Visors (T15 & T20), Grab Handle (T30) and the Coat Hangers (T20). The rear roof console is removed by simply using a thin plastic blade to prise out the light from the lining, I found the Tesco Clubcard on my keyring to be ideal for this task. Unclip the electrical connection. Remove the surround. The front roof console is removed in a similar way. Once the light is removed you will then have access to the 2 screws (T15). The console will then come away and you can unclip the electrical connections.

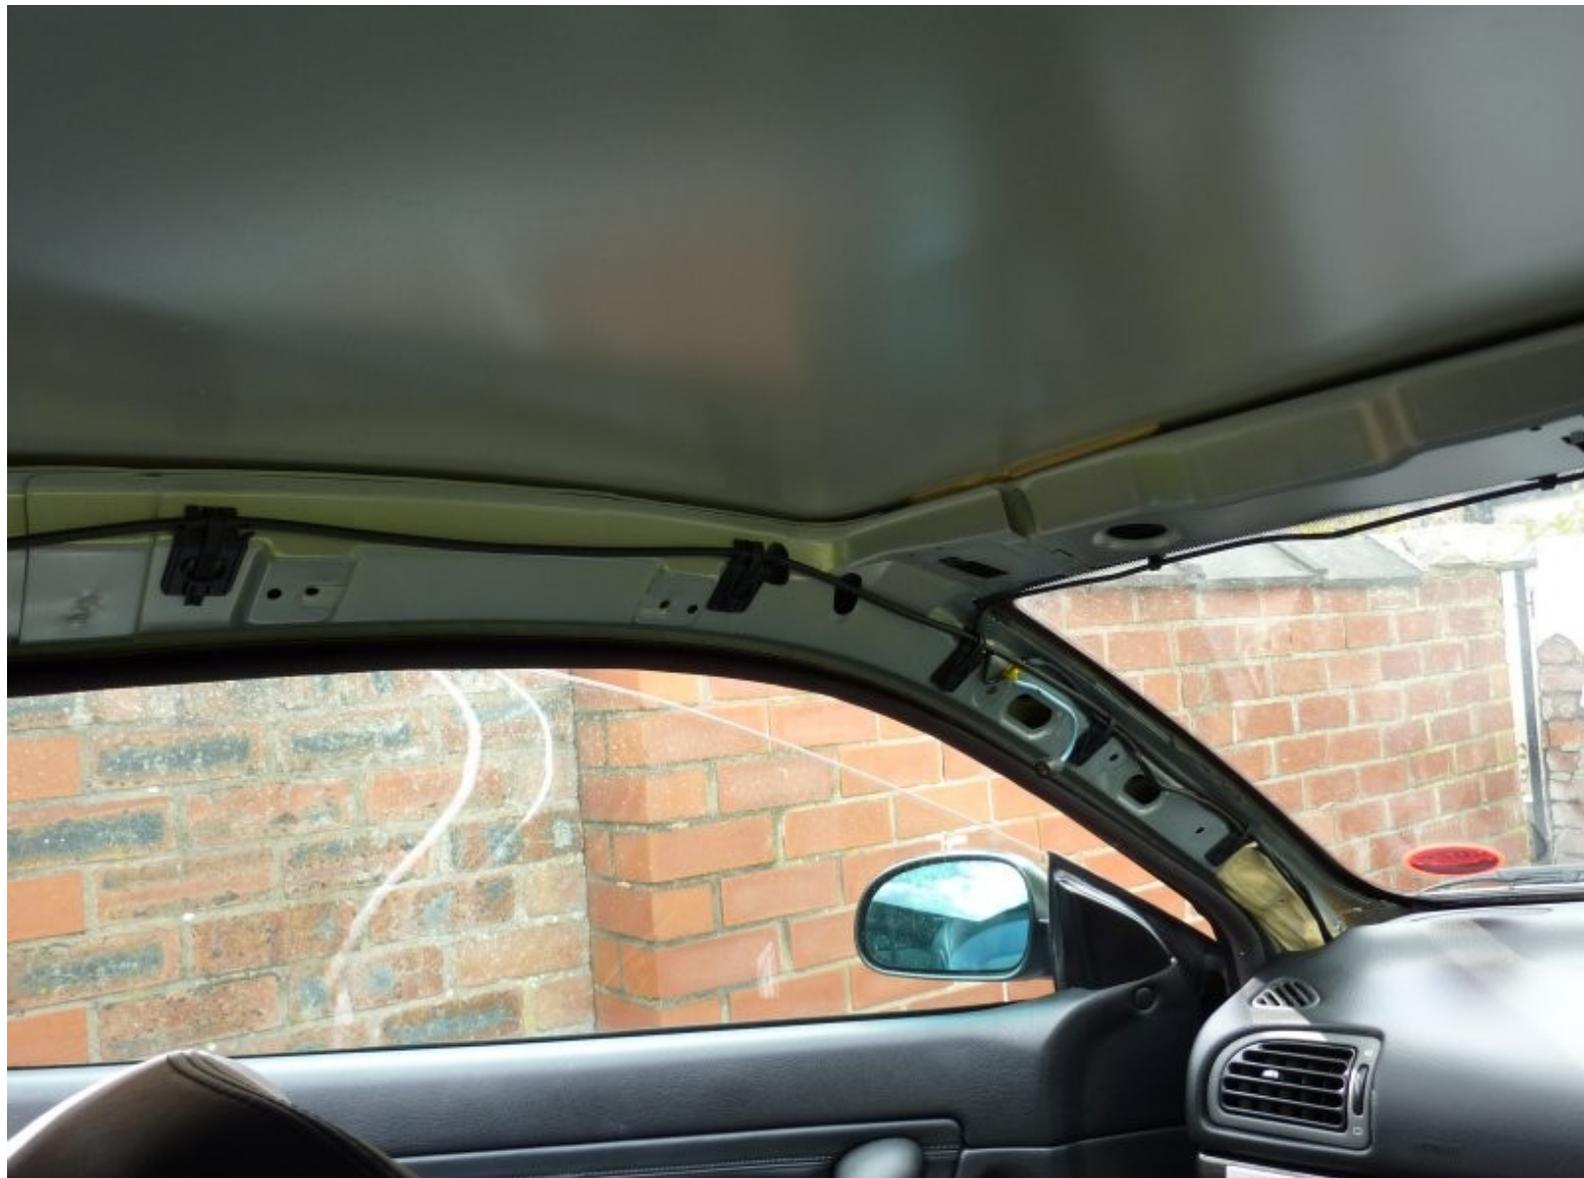
The A pillar covers come away by pulling the top away and I used an old credit card to get some leverage to then pull the trim away as though it was hinged at the windscreen. Gently work your way down until it comes away, taking care with the alarm sensor and unclipping it from the rear of the cover.

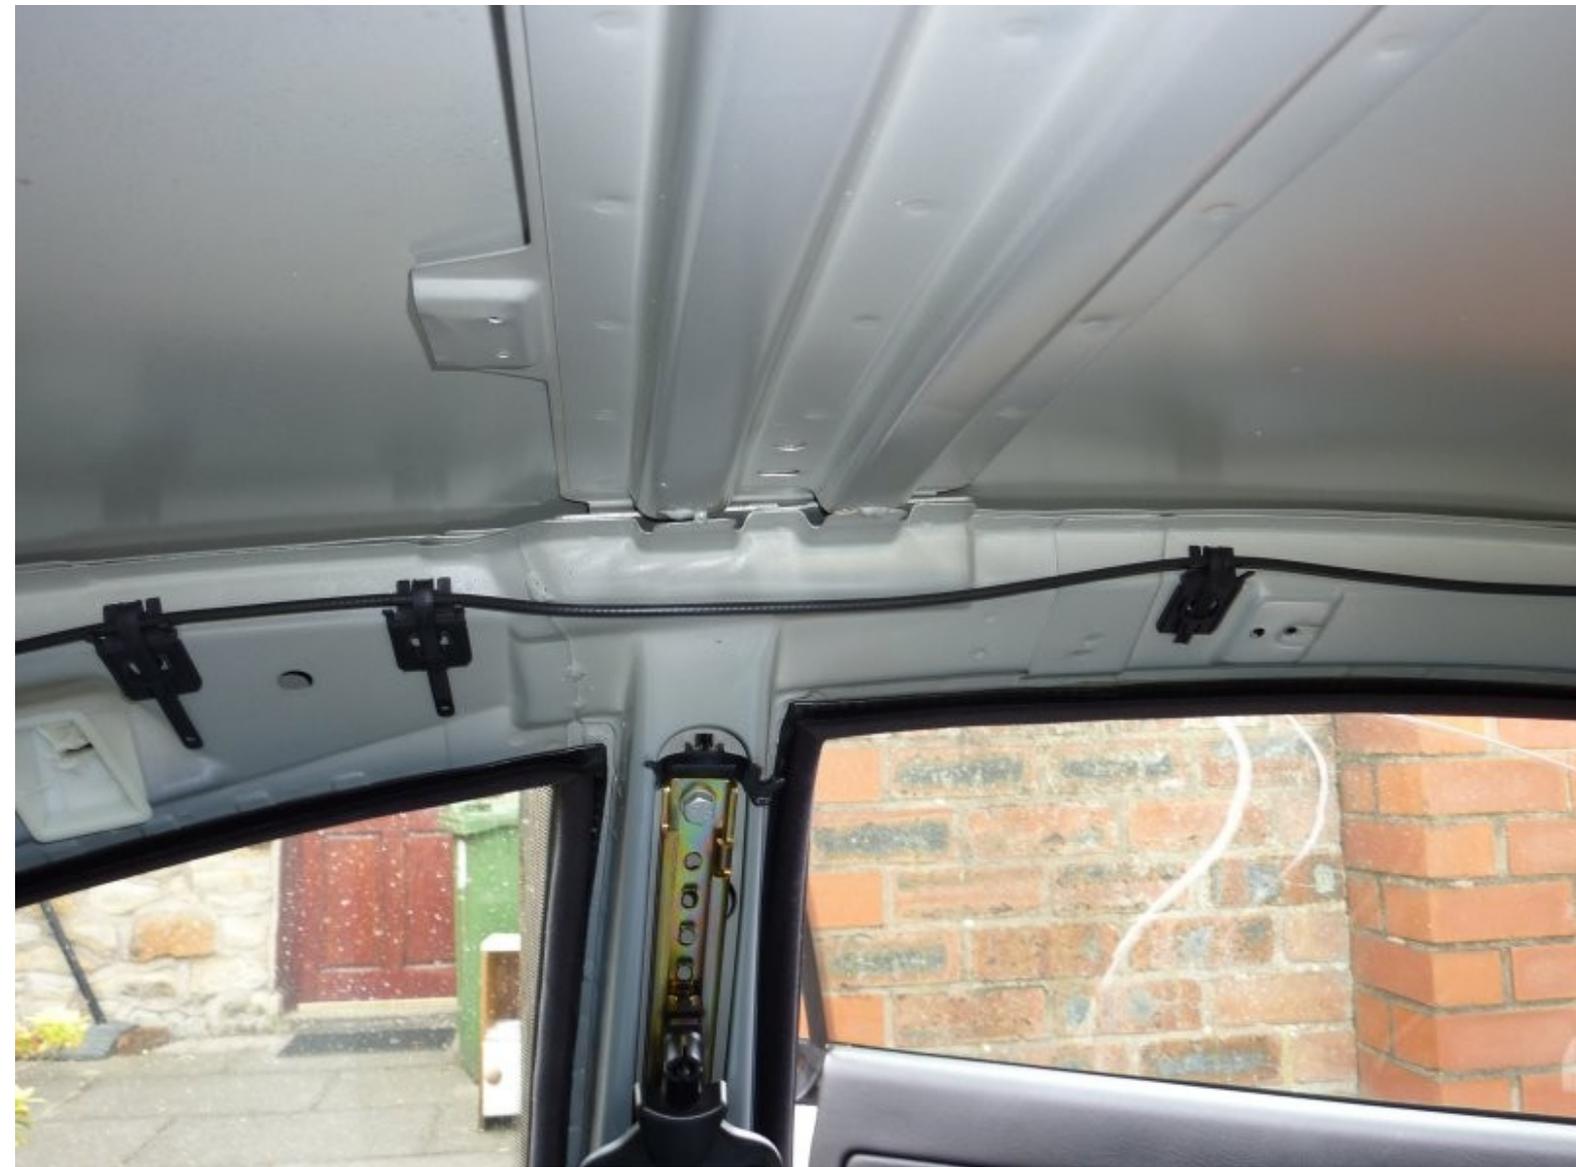
The B pillar ones are tackled by removing the triangular plastic cover and then removing the screw (T15). Once that is removed undo the bolt (17mm) - (Retighten to 3.5 ± 0.21 da.Nm.) that holds the seatbelt in. The pillar trim can then be removed by pulling at the top and then working down and lifting up and away. You might want to put the seatbelt bolt back in and put the shroud back on on both sides. This is to A) enable you to nip out if need be and B) stop you from potentially glancing your head against the exposed metal shaft (OUCH!/FFS!/...Yes, can I have an Ambulance please).

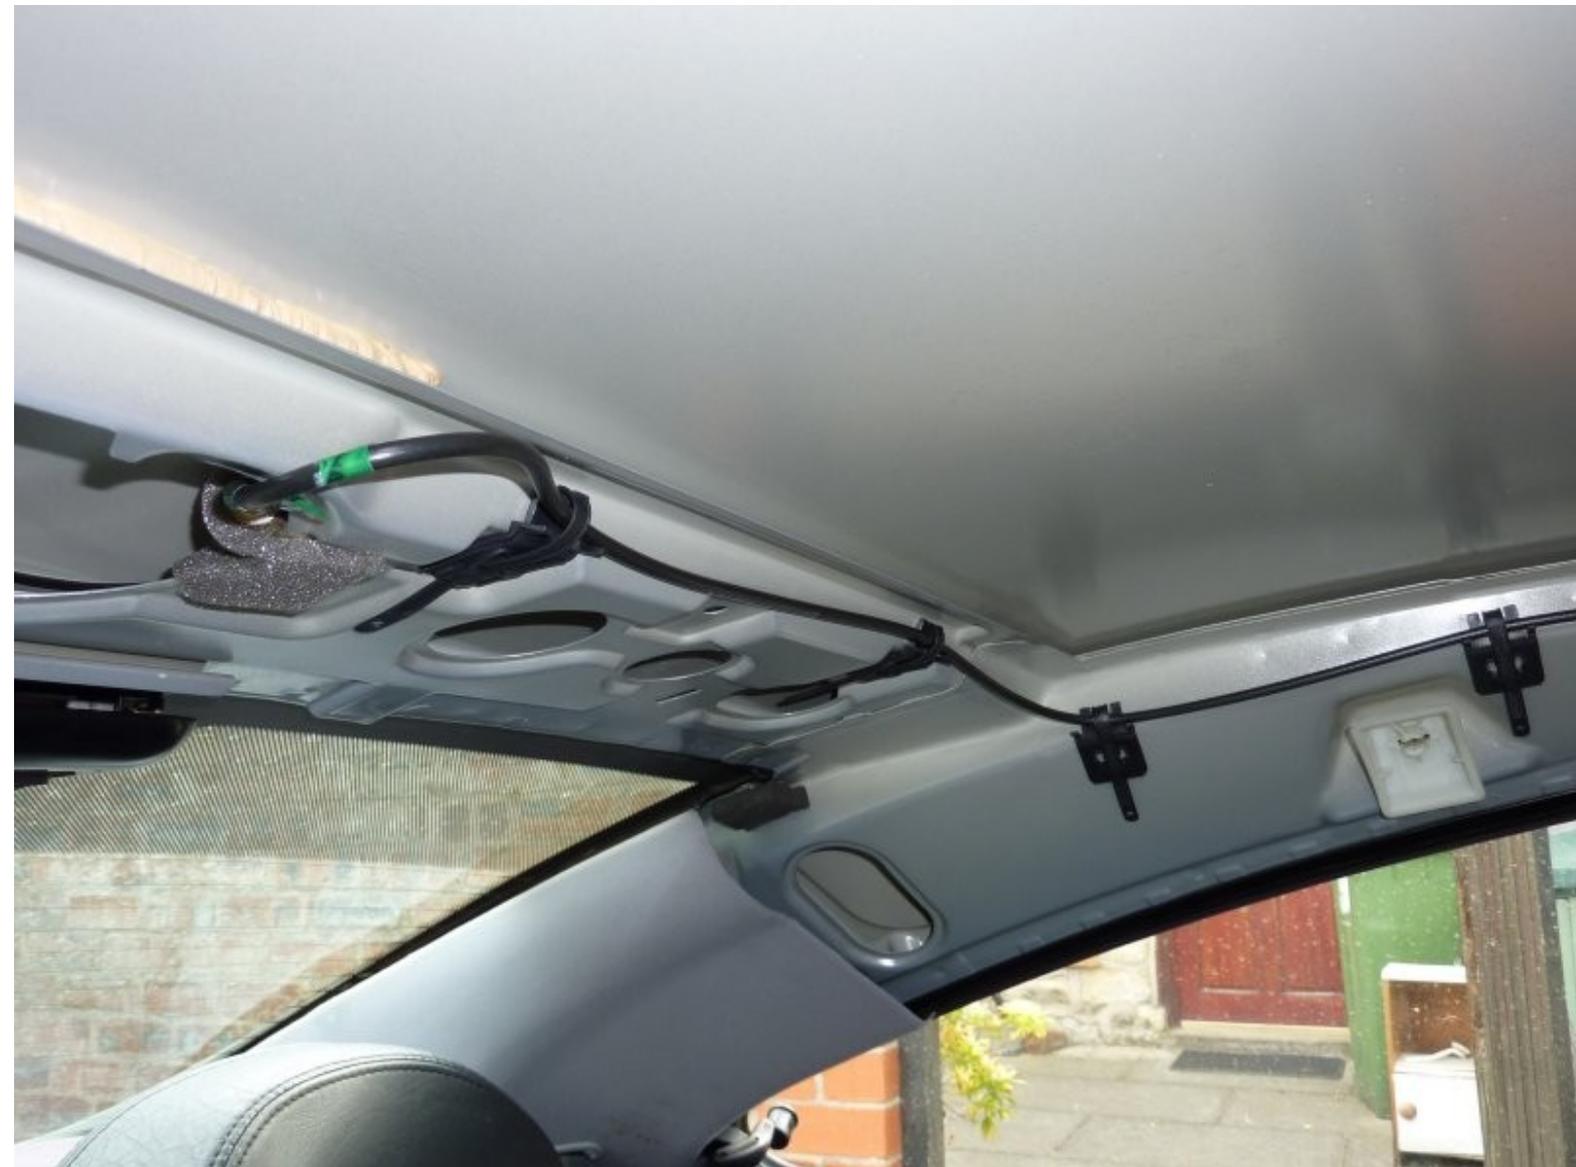
The rear covers do not need to be completely removed, just pulled away starting at the top and working down.

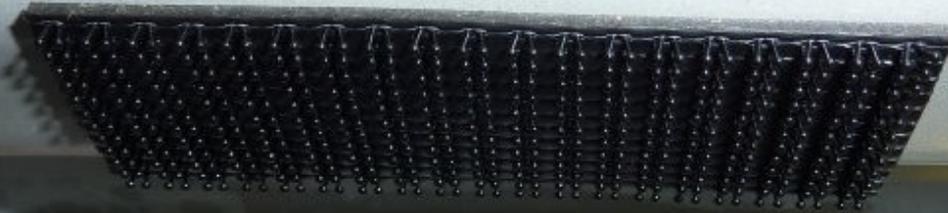
The roof lining has 2 fixings at the rear, one above each of the rear headrests. After those are pulled away, it just magic that is holding the lining up...Just kidding. You will just need to lift the lining up out of the felt like material at the top of the window areas. There is also a 'Stickle Brick' type device that is fixed to the roof between the B pillars to hold the lining, see pic. You can now call on your assistant to help you support the lining while it is removed through the passenger side. Reclining the front seats helps.
