I have recently suffered from the teeth breaking on my drivers side regulator due to the frozen weather and had to change it for a new one off Ade. This problem appeared one frozen morning - the window raises and lowered fine, it just wouldn't raise the final 10 mm and just 'juddered'. This has also been mentioned in the post [here](#). I took pictures whilst doing it so I could create a guide for anyone else who suffers this.

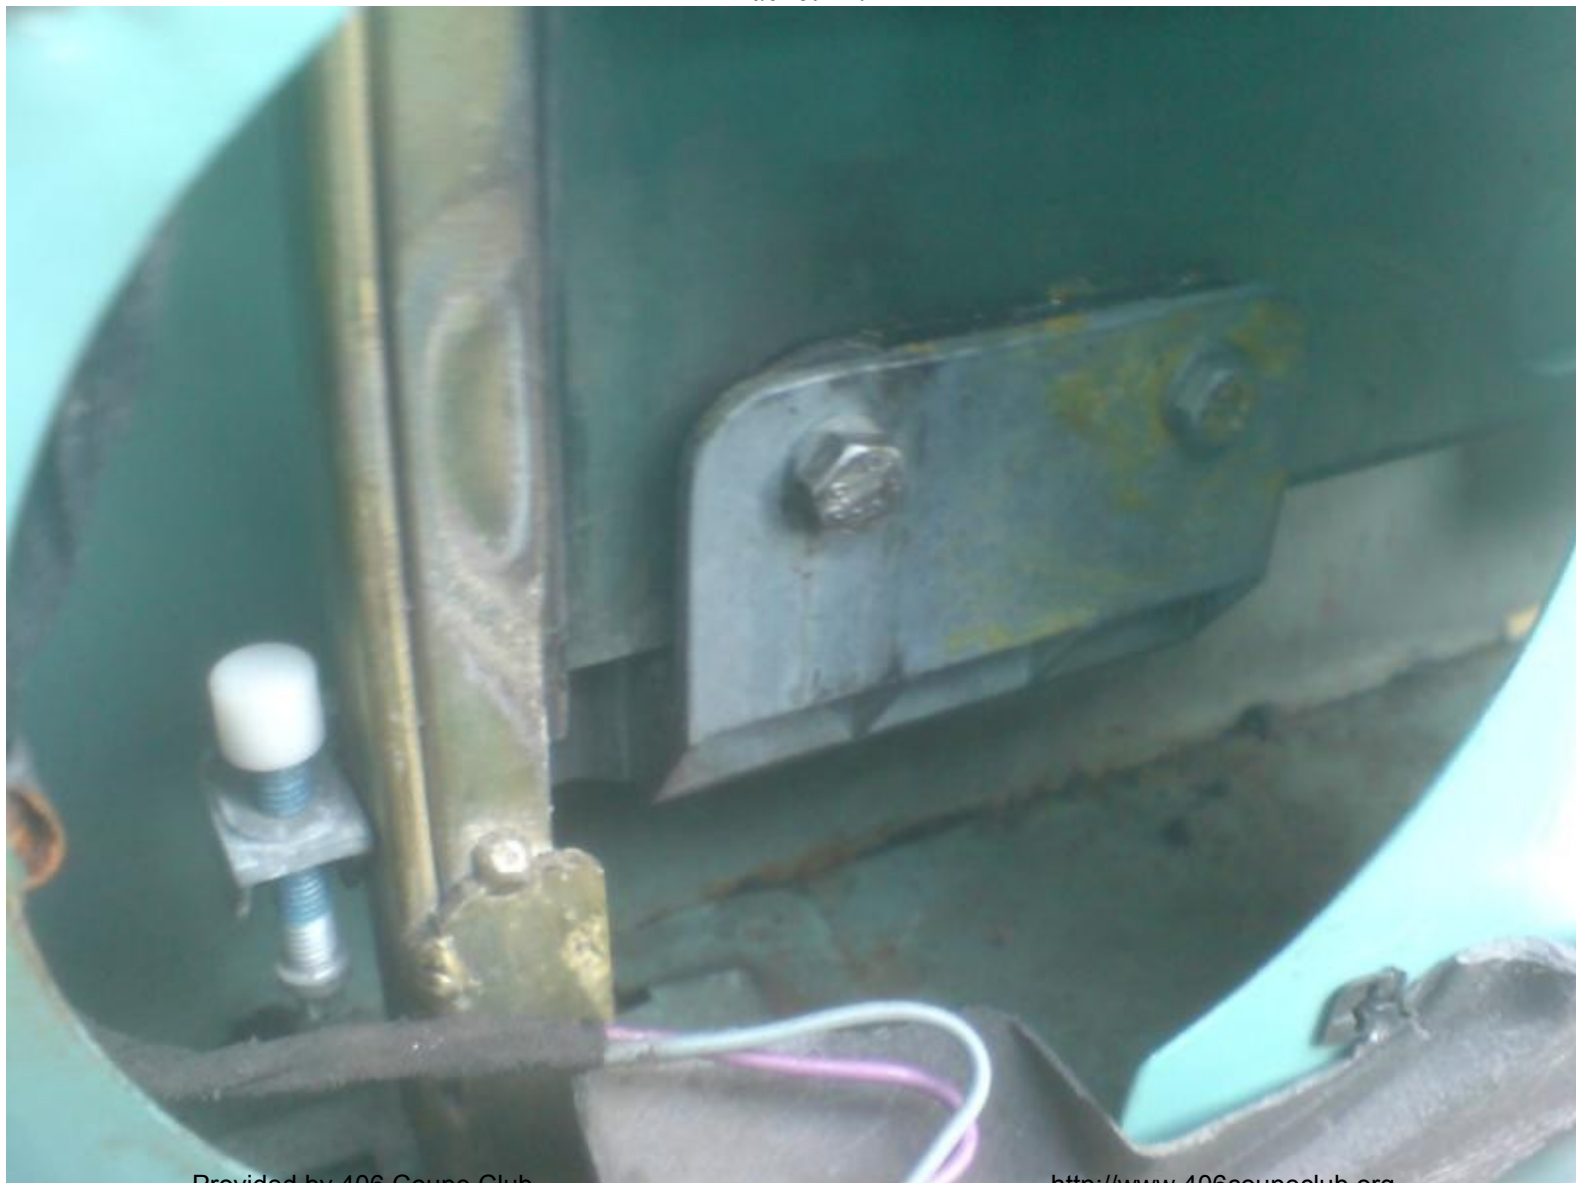
Bracket 11:

3. I then took the window out, although I'm not 100% sure this is required. I did it to give more room and make sure I wouldn't break it. To remove the window, remove the interior strip number 6 in the next picture. Then lower the window and use a 10mm socket to remove the 2 bolts (77 + 80 + 73) from bracket 11, removing the bracket as well. Then raise the window so that the bolts numbered 78 can be accessed from the outside of the door, through the circular holes exposed after removing the external trim strip. You will have to do one bolt and then move the window to get to the other one and remove metal strip 12. After this, lower the window and get access to the bottom of the window where the mechanism attached to the window, via sliders number 9. Remove the clips and then pull (quite hard) to separate the window from the mechanism. The window can then be lifted out of the door

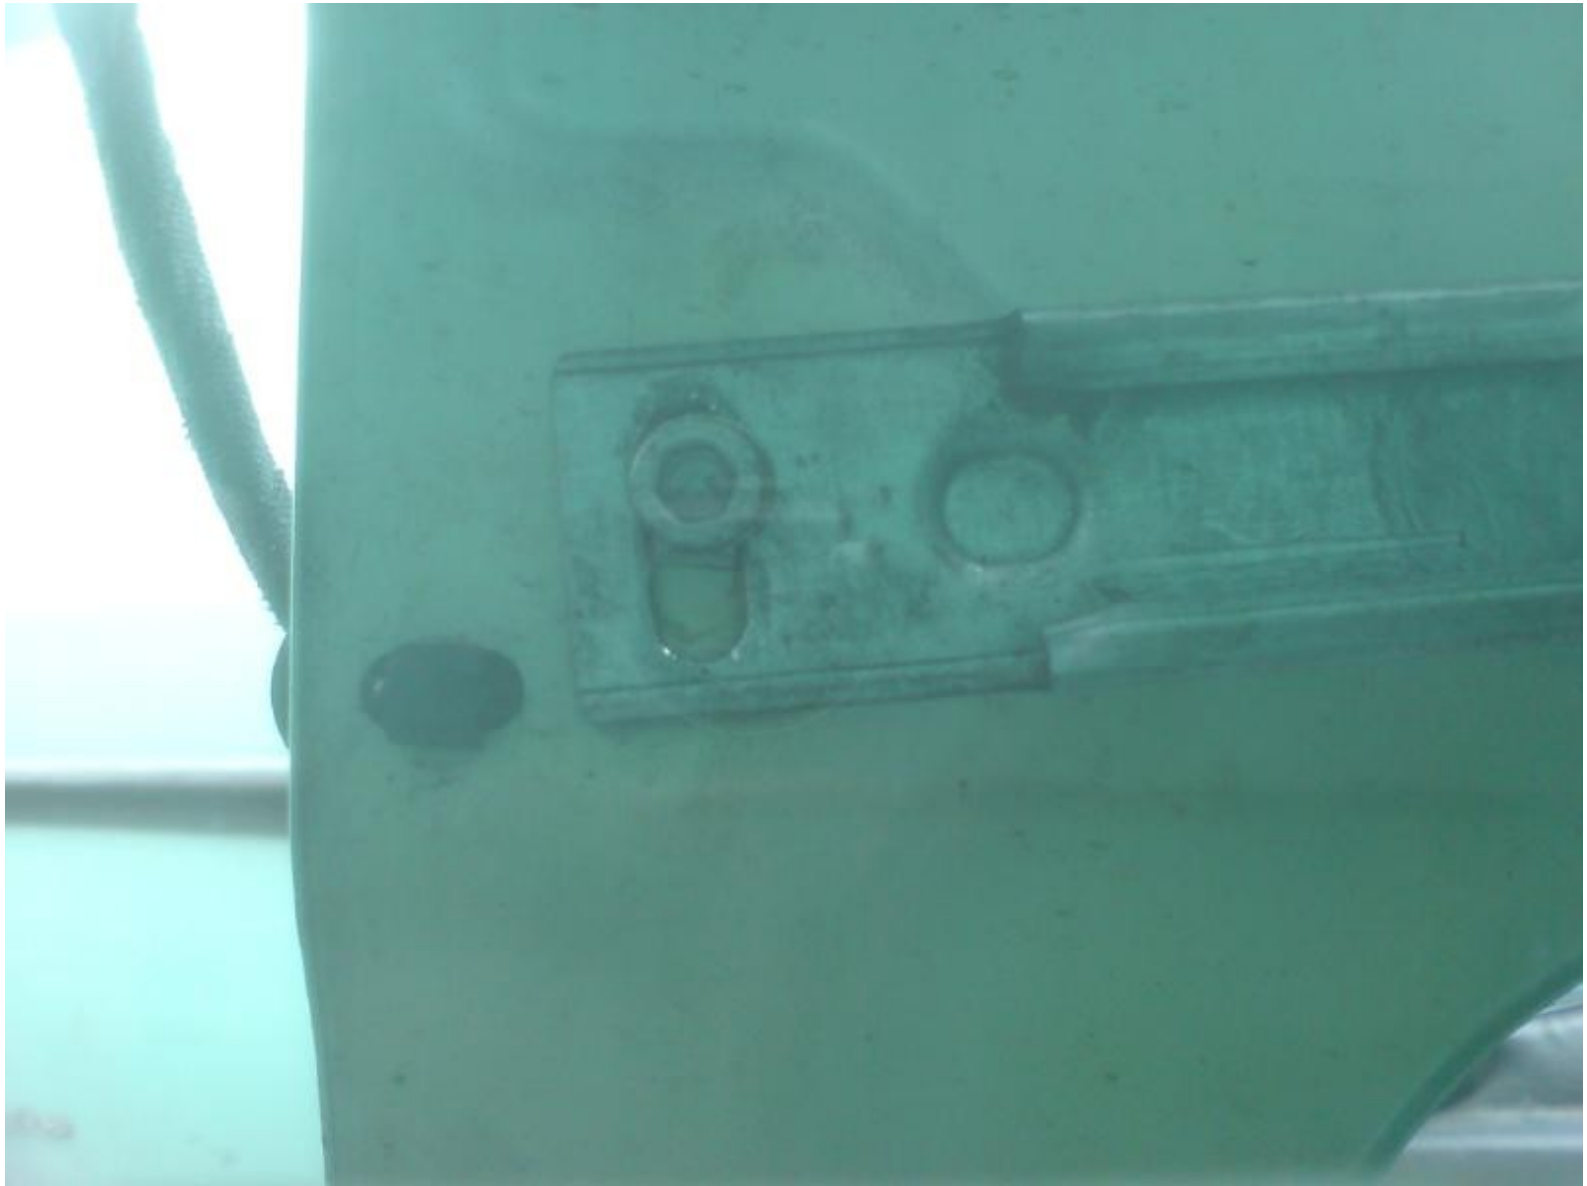
5. To fit the new regulator, wriggle it into the door and make sure the rail is in the correct location (if you struggle, you can connect the regulator to the wiring harness and adjust it to make it easier). Using a rivet gun (I got one for £3 and bought some Stanley 5 x 12 mm rivets like listed in the Parts catalogue - these were way too long and used some 5 mm ones that came with the gun), put rivets in the 4 holes shown above. use a smaller rivet (4mm?) to attach the side of the rail closest to the engine and put the bolt in the other end. Do not tighten is fully though:

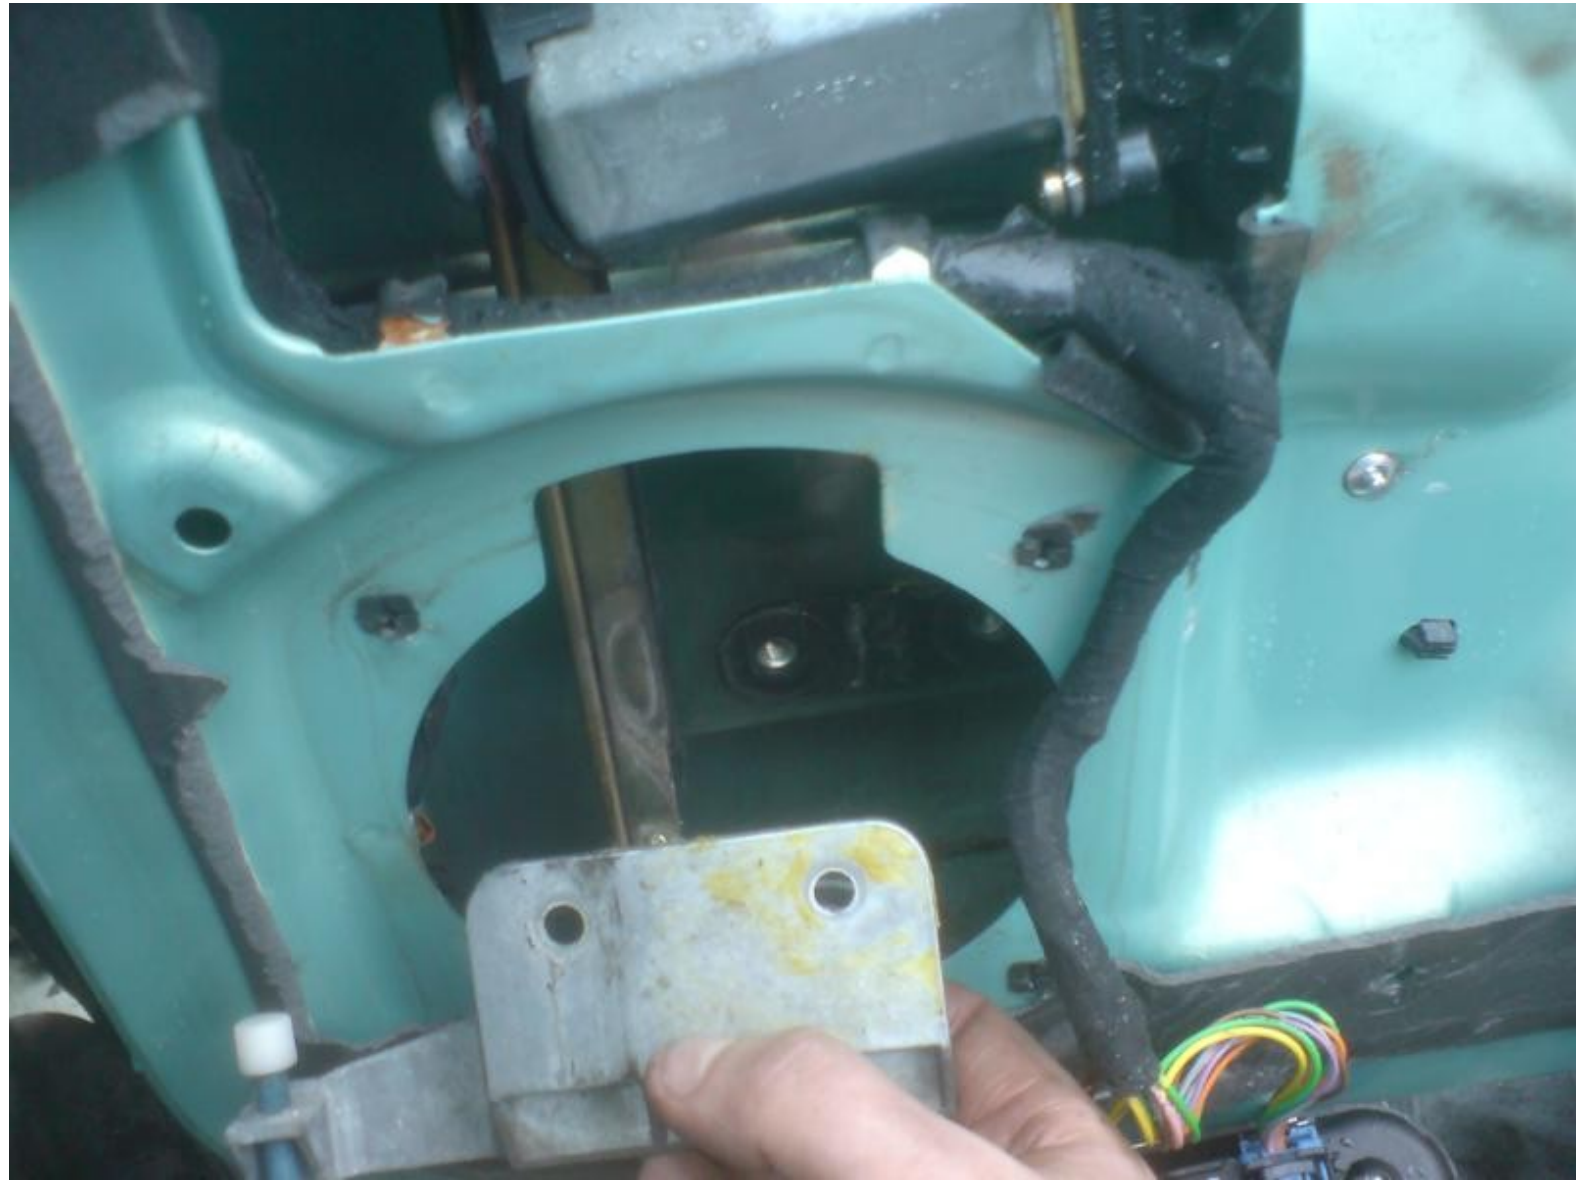
Bracket 11:

6. Before putting the window back, slide the clips removed earlier onto the 2 sliders as it is a lot easier with it out of the door. To put the window back, lower it carefully into the door then press the mechanism into the 2 sliders - press quite hard until it pops into position. Raise the window to allow the bolts/clips to be put back that were taken off earlier:

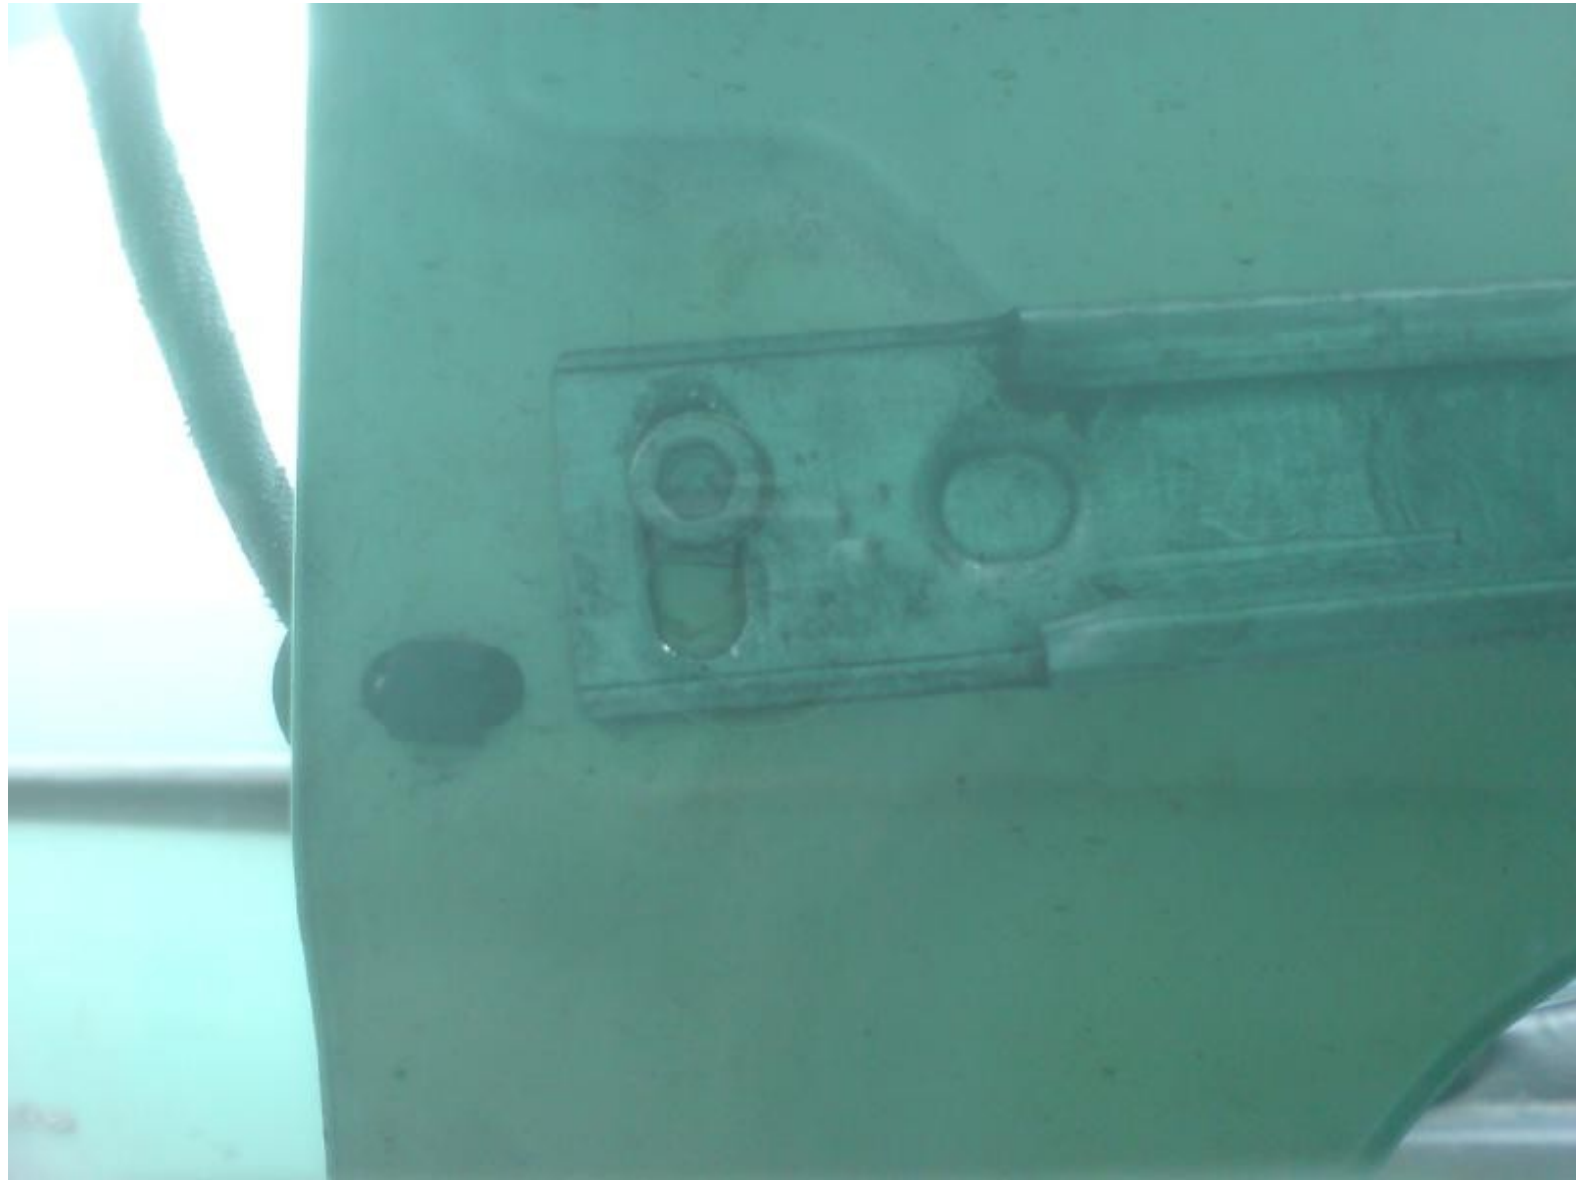
7. The best way for adjustment I found is to connect the window switch and raise the window to about an inch from being fully shut - its close to the shell but the window doesn't try to drop when the door is opened. You can then easily run your fingers between the gap (make sure you dont injure yourself!) and see if the gap is uniform - it might be smaller on one side than the other. First check that the seal around the shell/door frame is sat correctly and then move on to adjusting the rail:

This allows the rail to be raised and lowered to adjust front:back ratio. Once it is even, you can tighten the bolt. I found the rail needed to be around half way (one tip - have a look at your old rail...)
