How To: Brembo corrosion / stainless plates

Plate tectonics

Light-alloy brake calipers – as fitted to many Porsches during the 1980s and 1990s – can suffer from corrosion, which makes it difficult, if not impossible, to fit new friction pads, and can cause other problems, too. But renovating them isn't a particularly difficult job, reckons Philip Raby. Photographs by the author and Peter Robain

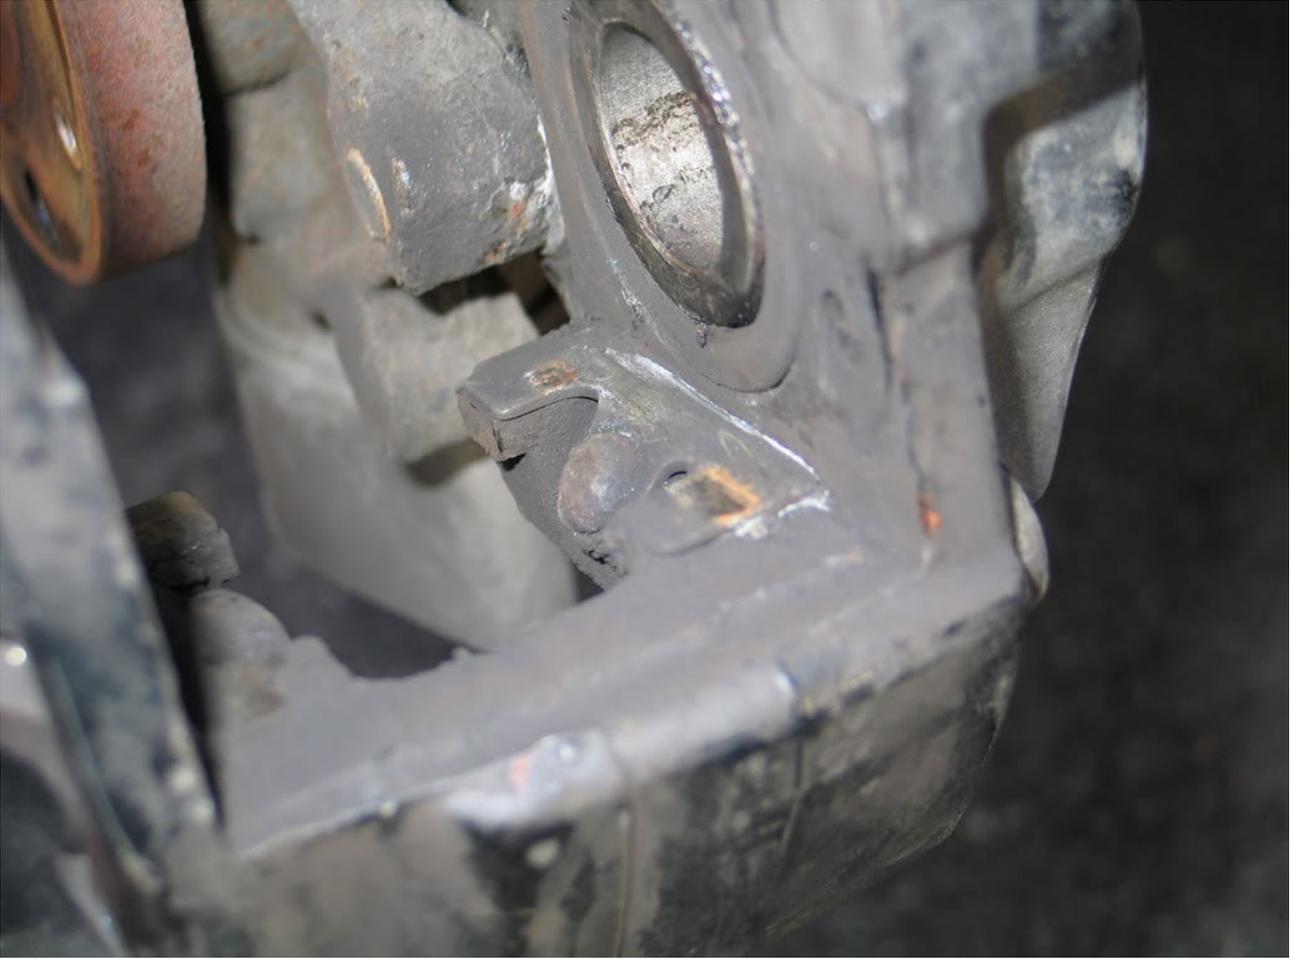
This one shows the lower, inboard s/s plate in place. White lines show the corrosion. Also, bolt head is full of dirt, this was thoroughly cleaned before attempting to open it (T27 is the size). Largest 'rusty' patch shows where pad presses against the plate, other end of the plate gets much less pressure, swapping top and bottom plates over improves this.

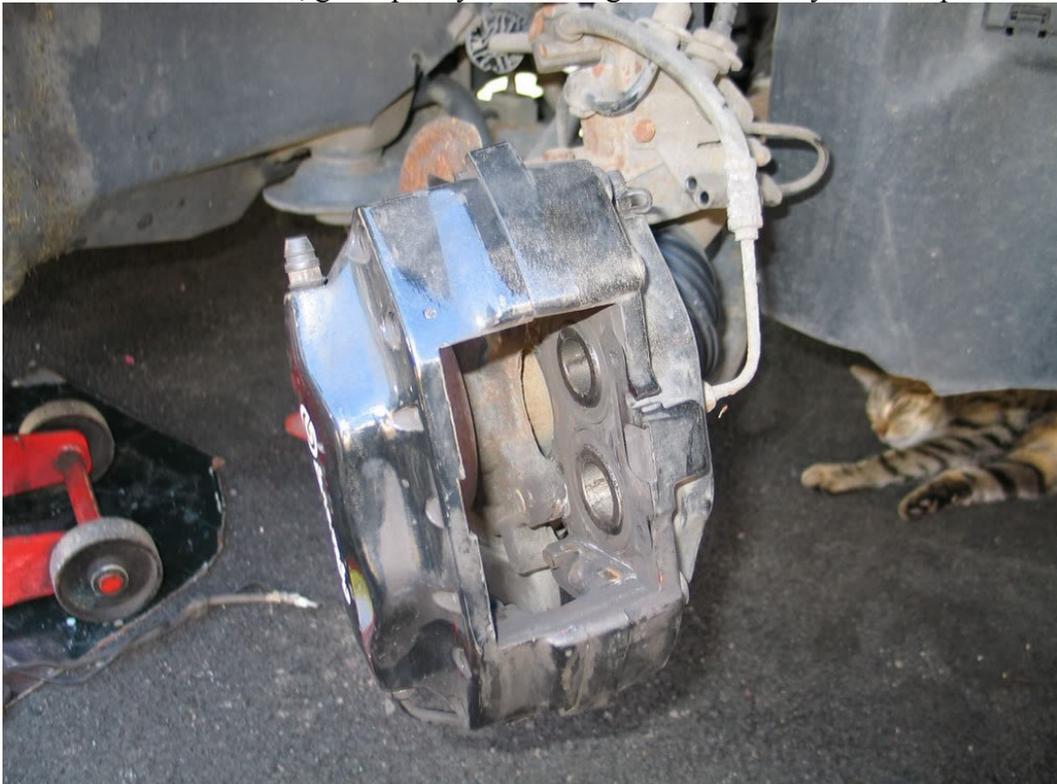
Caliper mounted on hub less disc, gives plenty of working room. Note my little helper under the car 😊

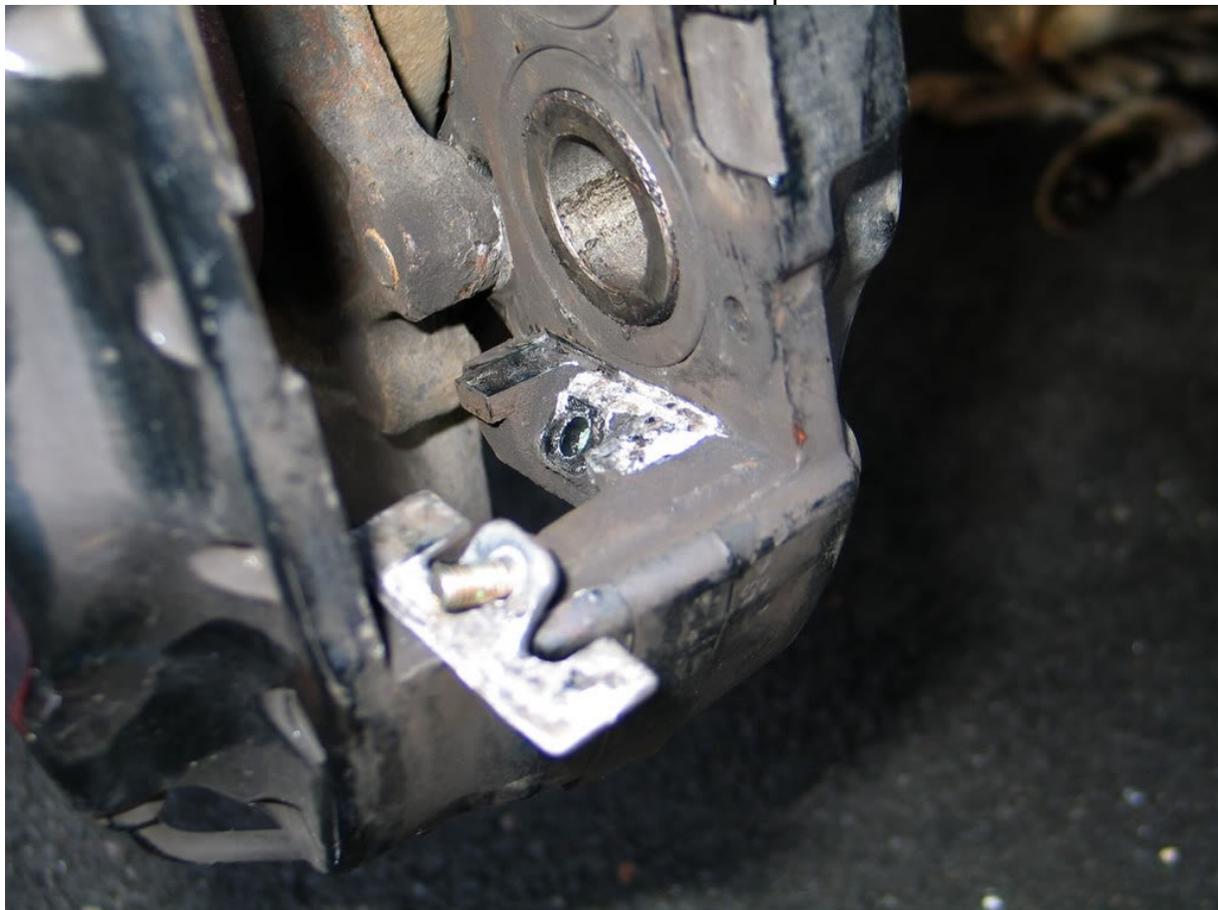
Corrosion that was under the plate.

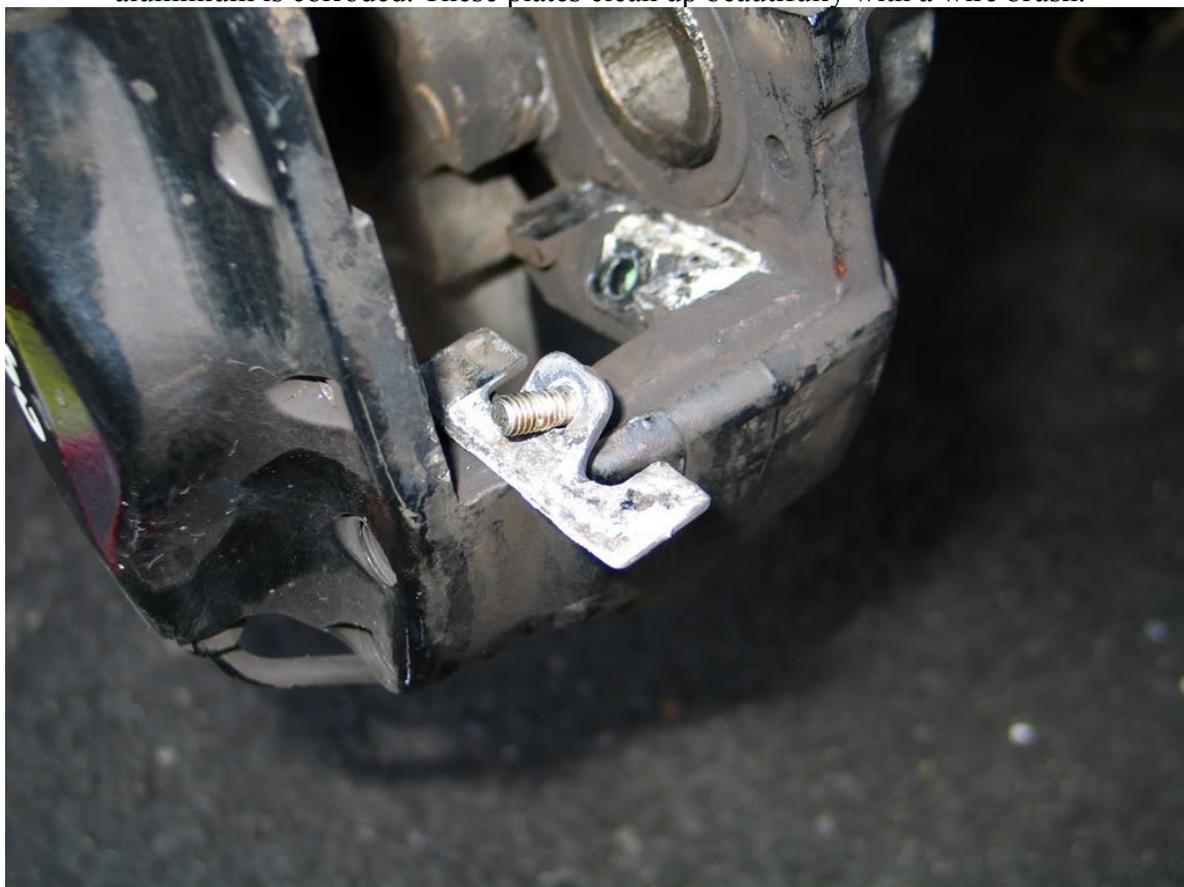
Back of plate. Plate surface itself is perfect and not corroded, the corrosion is only on top, stuck to the stainless, only the aluminium is corroded. These plates clean up beautifully with a wire brush.

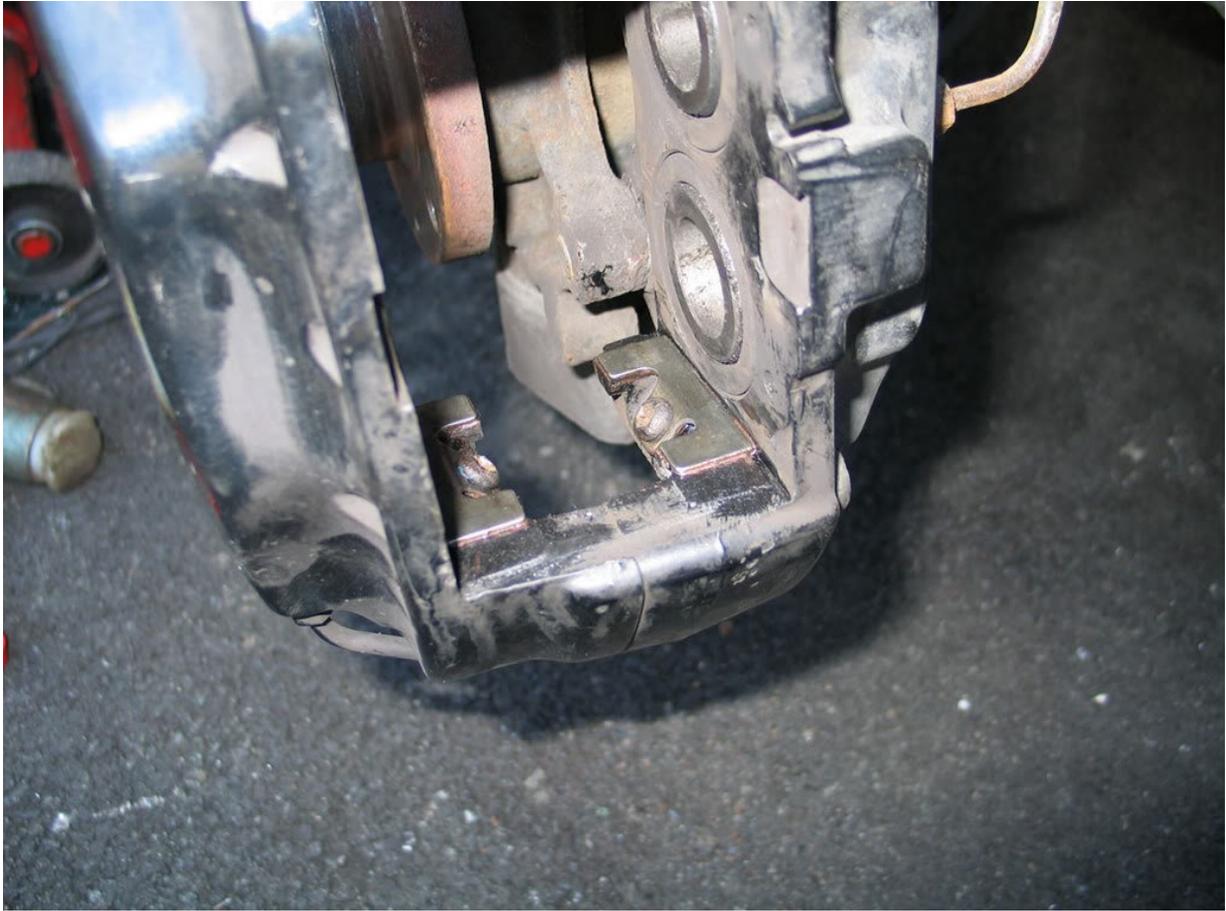
Back together. Fresh black is the new paint and you can see the 'coppa slip' coming out from under the plate. You can also see the plastic mallet used to persuade the disc off, worked very well without any damage.

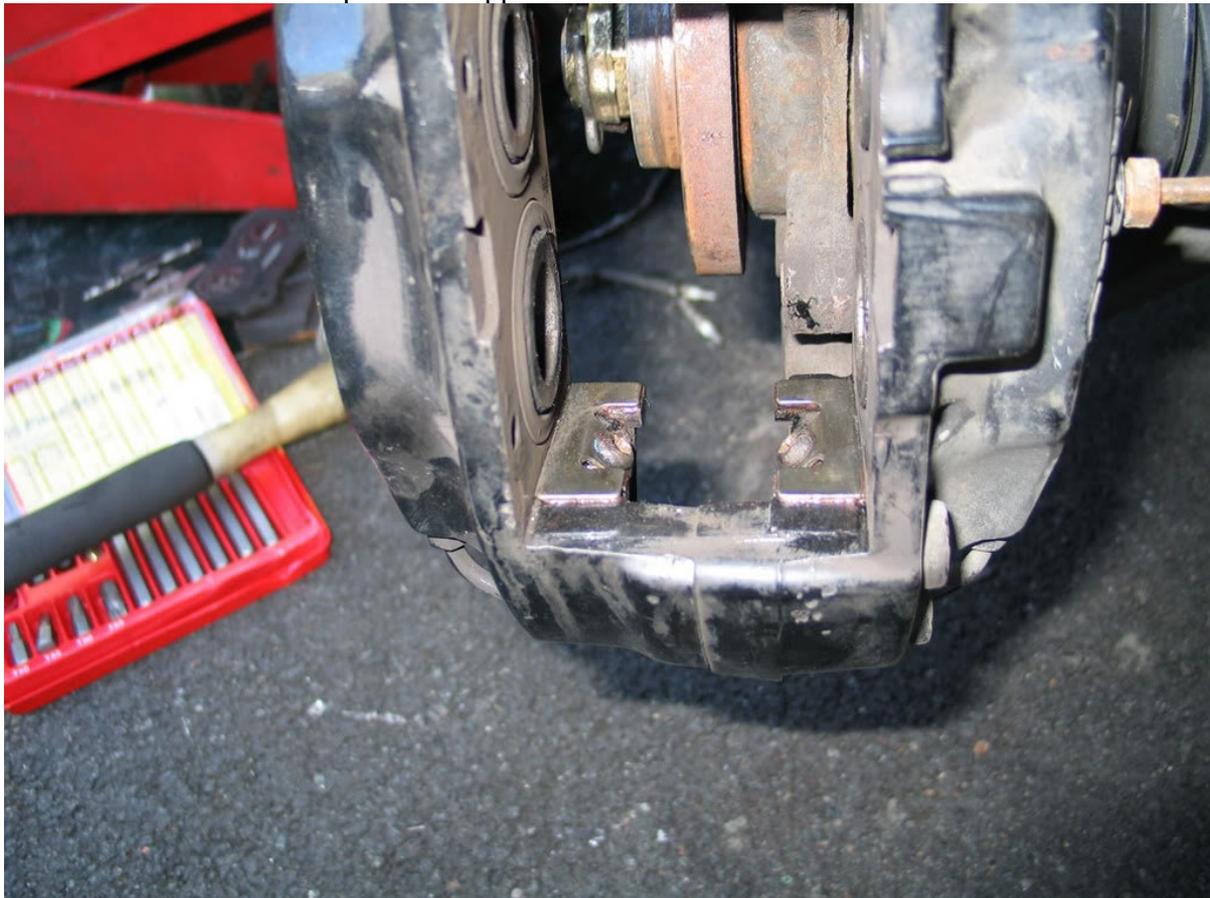
Another finished view. The plates came up like new with a gentle application of a wire brush. These plates are actually the top ones swapped over with the bottom ones.

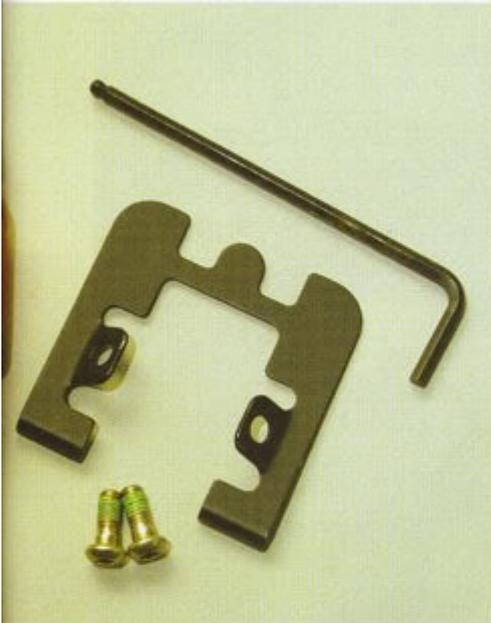
Repair kit consists of plate and two special screws – you'll need four kits per car

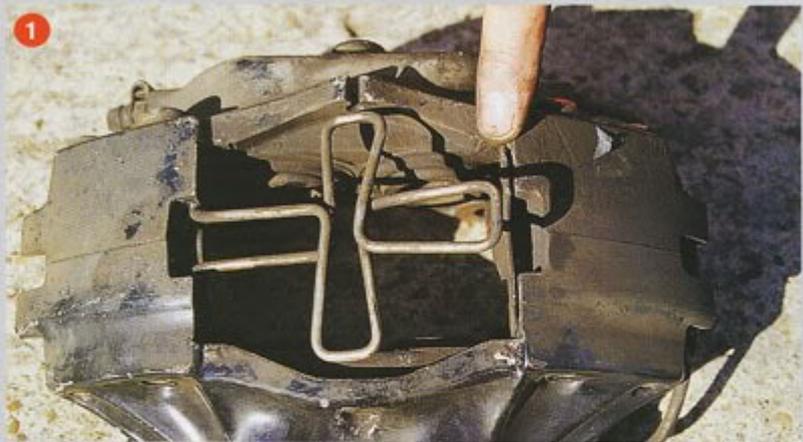
This is a front caliper from our 964-model 911 Carrera 4. The stainless-steel plate on the left of the photo has clearly lifted away from the aluminium caliper body beneath. It would be impossible to fit new brake pads in this situation without grinding material from the pads' backing plates – which certainly isn't recommended

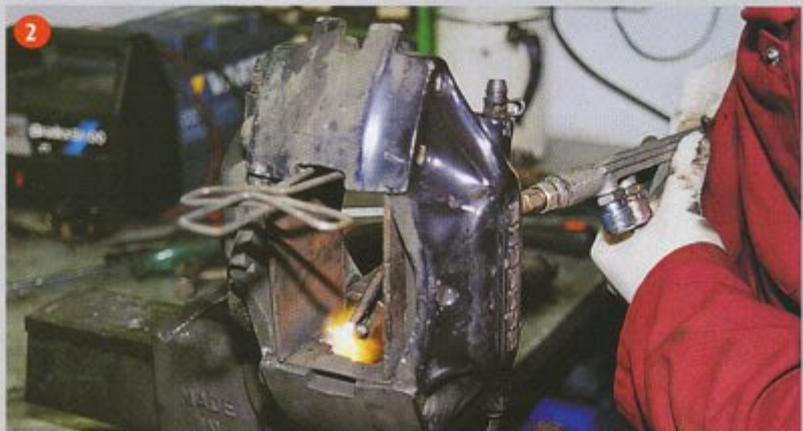
Once you've removed the brake pads you need to undo the two screws holding each plate in place. They're secured with thread-locking compound, so you'll have to heat them in order to release them. Protect the pistons and their rubber seals with steel plates (cut roughly to the size of the brake pads) and direct a blowtorch on the screw head until it's red-hot. You can then remove it with a 4mm hexagonal key (or possibly a Torx driver if the screw has been renewed before; more on this in a moment)

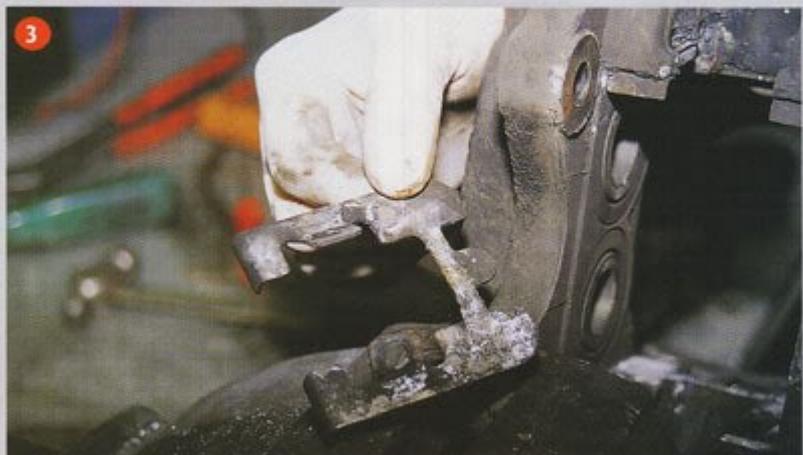
Once the screws are out of the way the plate should be free to move. But you might still need to lever it away from the caliper using a screwdriver (take care not to damage the aluminium, though). Our 964's calipers weren't badly corroded but, as you can see, the plate has clearly seen better days and is fit only for the bin

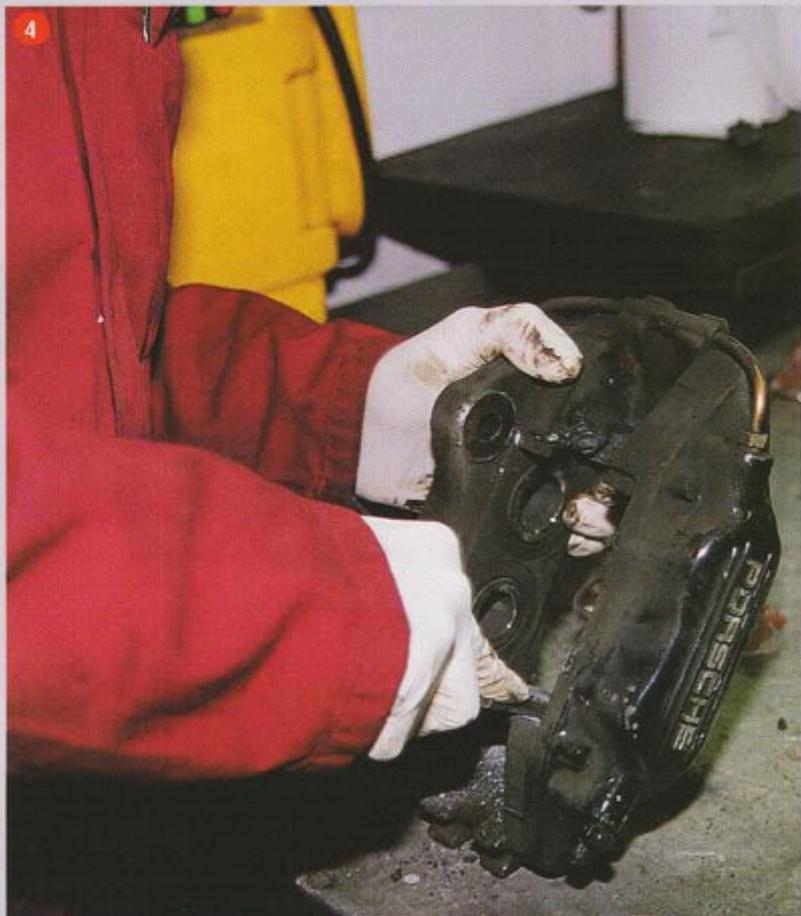
Although the plate must be replaced, the caliper itself can almost always be reclaimed for another tour of duty. You'll need a fine file carefully to smooth off any corrosion in the area round the stainless-steel plate. It's important not to get too carried away, though, and remove good metal from the caliper, otherwise the pads won't be held firmly and could vibrate and squeal. Check that the new plate sits correctly

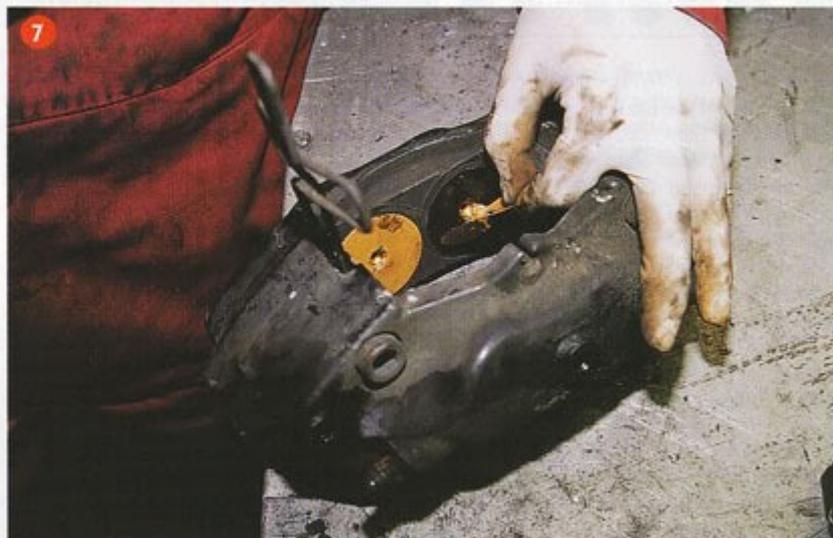
It's important to fit new anti-squeal shims. These have special self-adhesive pads that stick to the backs of the brake pads (so remember to peel off the backing paper before fitting the pads). The shims dampen any vibration, thus reducing the risk of noise during heavy or even moderate braking. Tit new wear-indicator wires and clips, too

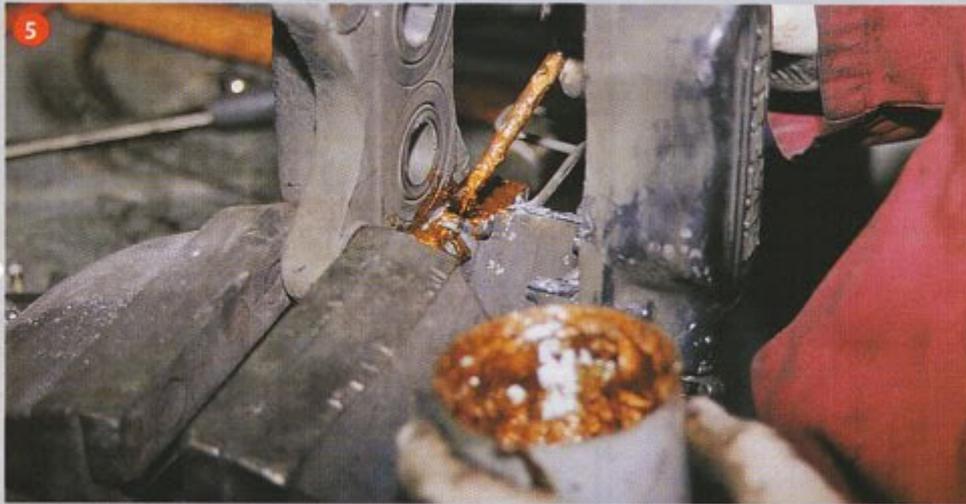
Once you're happy with the condition of the surface, use a brush to spread a very thin coat of high-temperature copper grease around the area that the plate will sit on. Don't overdo it, though; you don't want grease finding its way onto the pads and discs. This will go some way to prevent corrosion recurring. Eventually, though, this will dry up and corrosion will set in again. You're looking at up to five or even 10 years, though

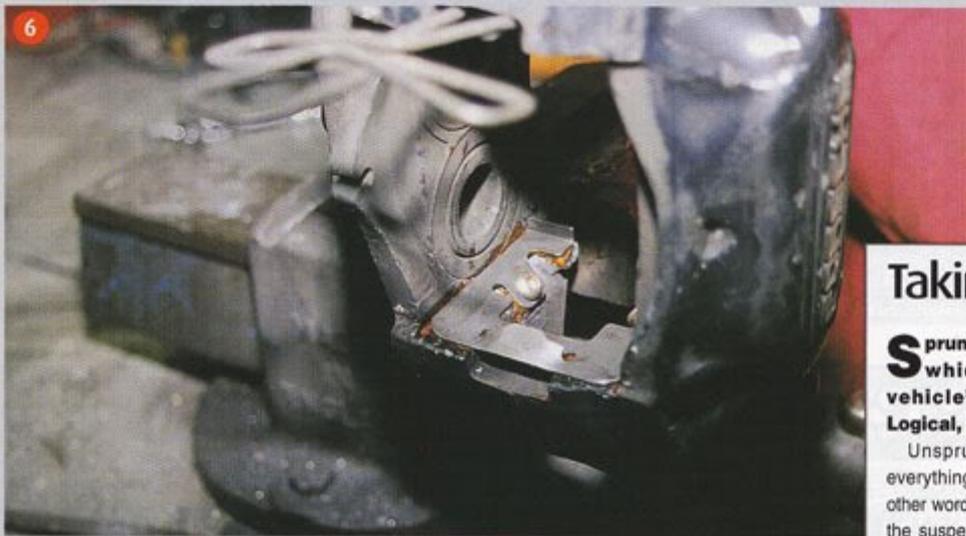
Now you can fit the new plates. It's essential to use thread-locking compound on the screw threads. Always use new plates and new screws; they come together in a special kit. Wipe off any excess grease at this stage

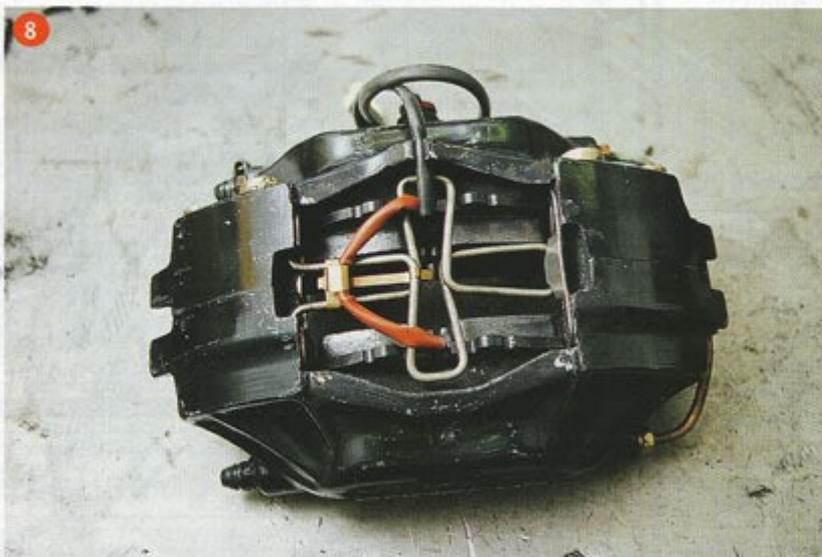
Here's the reassembled caliper complete with new pads. Note that the stainless-steel plate now sits firmly against the aluminium. The caliper shouldn't require any further attention - apart from routine fitting of new friction pads as required - for several years
